TECHNICAL MEMORANDUM

Project No. 20138294

NUTANA SLOPE INSTABILITY UPDATE – MAY 2023

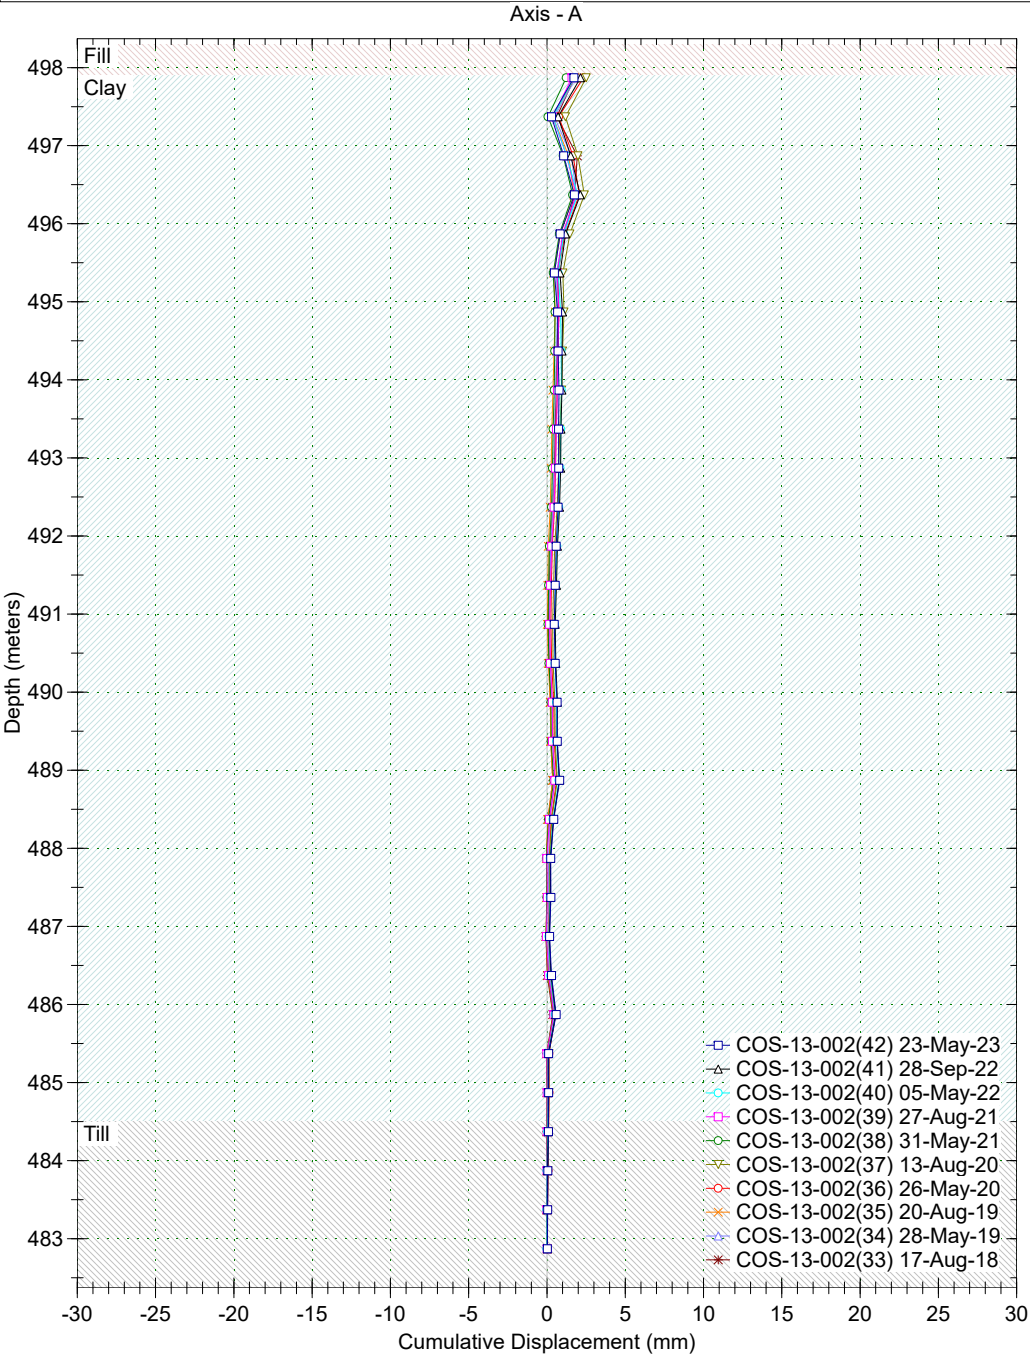
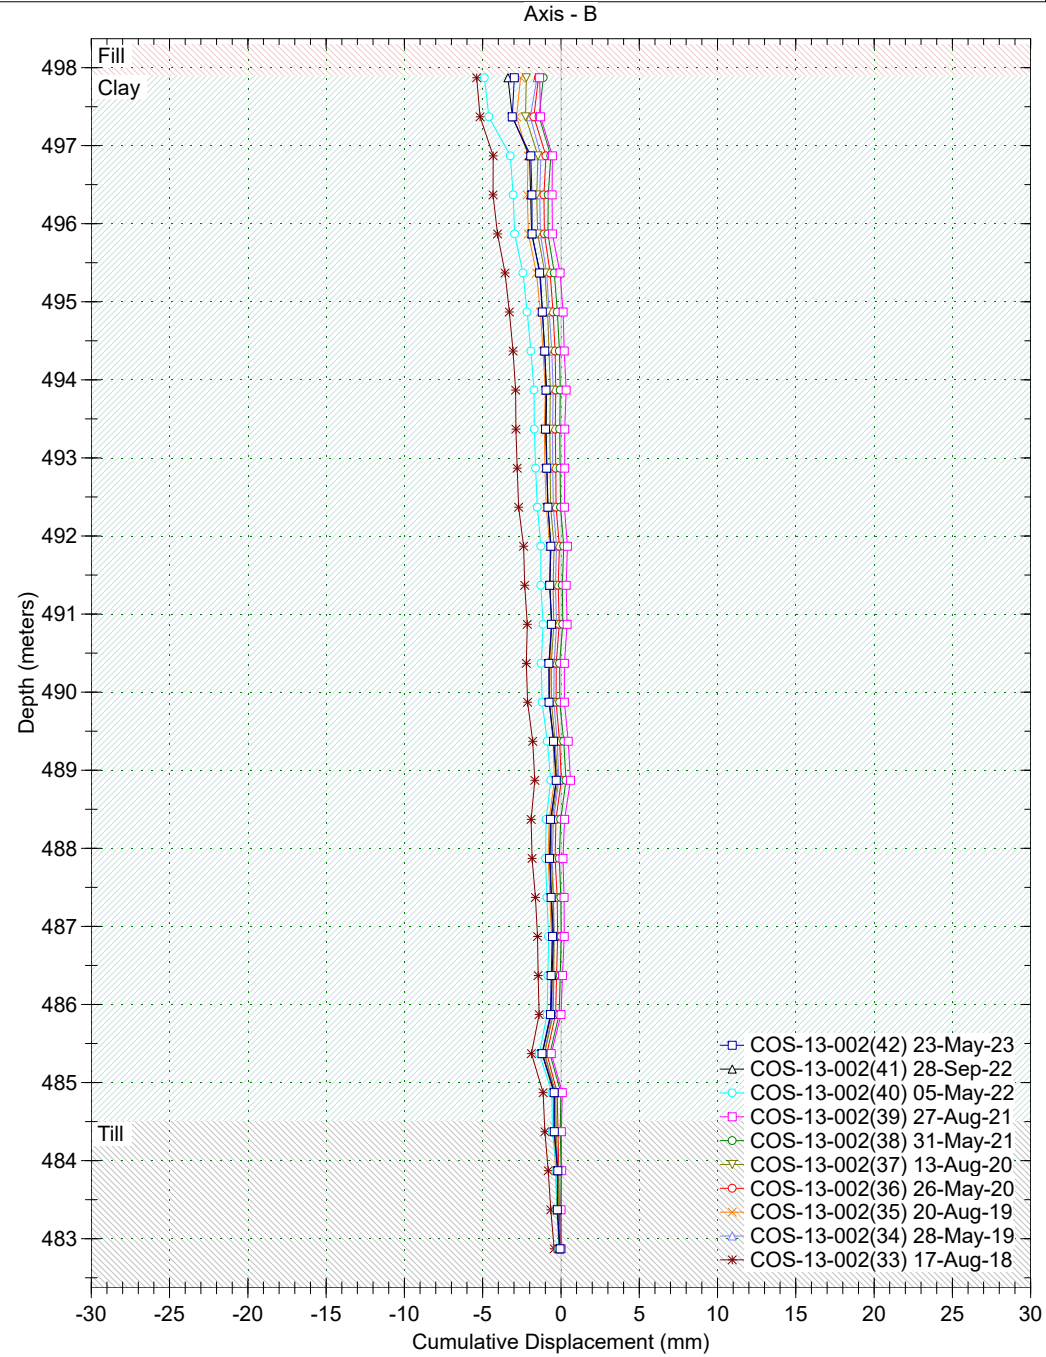
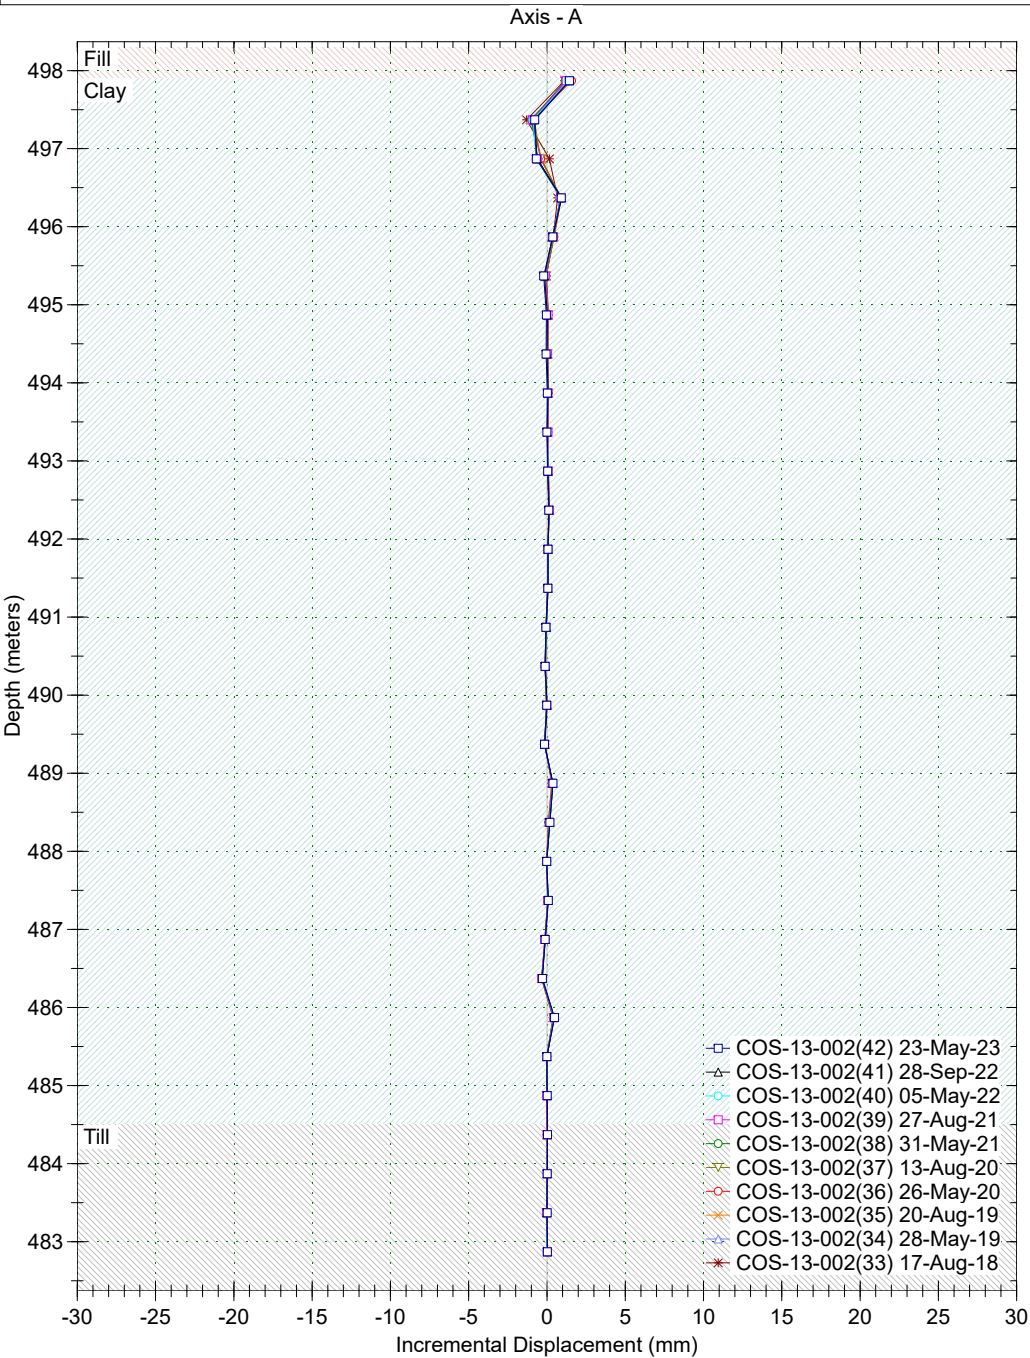
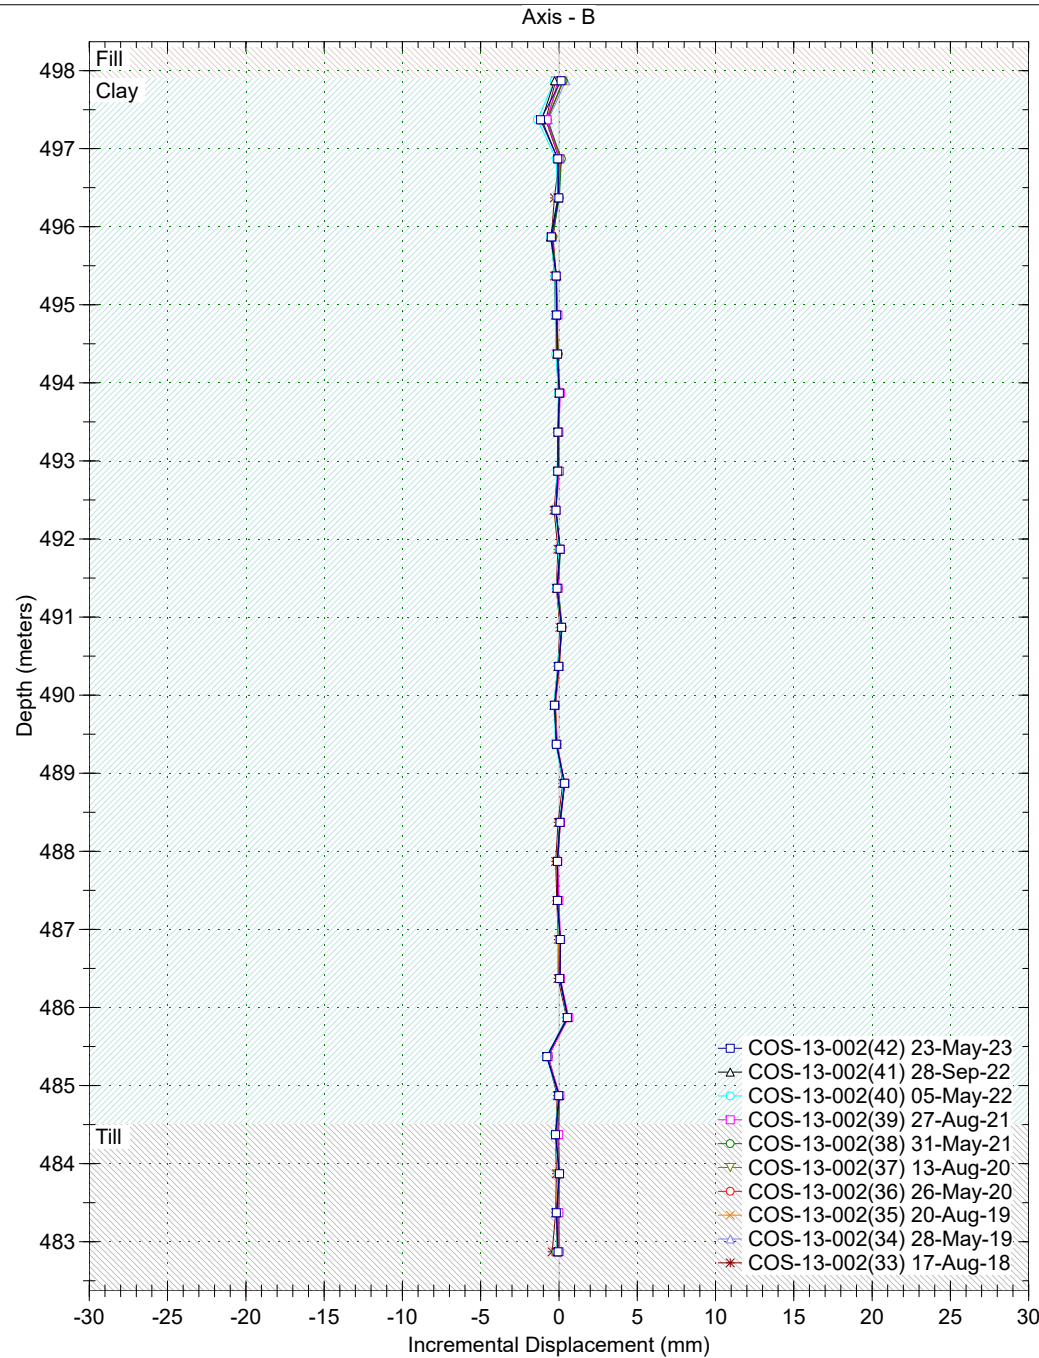
Borehole : COS-13-002
 Project : Nutana Slope
 Location : 307 11th St. E. (Front)
 Northing : 5775567.41
 Easting : 386043.54
 Collar : -0.113

- Inclinometers COS-13-002, COS-13-004, and 20-111 indicated insignificant movement (less than 2 mm or 0.08 in), between September 28, 2022 and May 23, 2023.
- Inclinometer COS-13-005 indicated insignificant movement (less than 2 mm or 0.08 in) between September 28, 2022 and May 25, 2023.
- Inclinometer 20-109 indicated approximately 2 mm (0.08 in) of cumulative downslope movement between September 28, 2022 and May 23, 2023. This inclinometer plot showed a drift in direction parallel with the Cherry Lane similar to what was observed in 2022.

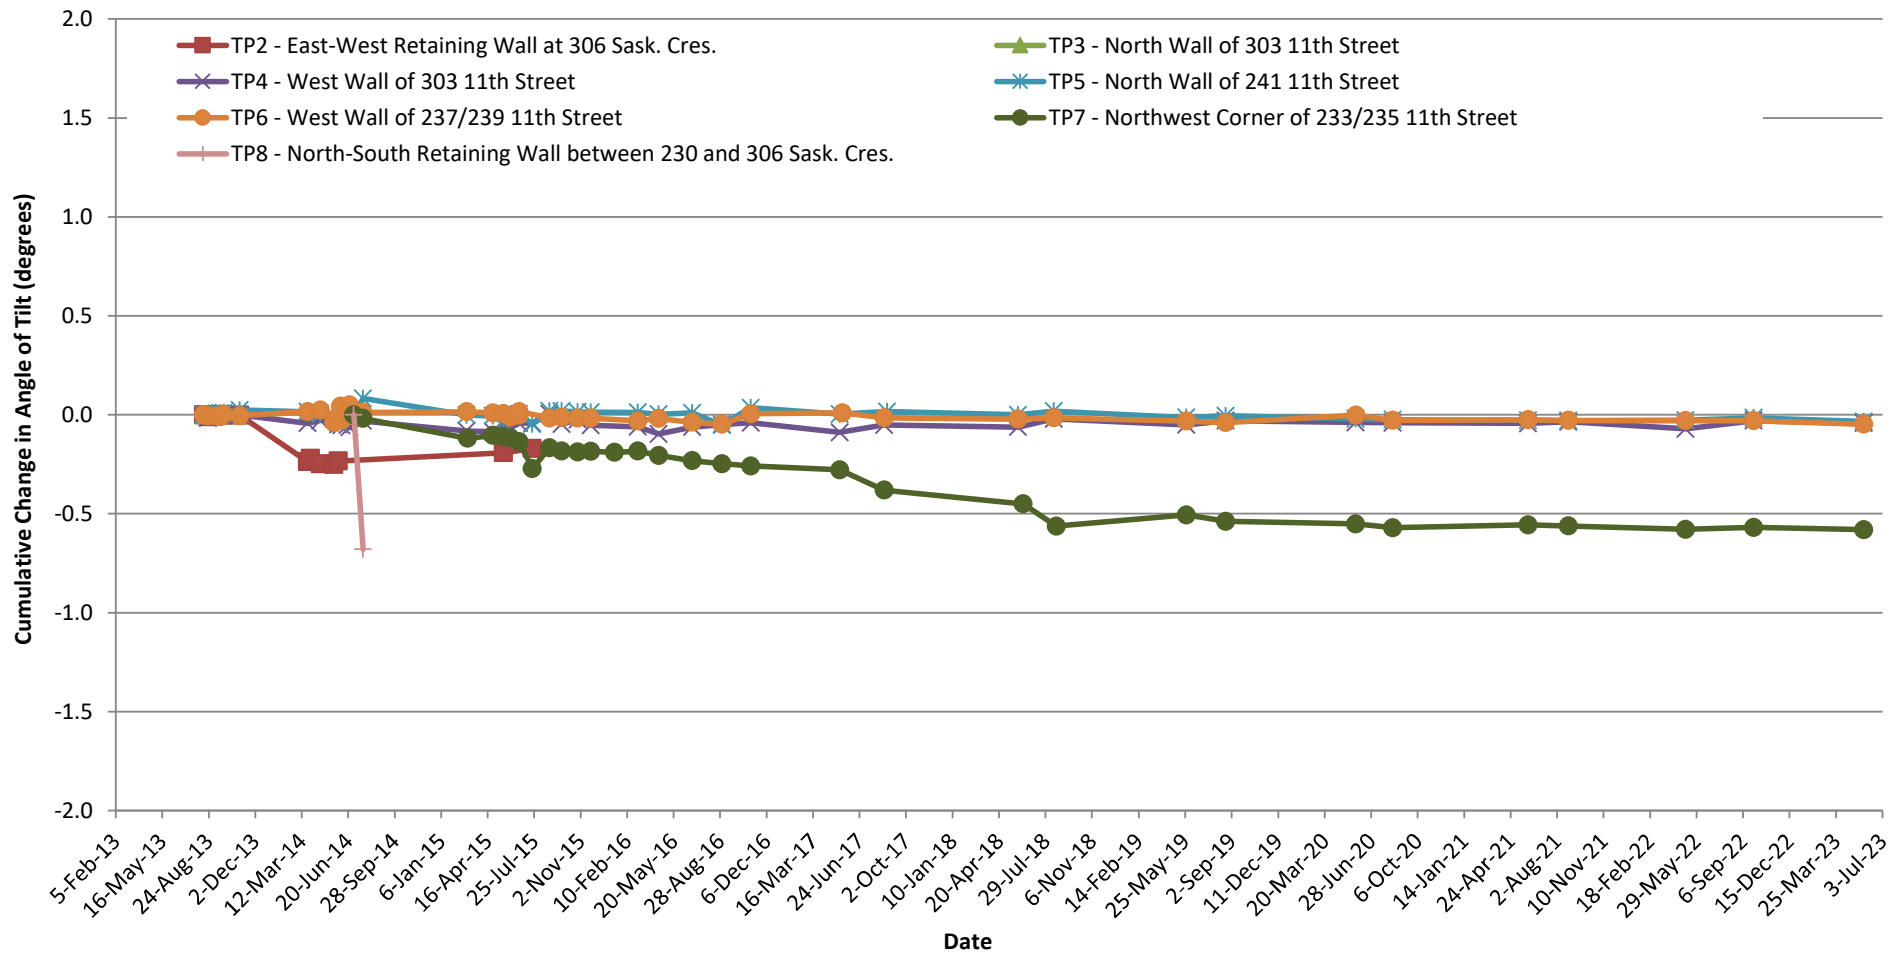
FIGURE: 4

- The results of tilt plate monitoring are shown on Figure 4 for the City of Saskatoon tilt plates, and in Figure 5 for the tilt plates installed on SL&P power poles.
- Tilt plates TP4, TP5, TP6, and TP7 indicate insignificant changes in angle of tilt (less than 0.05 degrees) between September 28, 2022 and May 23, 2023.
- Tilt plate SLP3 indicated a change in angle of tilt of approximately 0.34 degrees, towards the north, between September 28, 2022 and May 23, 2023.
- Tilt plate SLP4 indicated an insignificant change in angle of tilt (less than 0.05 degrees) between September 28, 2022 and May 25, 2023.
- Tilt plates SLP5 and SLP6 indicated insignificant changes in angle of tilt (less than 0.05 degrees) between September 28, 2022 and May 23, 2023.

- Notes:
- 1) Positive changes in tilt indicate tilting toward the monitoring structure.
 - 2) TP1, located on the retaining wall between 230 and 306 Sask. Cres., is not monitored for health and safety reasons; monitoring results for this tilt plate show a change in angle of tilt of approximately 9 degrees between August 2013 and June 2014.
 - 3) TP3 and TP8 are destroyed, and TP2 is buried.

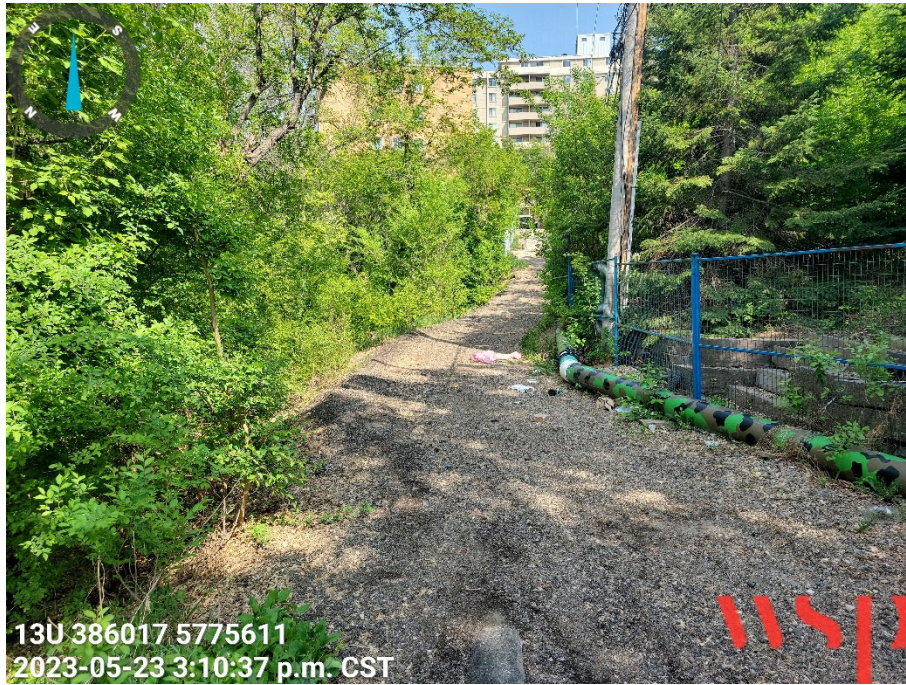
The east slide occurred in June 2013 and impacted a slope area of approximately 50 m (165 ft) long and 30 m (100 ft) wide. It is most pronounced in the back yards of 303, 305, 307, and 309 11th Street East, through the back alley, and into the back yard of 306, 310 and 316 Saskatchewan Crescent East.

Photograph 1: Looking east down the back alley at the East Failure (May 23, 2023)

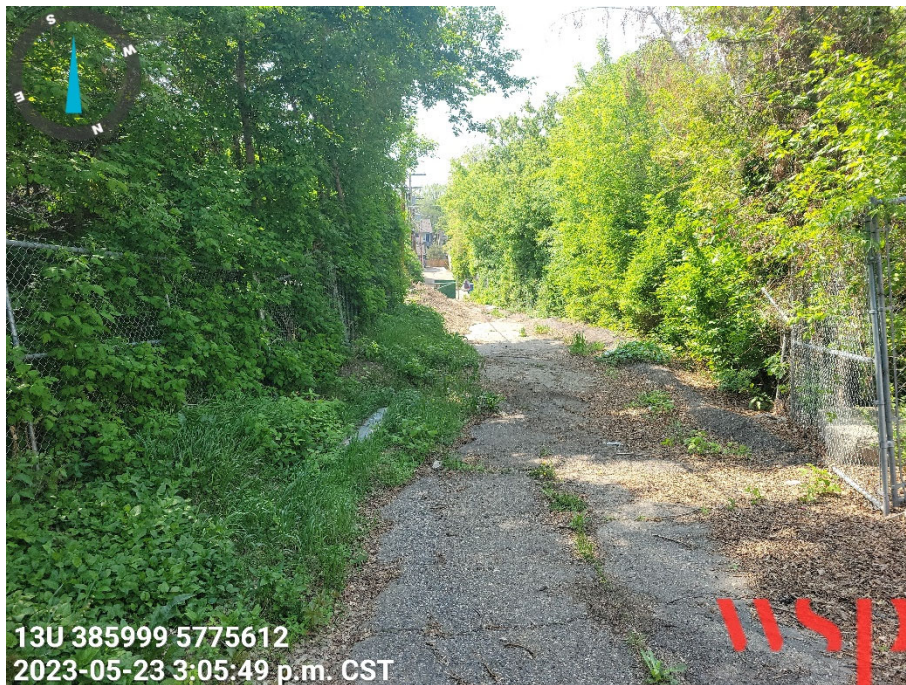
The west slide occurred in June 2012 and impacted a slope area approximately 70 m (230 ft) long and 40 m (130 ft) wide. It is most pronounced in the back yards of 229, 231, 233/235, and 237/239 11th Street East, through the back alley, and into the back yard of 222 Saskatchewan Crescent East.

Photograph 2: Looking west down the back alley at the West Failure (May 23, 2023)
