## TECHNICAL MEMORANDUM

**Project No.** CA-GLD-20138294

### NUTANA SLOPE INSTABILITY UPDATE – AUGUST 2023

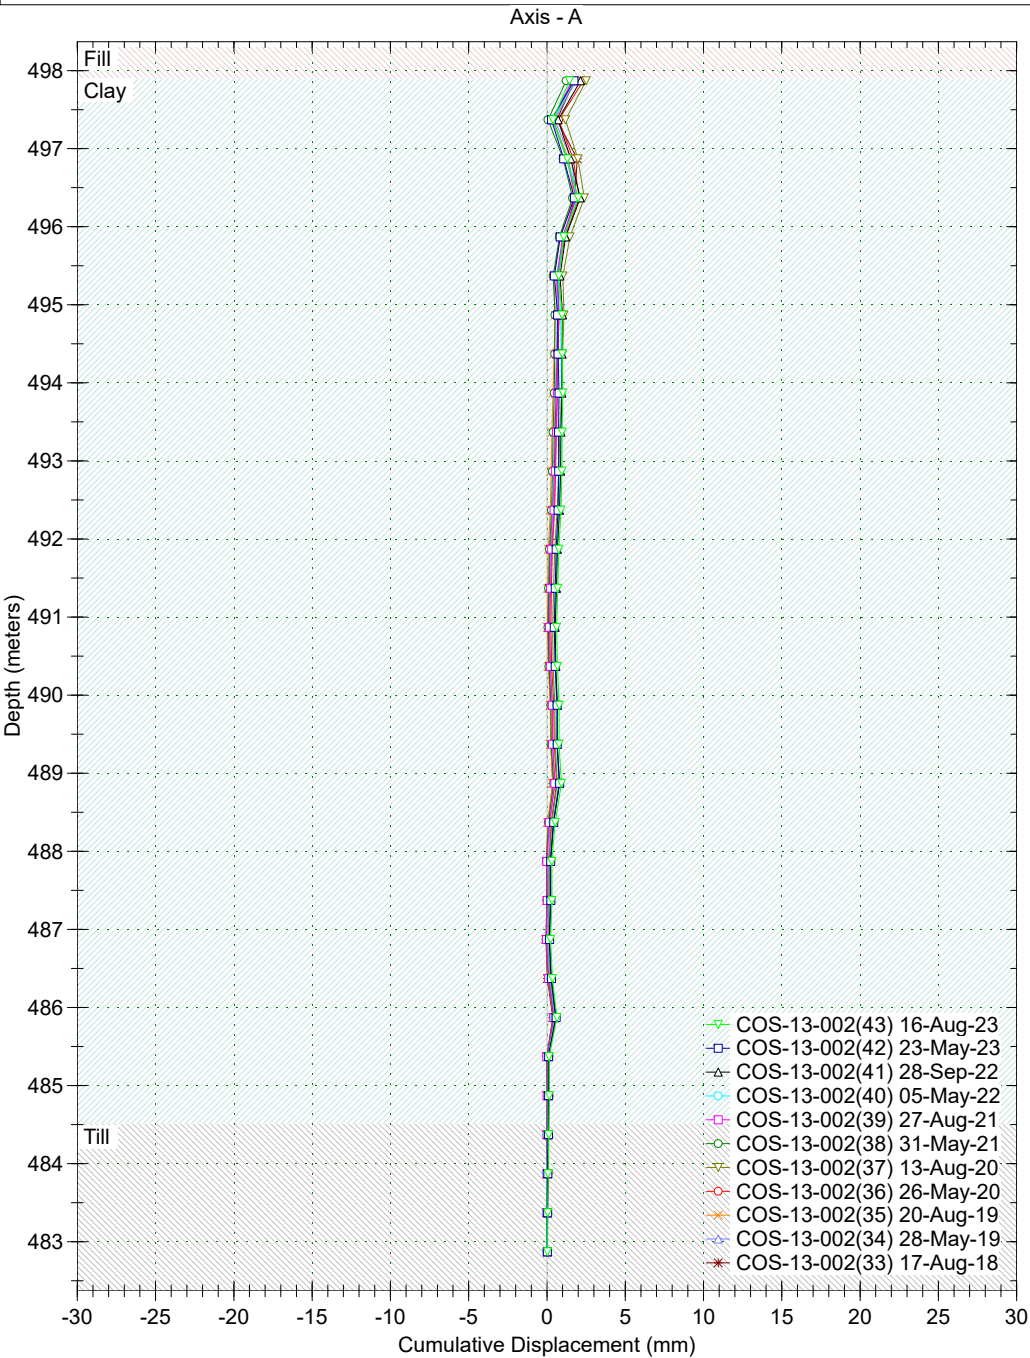
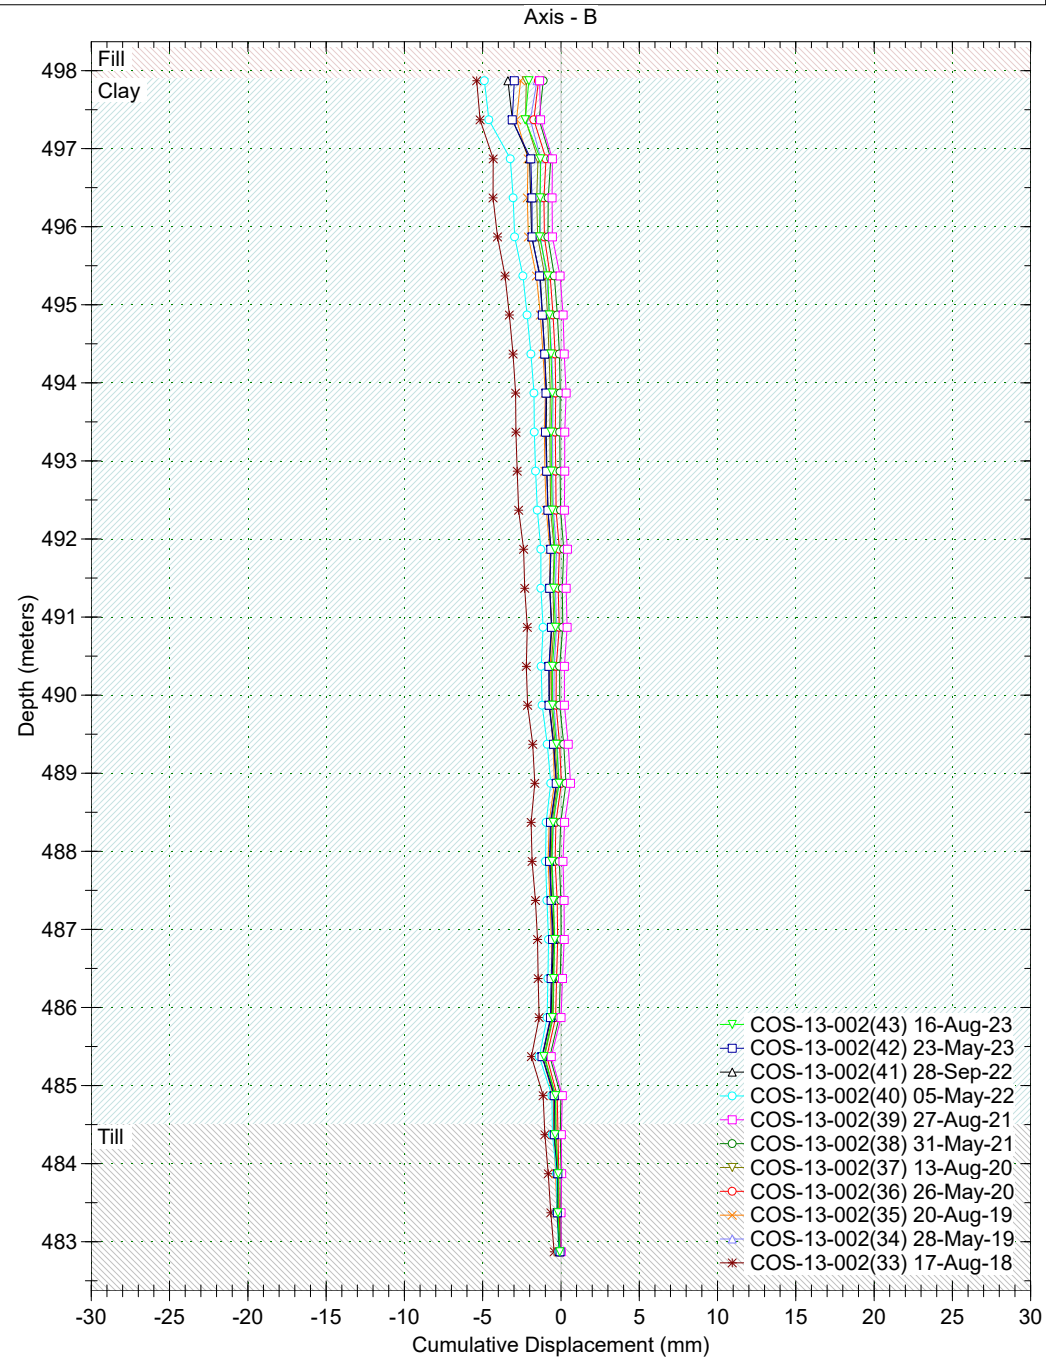
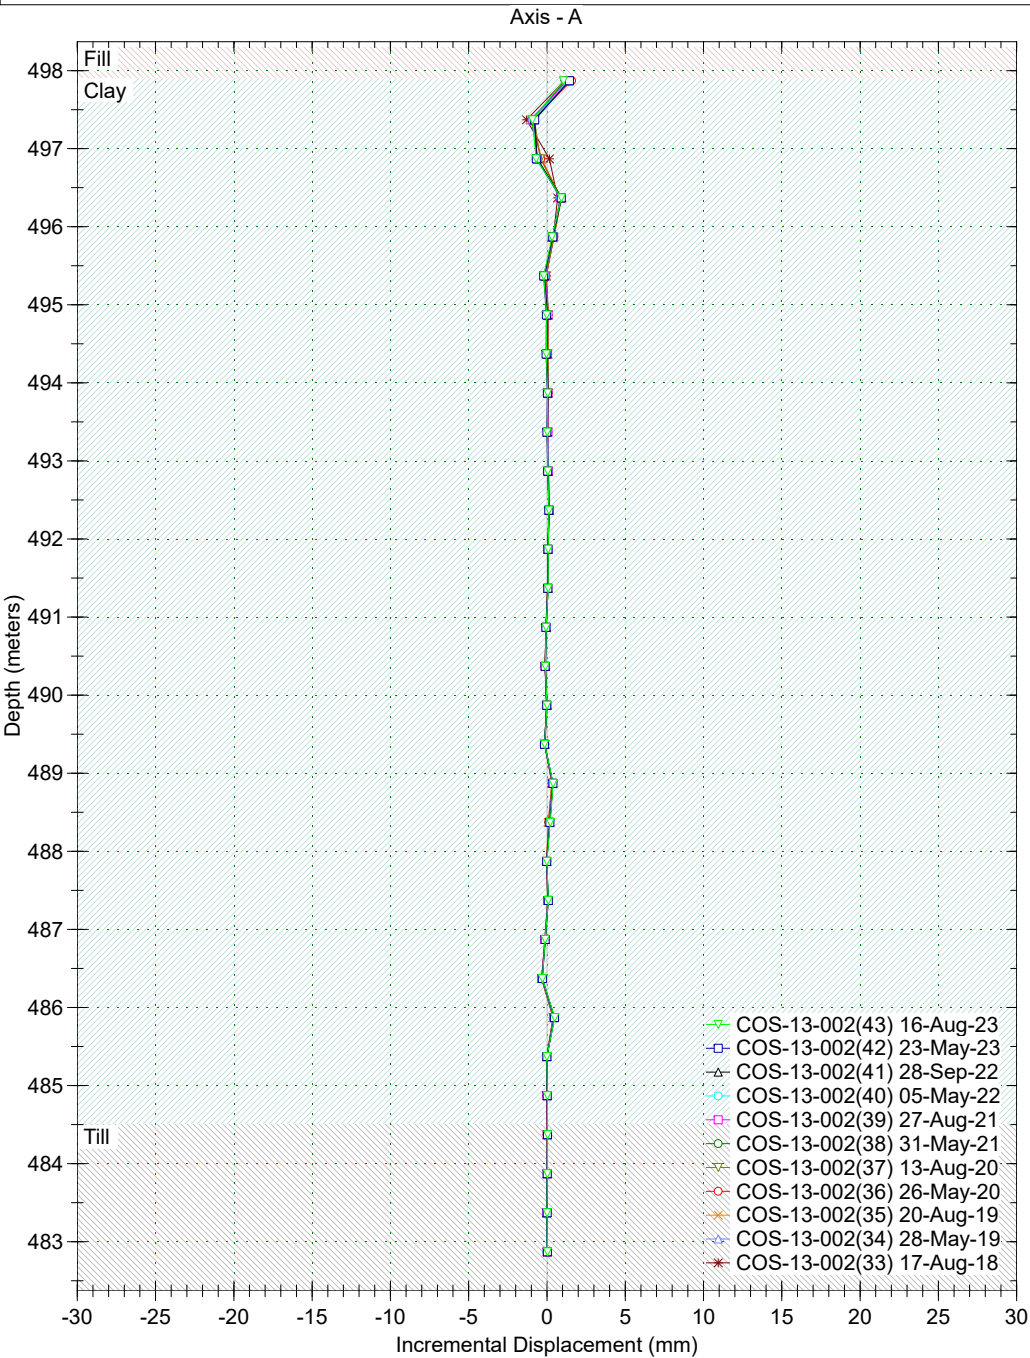
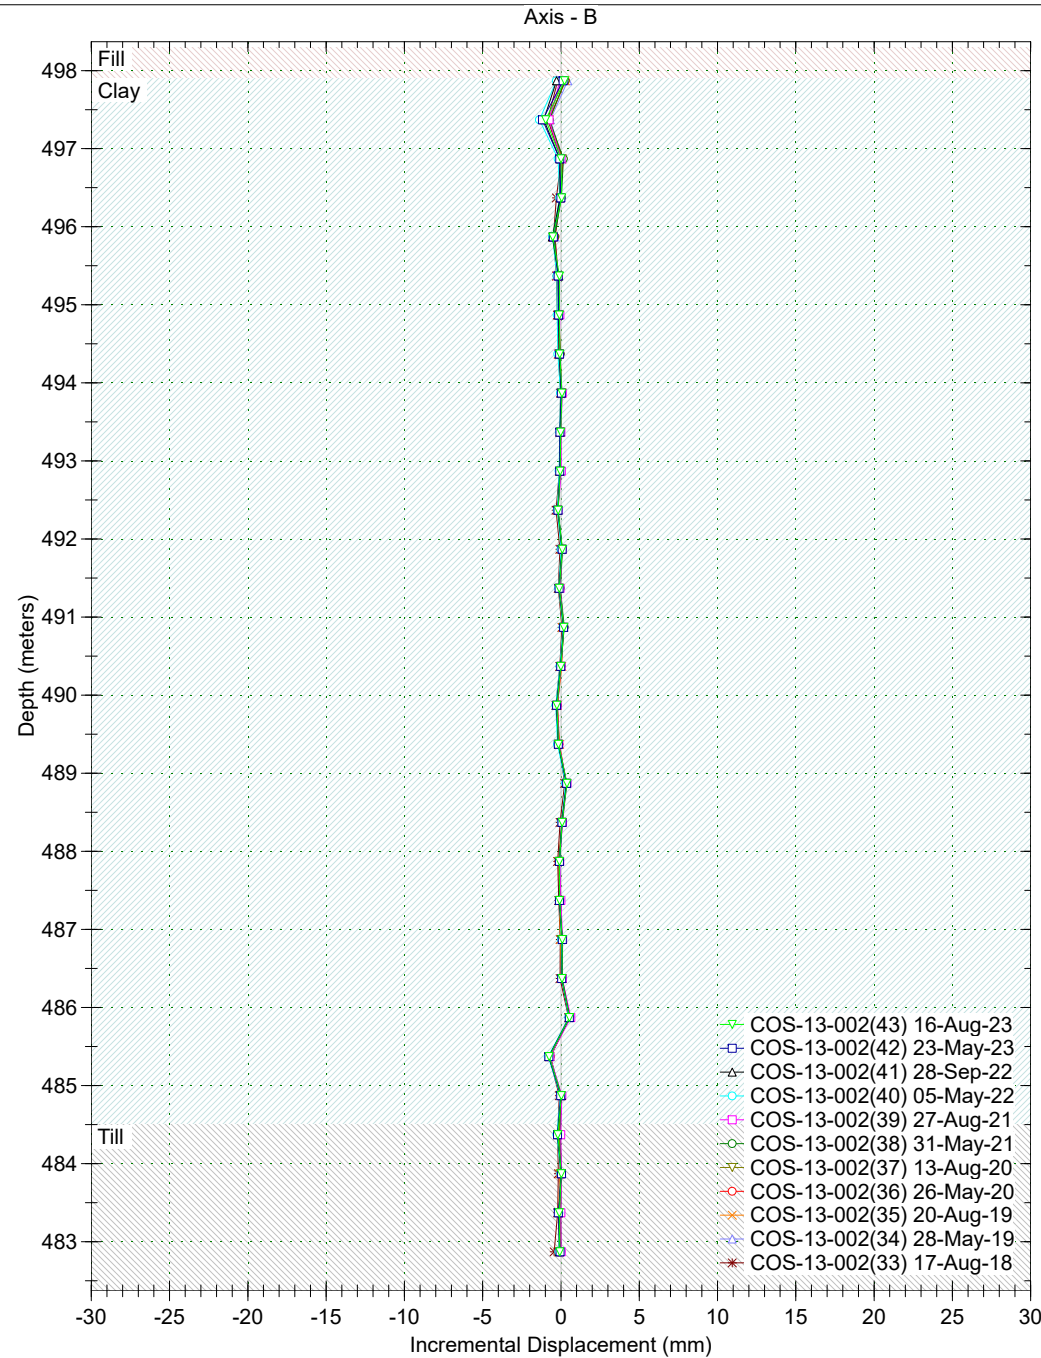
Borehole : COS-13-002  
 Project : Nutana Slope  
 Location : 307 11th St. E. (Front)  
 Northing : 5775567.41  
 Easting : 386043.54  
 Collar : -0.113

- Inclinometers COS-13-002, COS-13-004, and 20-111 indicated insignificant movement (less than 2 mm or 0.08 in), between May 23 and August 16, 2023.
- Inclinometer COS-13-005 indicated insignificant movement (less than 2 mm or 0.08 in) between May 25 and August 16, 2023.
- Inclinometer 20-109 indicated approximately 3 mm (0.12 in) of cumulative downslope movement between May 23 and August 16, 2023. This inclinometer plot showed a drift in direction parallel with Cherry Lane similar to what was observed in 2022.

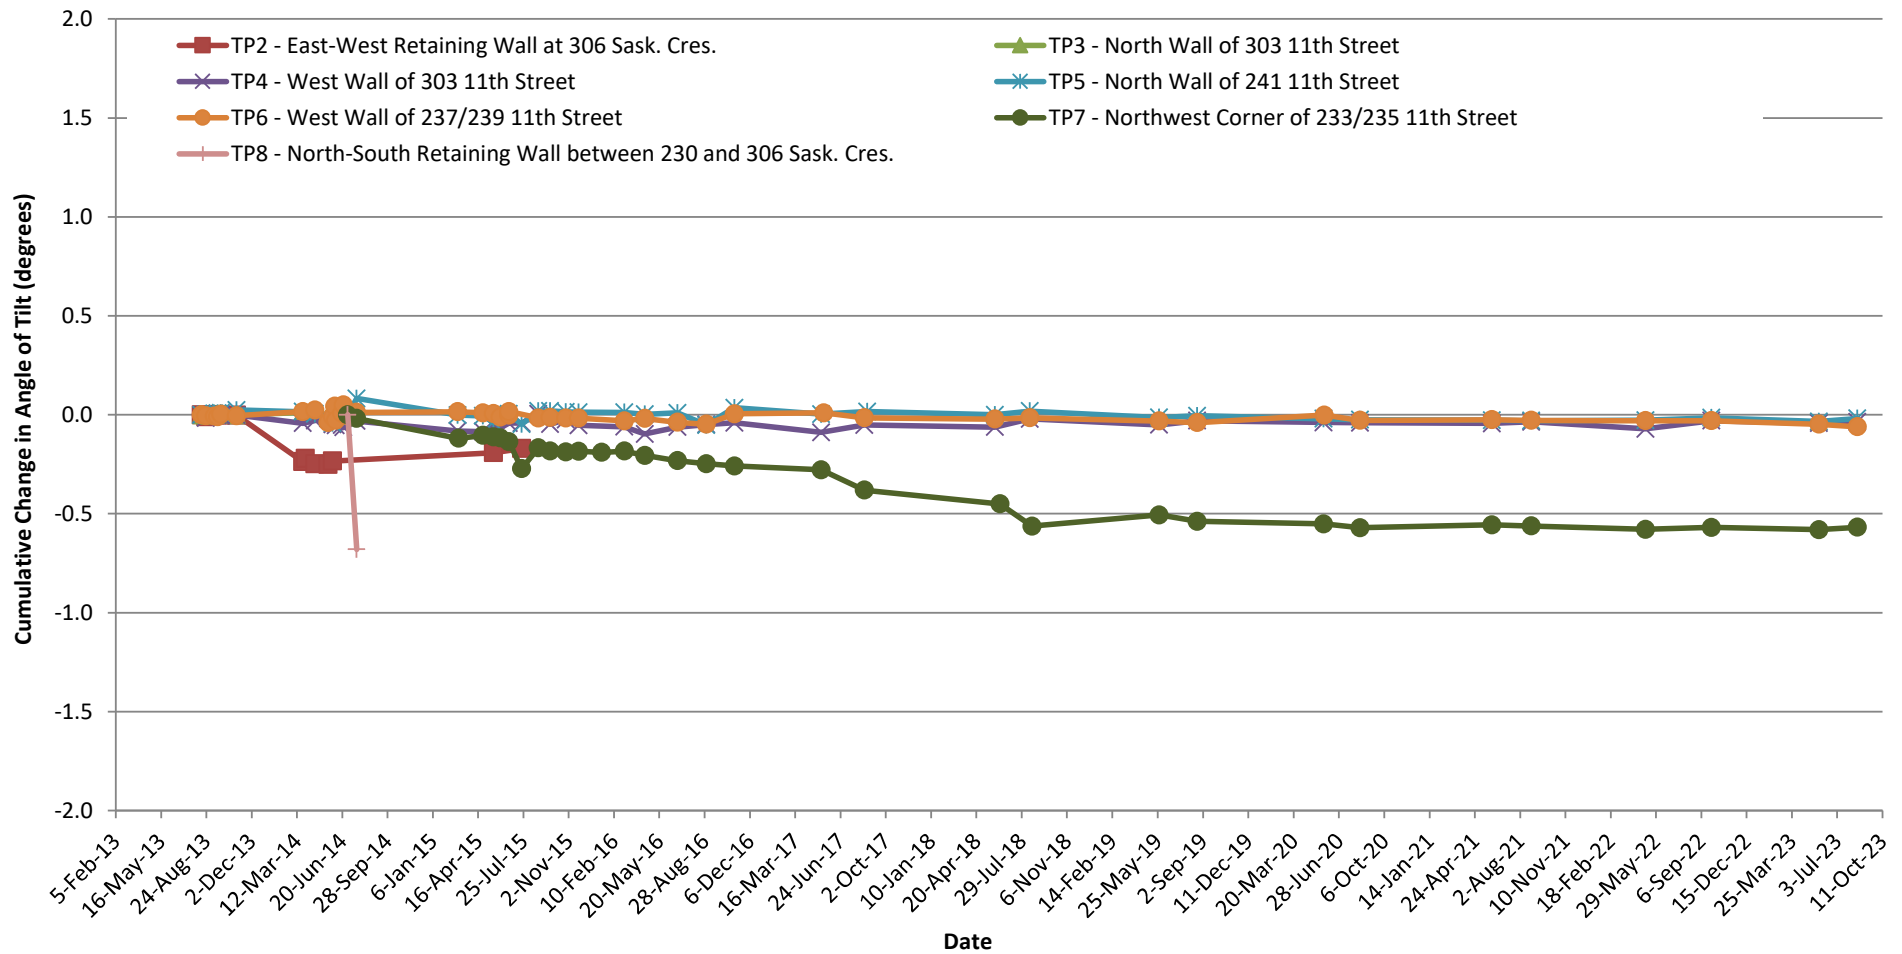
<b>NUTANA SLOPE INSTABILITY</b>	
<b>RESULTS OF TILT MONITORING</b> <i>Aug 2023 Monitoring</i>			
PROJECT	20138294	FILE No.	
DESIGN		SCALE	N/A
CADD		REV.	
CHECK		<b>FIGURE: 4</b>	
REVIEW

- Tilt plates TP4, TP5, TP6, and TP7 indicate insignificant changes in angle of tilt (less than 0.05 degrees) between May 23 and August 16, 2023.
- Tilt plate SLP3 indicated a change in angle of tilt of approximately 0.11 degrees, towards the south, between May 23 and August 16, 2023. However, this SLP3 readings have been erratic, total angle of tilt from April 17, 2015 to August 16, 2023 is approximately 0.2 degrees.

- Notes:
- 1) Positive changes in tilt indicate tilting toward the monitoring structure.
  - 2) TP1, located on the retaining wall between 230 and 306 Sask. Cres., is not monitored for health and safety reasons; monitoring results for this tilt plate show a change in angle of tilt of approximately 9 degrees between August 2013 and June 2014.
  - 3) TP3 and TP8 are destroyed, and TP2 is buried.

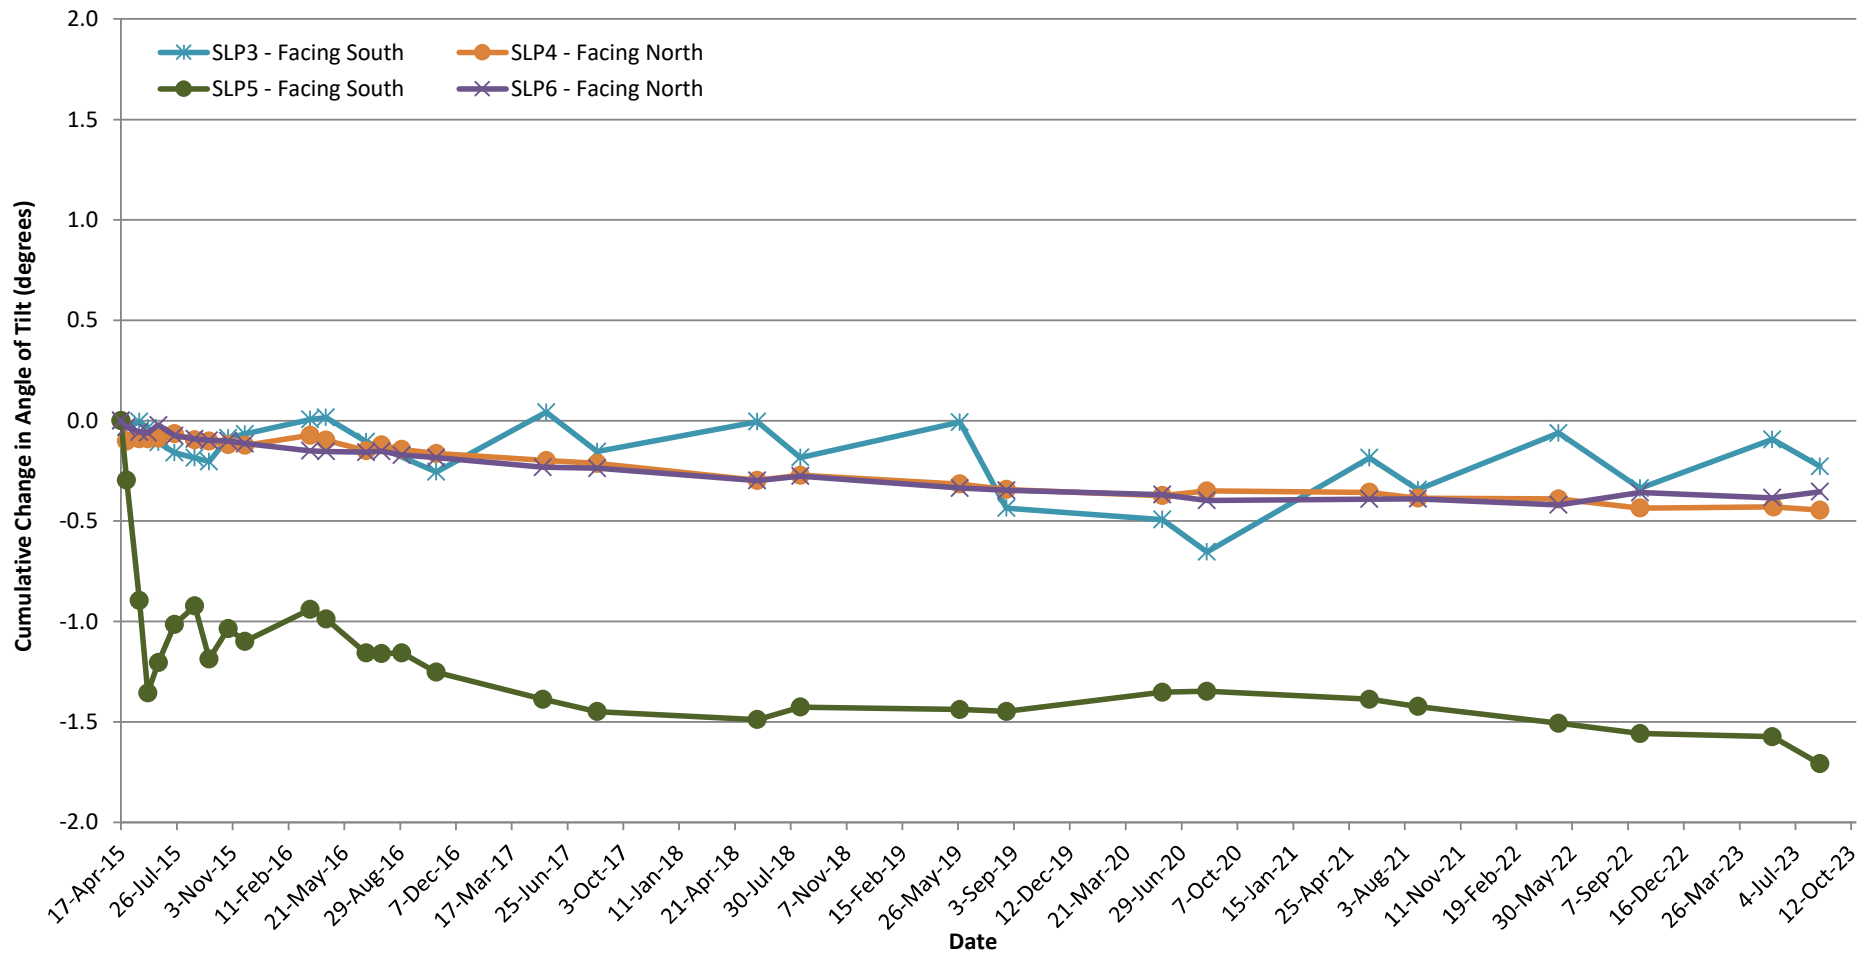
<b>NUTANA SLOPE INSTABILITY</b>	
<b>RESULTS OF TILT MONITORING</b> <i>August 2023 Monitoring</i>			
PROJECT	20138294	FILE No.	
DESIGN		SCALE	N/A
CADD		REV.	
CHECK		<b>FIGURE: 5</b>	
REVIEW

- Tilt plate SLP4 indicated an insignificant change in angle of tilt (less than 0.05 degrees) between May 25 and August 16, 2023.
- Tilt plate SLP5 indicated a change in angle of tilt of approximately 0.14 degrees, towards the south, between May 23 and August 16, 2023.

- Tilt plates SLP6 indicated insignificant changes in angle of tilt (less than 0.05 degrees) between May 23 and August 16, 2023.

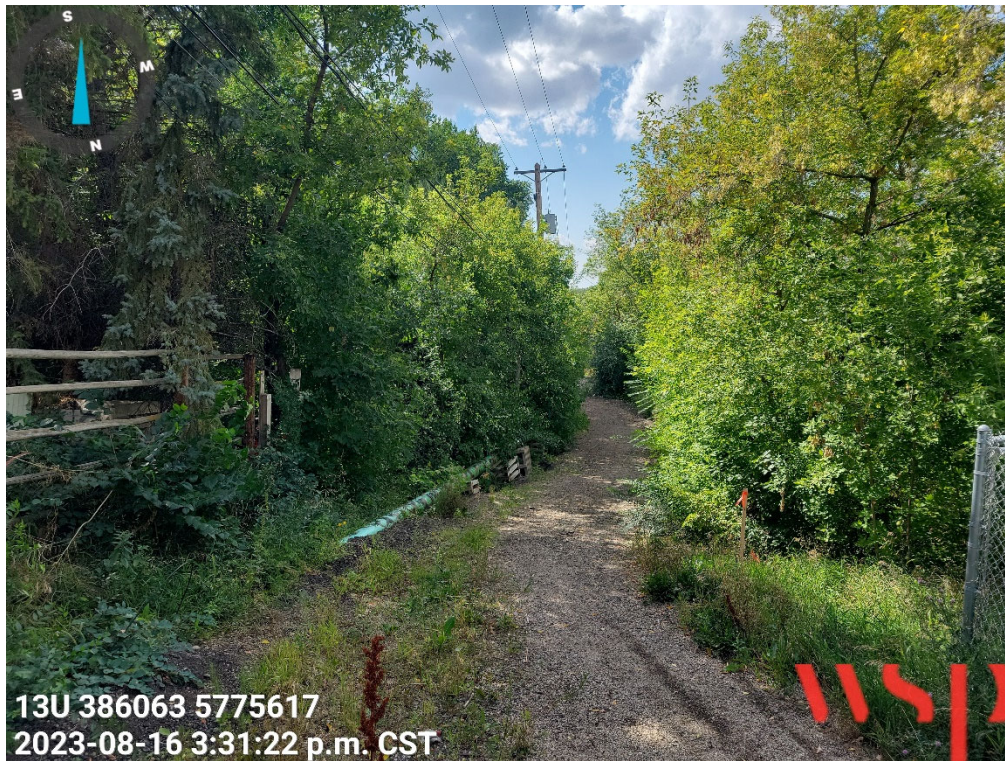
Photograph 1: Looking west down the back alley at the East Failure (August 16, 2023)

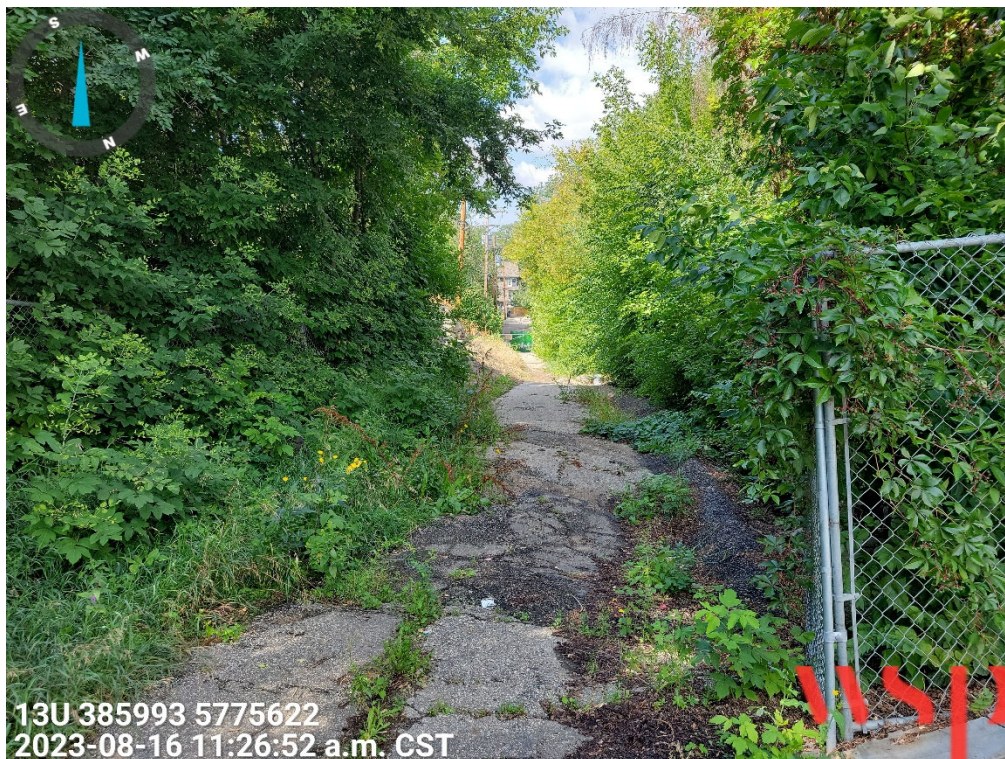
Photograph 2: Looking west down the back alley at the West Failure (August 16, 2023)
