CITY OF SASKATOON

Asbestos-Containing Building Materials Assessment Report - 29th Street Substation

Report Number: 1667963

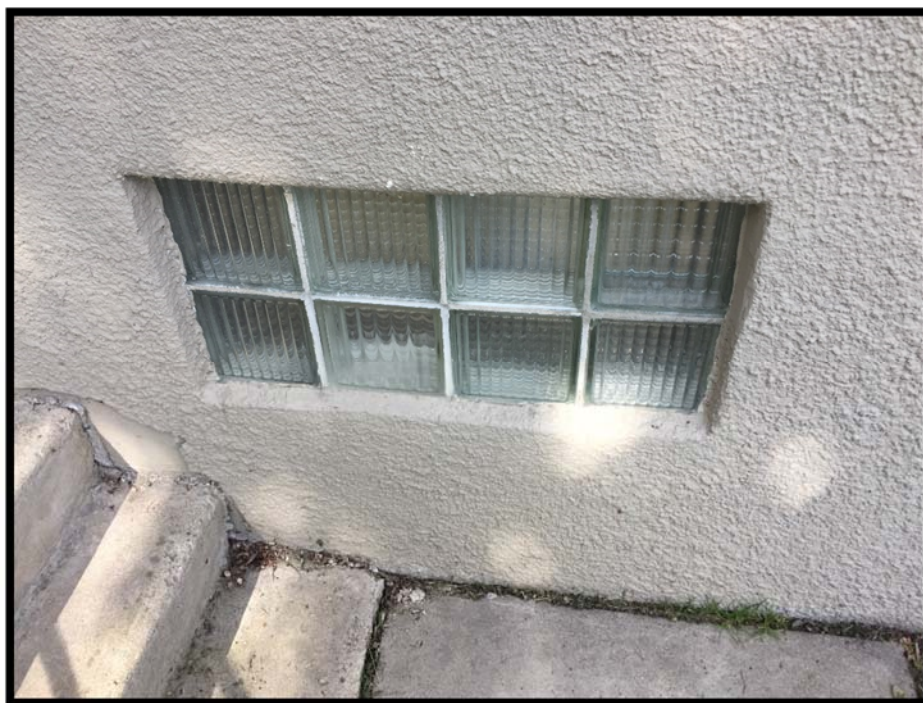
Five (5) samples of exterior stucco were collected during the assessment. One of the samples collected was found to contain 1.4% Chrysotile asbestos. Asbestos-containing exterior stucco (see Photograph 1 in Appendix B) was observed in the following locations:

- Exterior (approximately 2,175 ft²).

Asbestos was positively identified within the exterior stucco on Site. Asbestos was not identified in the remaining samples collected and analyzed.

Photograph 1: Asbestos-Containing Exterior Stucco.

If scheduled for impact, asbestos-containing exterior stucco should be abated following the high-risk abatement work procedures as outlined in the *Saskatchewan Asbestos Abatement Manual (2017)*. Alternatively, as the exterior stucco was observed in good condition, and with a priority rating of 4 (please see the room by room spreadsheet provided in Appendix C for a description of the priority ratings), it can be managed in place if not scheduled for impact. Due to the material being located on the exterior of the building being exposed to the elements, removal should be scheduled within a reasonable timeframe.

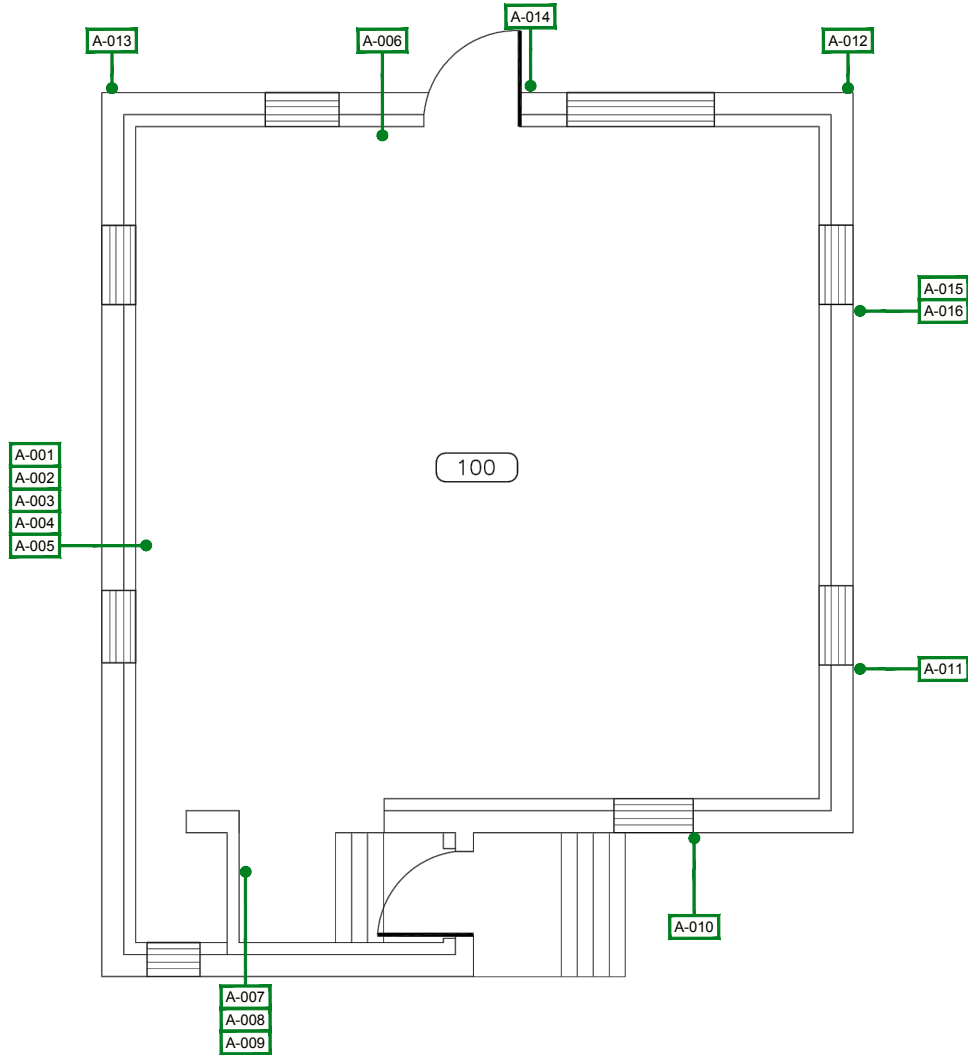
FIGURE
 1

1. ASBESTOS IS A CARCINOGEN. DO NOT BREATHE ASBESTOS DUST.
2. ASBESTOS-CONTAINING STUCCO IS LOCATED ON THE EXTERIOR OF THE BUILDING.
