# **BERSCH CONSULTING LTD.**

## **Hazardous Building Material Assessment 88 King Street Saskatoon, Saskatchewan**

**November 2017**

*Project No:* **B67HAL01G**

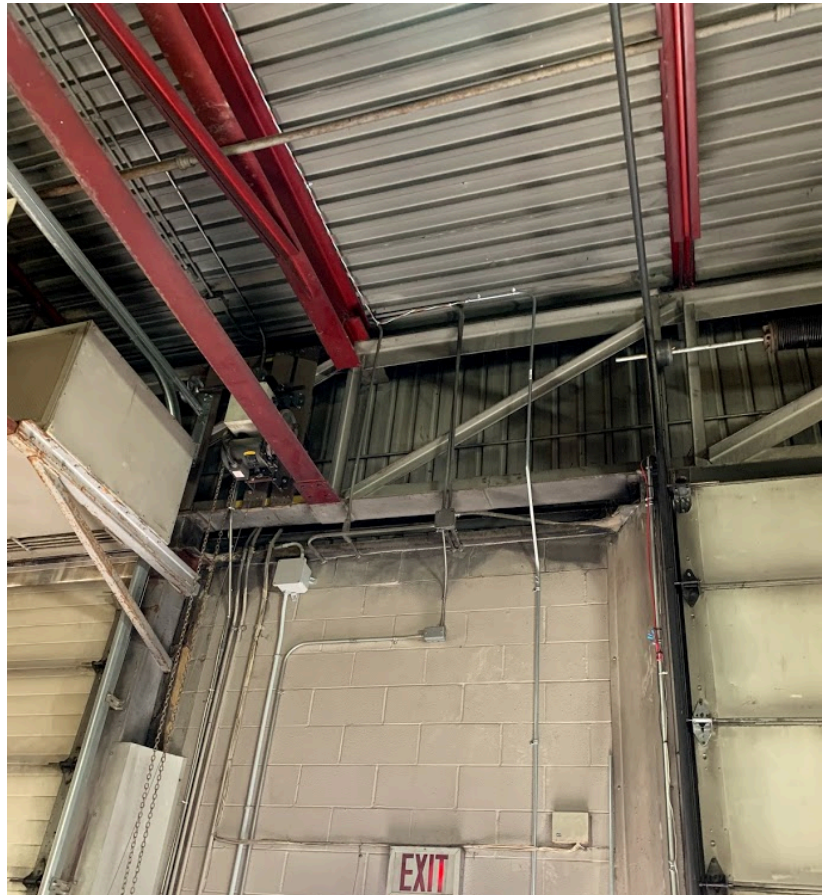
B67PRC23K – 002

Interior Wall on South Side of  
Building  
Metal Clad Wall above Overhead  
Doors.

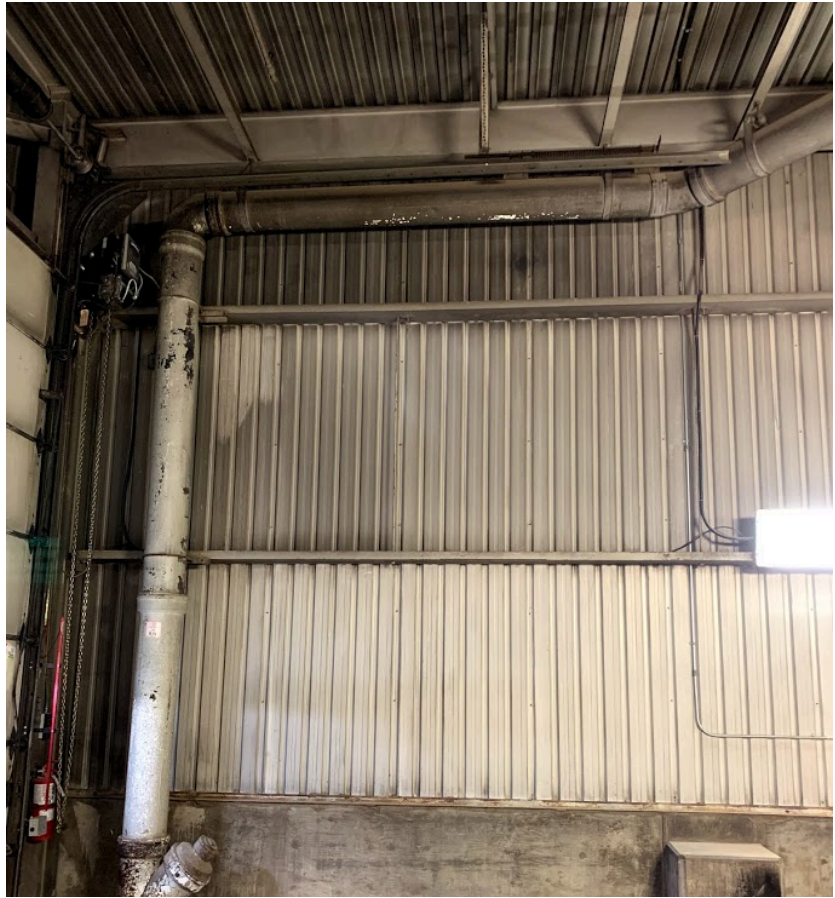
B67PRC23K - 003

Fiberglass Insulation Found Within the Wall Cavity

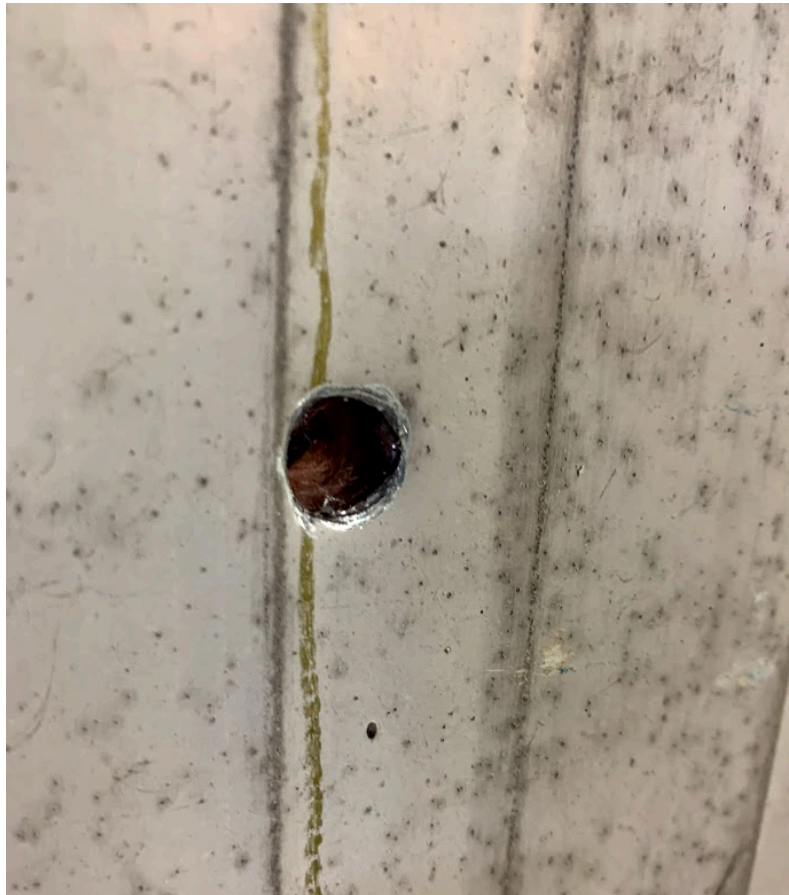
B67PRC23K - 004

Fiberglass Insulation within Wall Cavity of Metal Clad

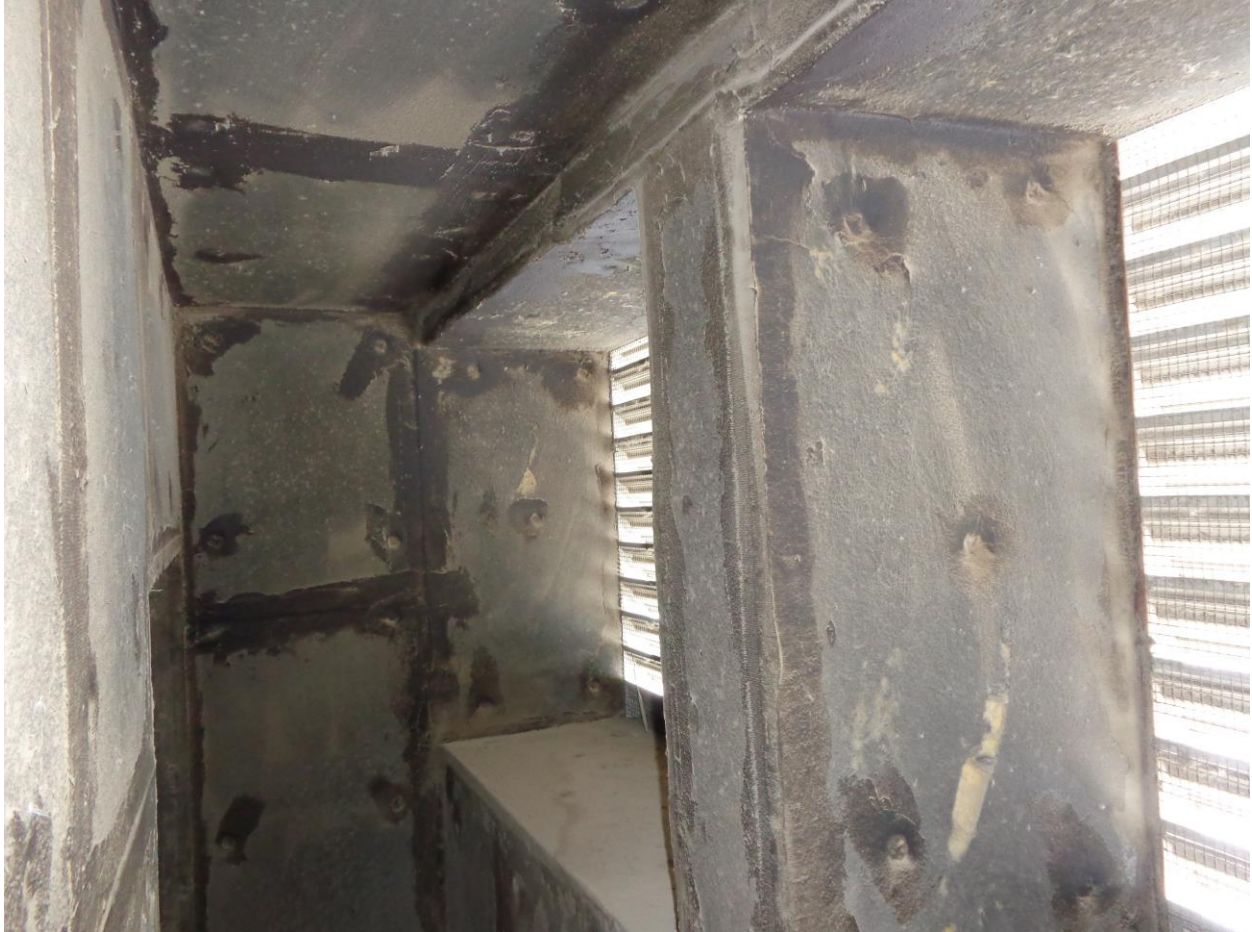
**Photo 1: 225 Mechanical Room – S.A Fan S-1 Black Tar on Fiberglass Inside the Intake Air on the North Wall. Asbestos Containing Material.**

1. Removal of the floor tile as a priority 2 in the main floor Janitor Room 122 is recommended. Two broken tiles are present. The other 2 locations of floor tile are in good condition. The tar coating the fiberglass within the intake air plenum is in good condition. These materials shall be managed as part of the asbestos management plan.

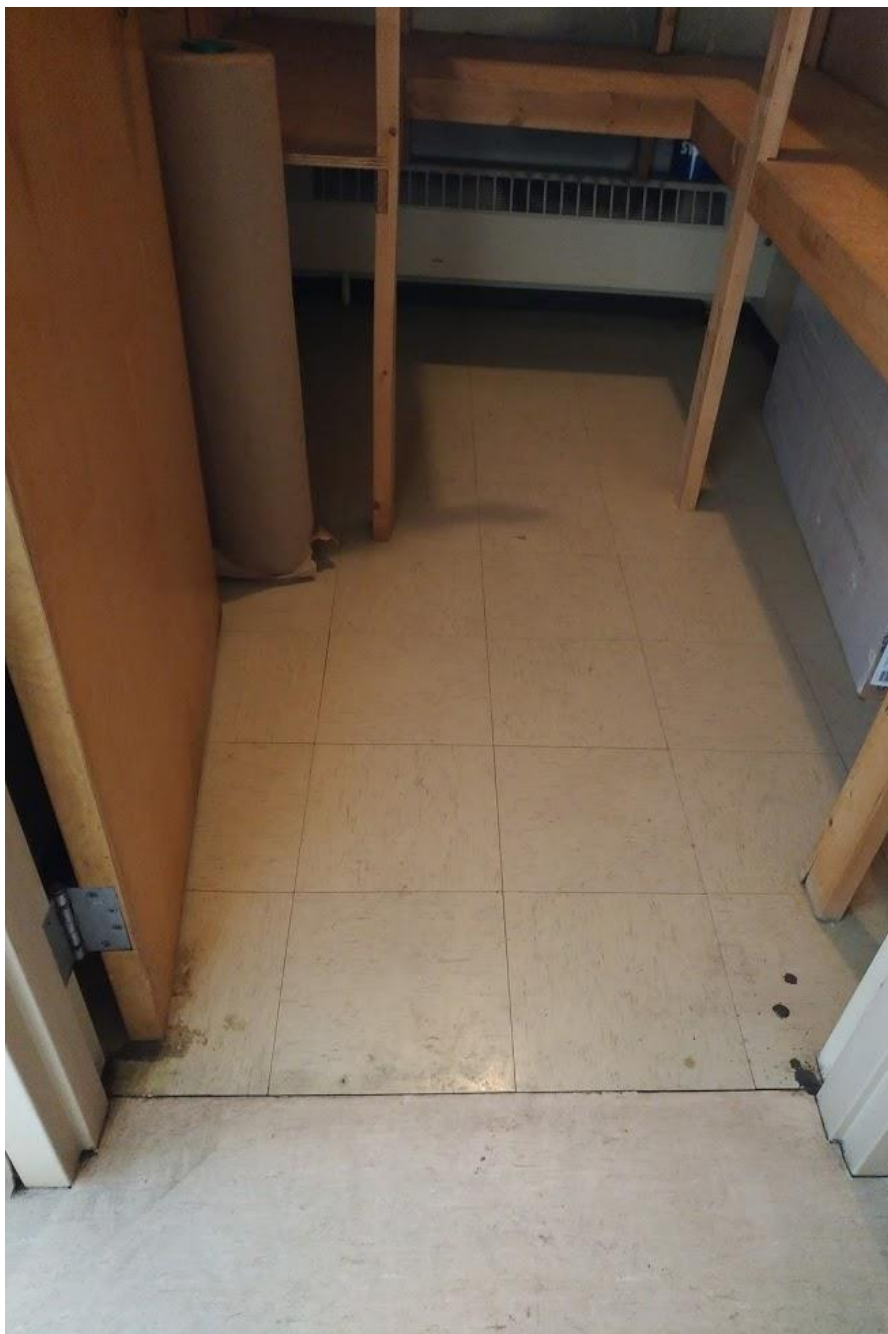
**Photo 2: 219 Storage Room – 1' X 1' Floor Tile White w Faint Brown & Grey Streaks. Asbestos Containing Material.**

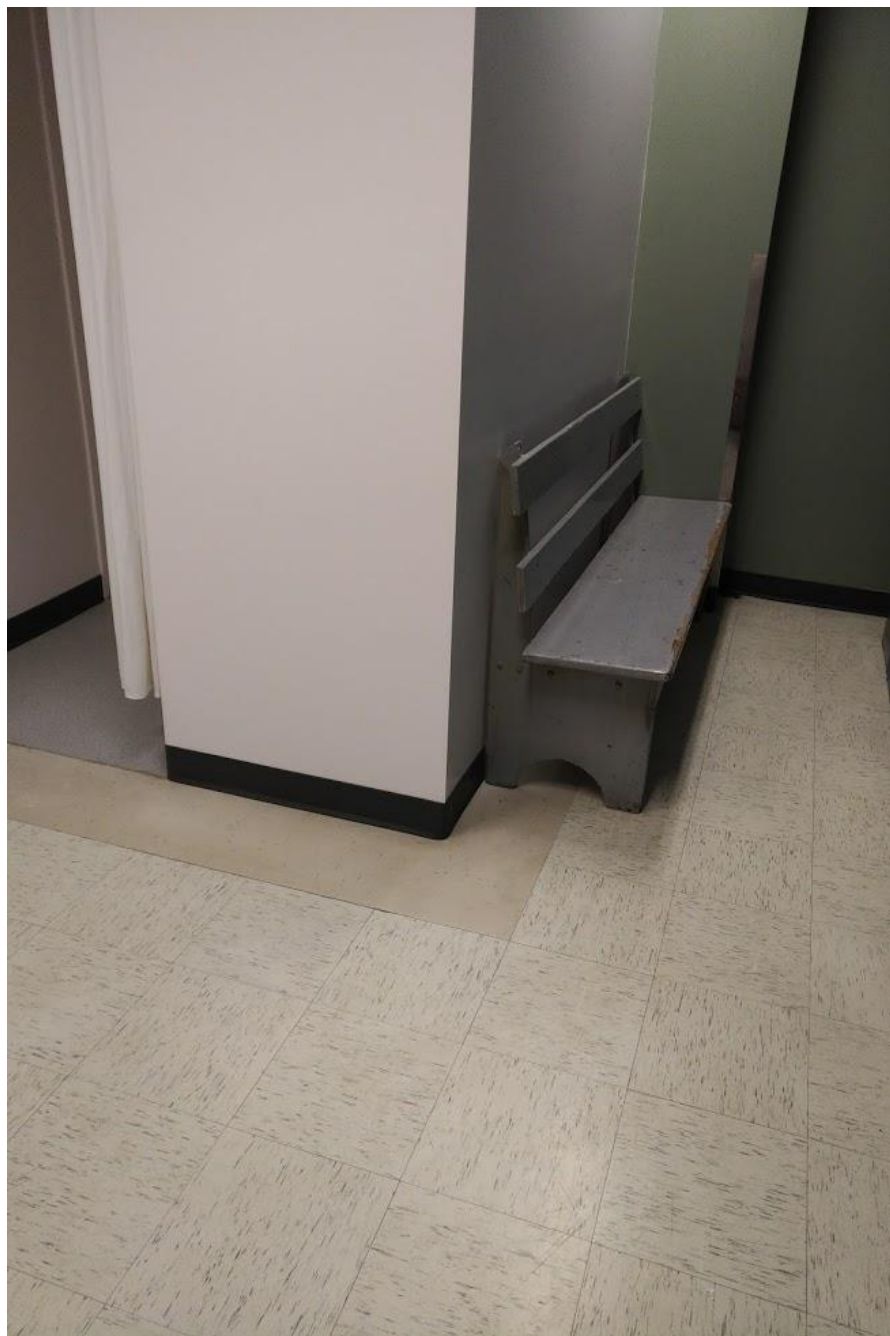
**Photo 3: 210 Female Locker Room – 1' X 1' Floor Tile White w Grey Streaks. Asbestos Containing Material.**

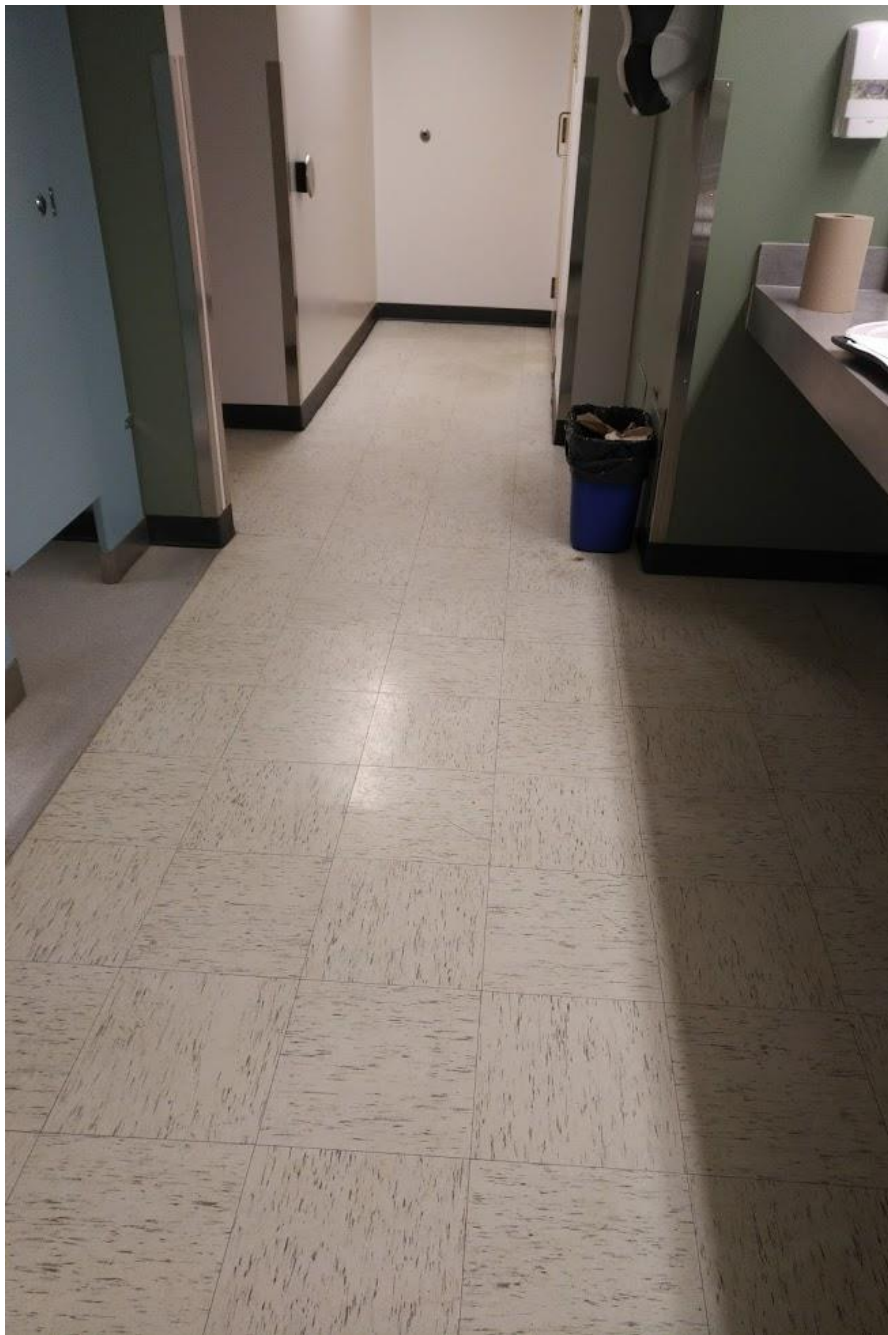
**Photo 4: 209 Female Washroom – 1' X 1' Floor Tile White w Grey Streaks. Asbestos Containing Material.**

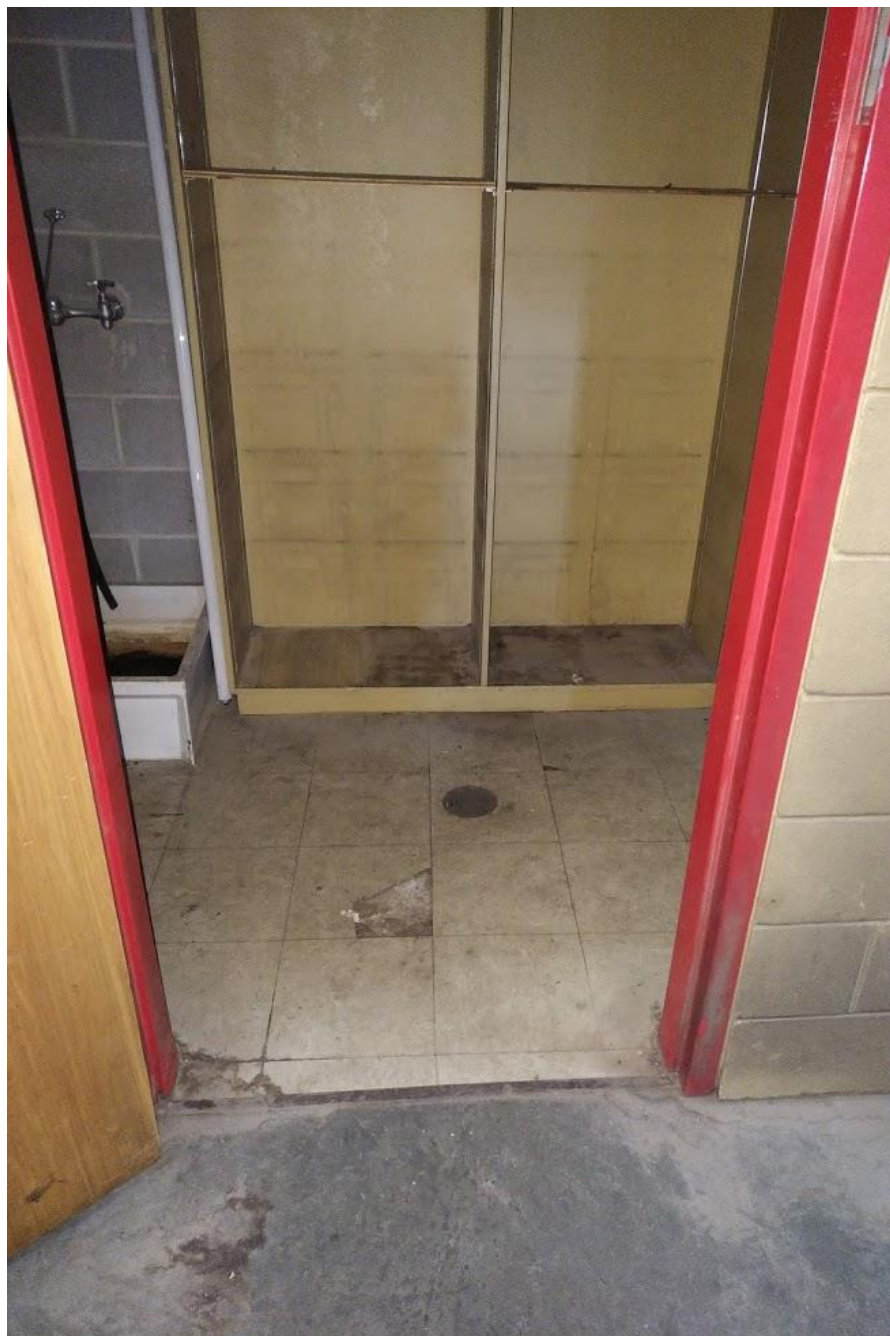
**Photo 5: 122 Janitor Room – 1' X 1' Floor Tile Beige w Faint Grey Streaks. Asbestos Containing Material.**

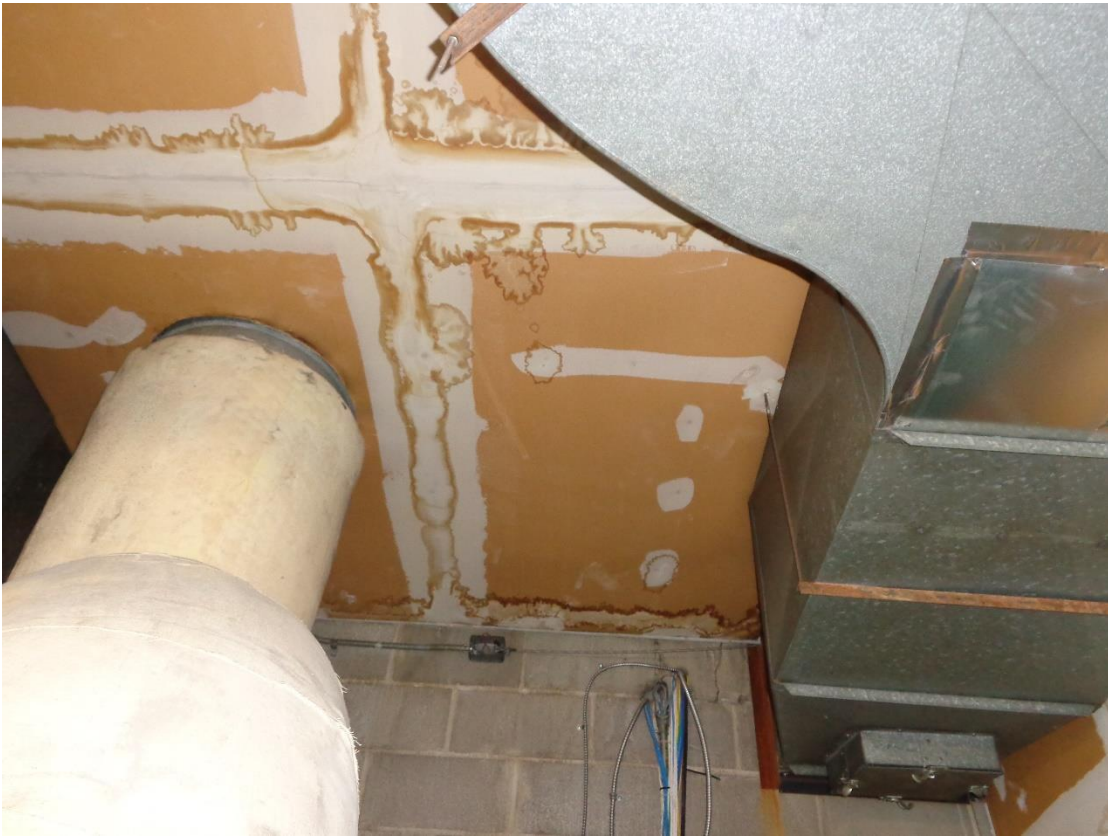
- A.** Sample #M1 – Remediation is not warranted as a result of the Rare count of Ascospores, Basidiospores and Cladosporium spores/structures. The staining along the ceiling of the 225 Mechanical Room is primarily the result water staining from previous roof leakage that has since been corrected.
- B.** Sample #M2 – Remediation is not warranted as a result of the Rare count of Ascospores, Basidiospores and Cladosporium spores/structures. The blackened color is a discoloration similarly associated with mold growth. In this instance the discoloring of the canvas jacket on the S1 Intake in room 225 is not the result of mold growth.

**Photo 1: 225 Mechanical - Ceiling Water Staining**

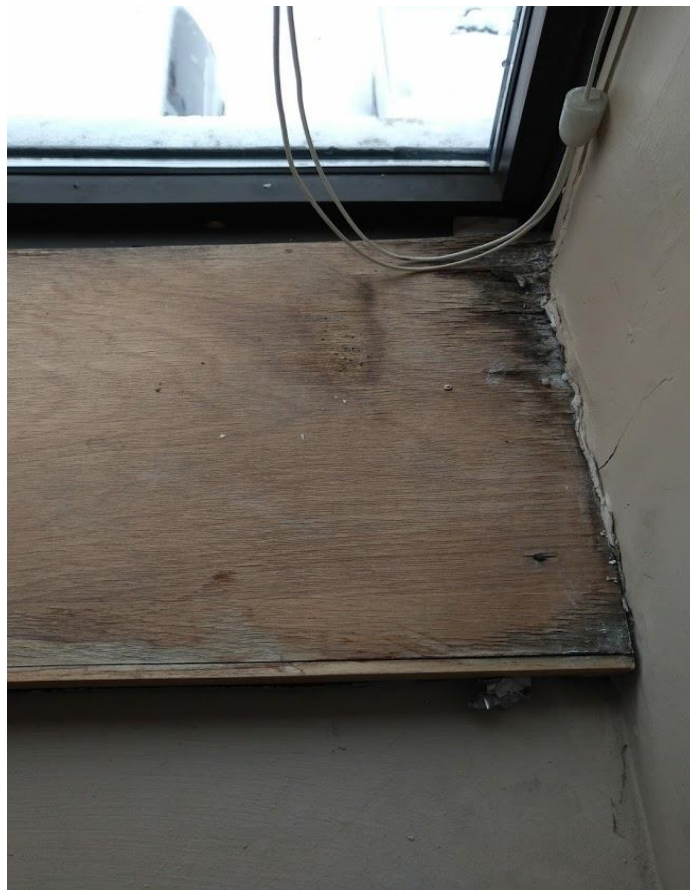
**Photo 2: 218 Staff Lounge – Northeast Corner of Window Sill - Water Staining**
