**A.C.T. Center
Asbestos Survey Report**

December 2014

Prepared For: City Of Saskatoon- Infrastructure Services Department
3130 Laurier Drive, Saskatoon, SK.
Attn: Brent Anderson

Prepared By: Bersch & Associates Ltd.
Project No. : B67SRL16

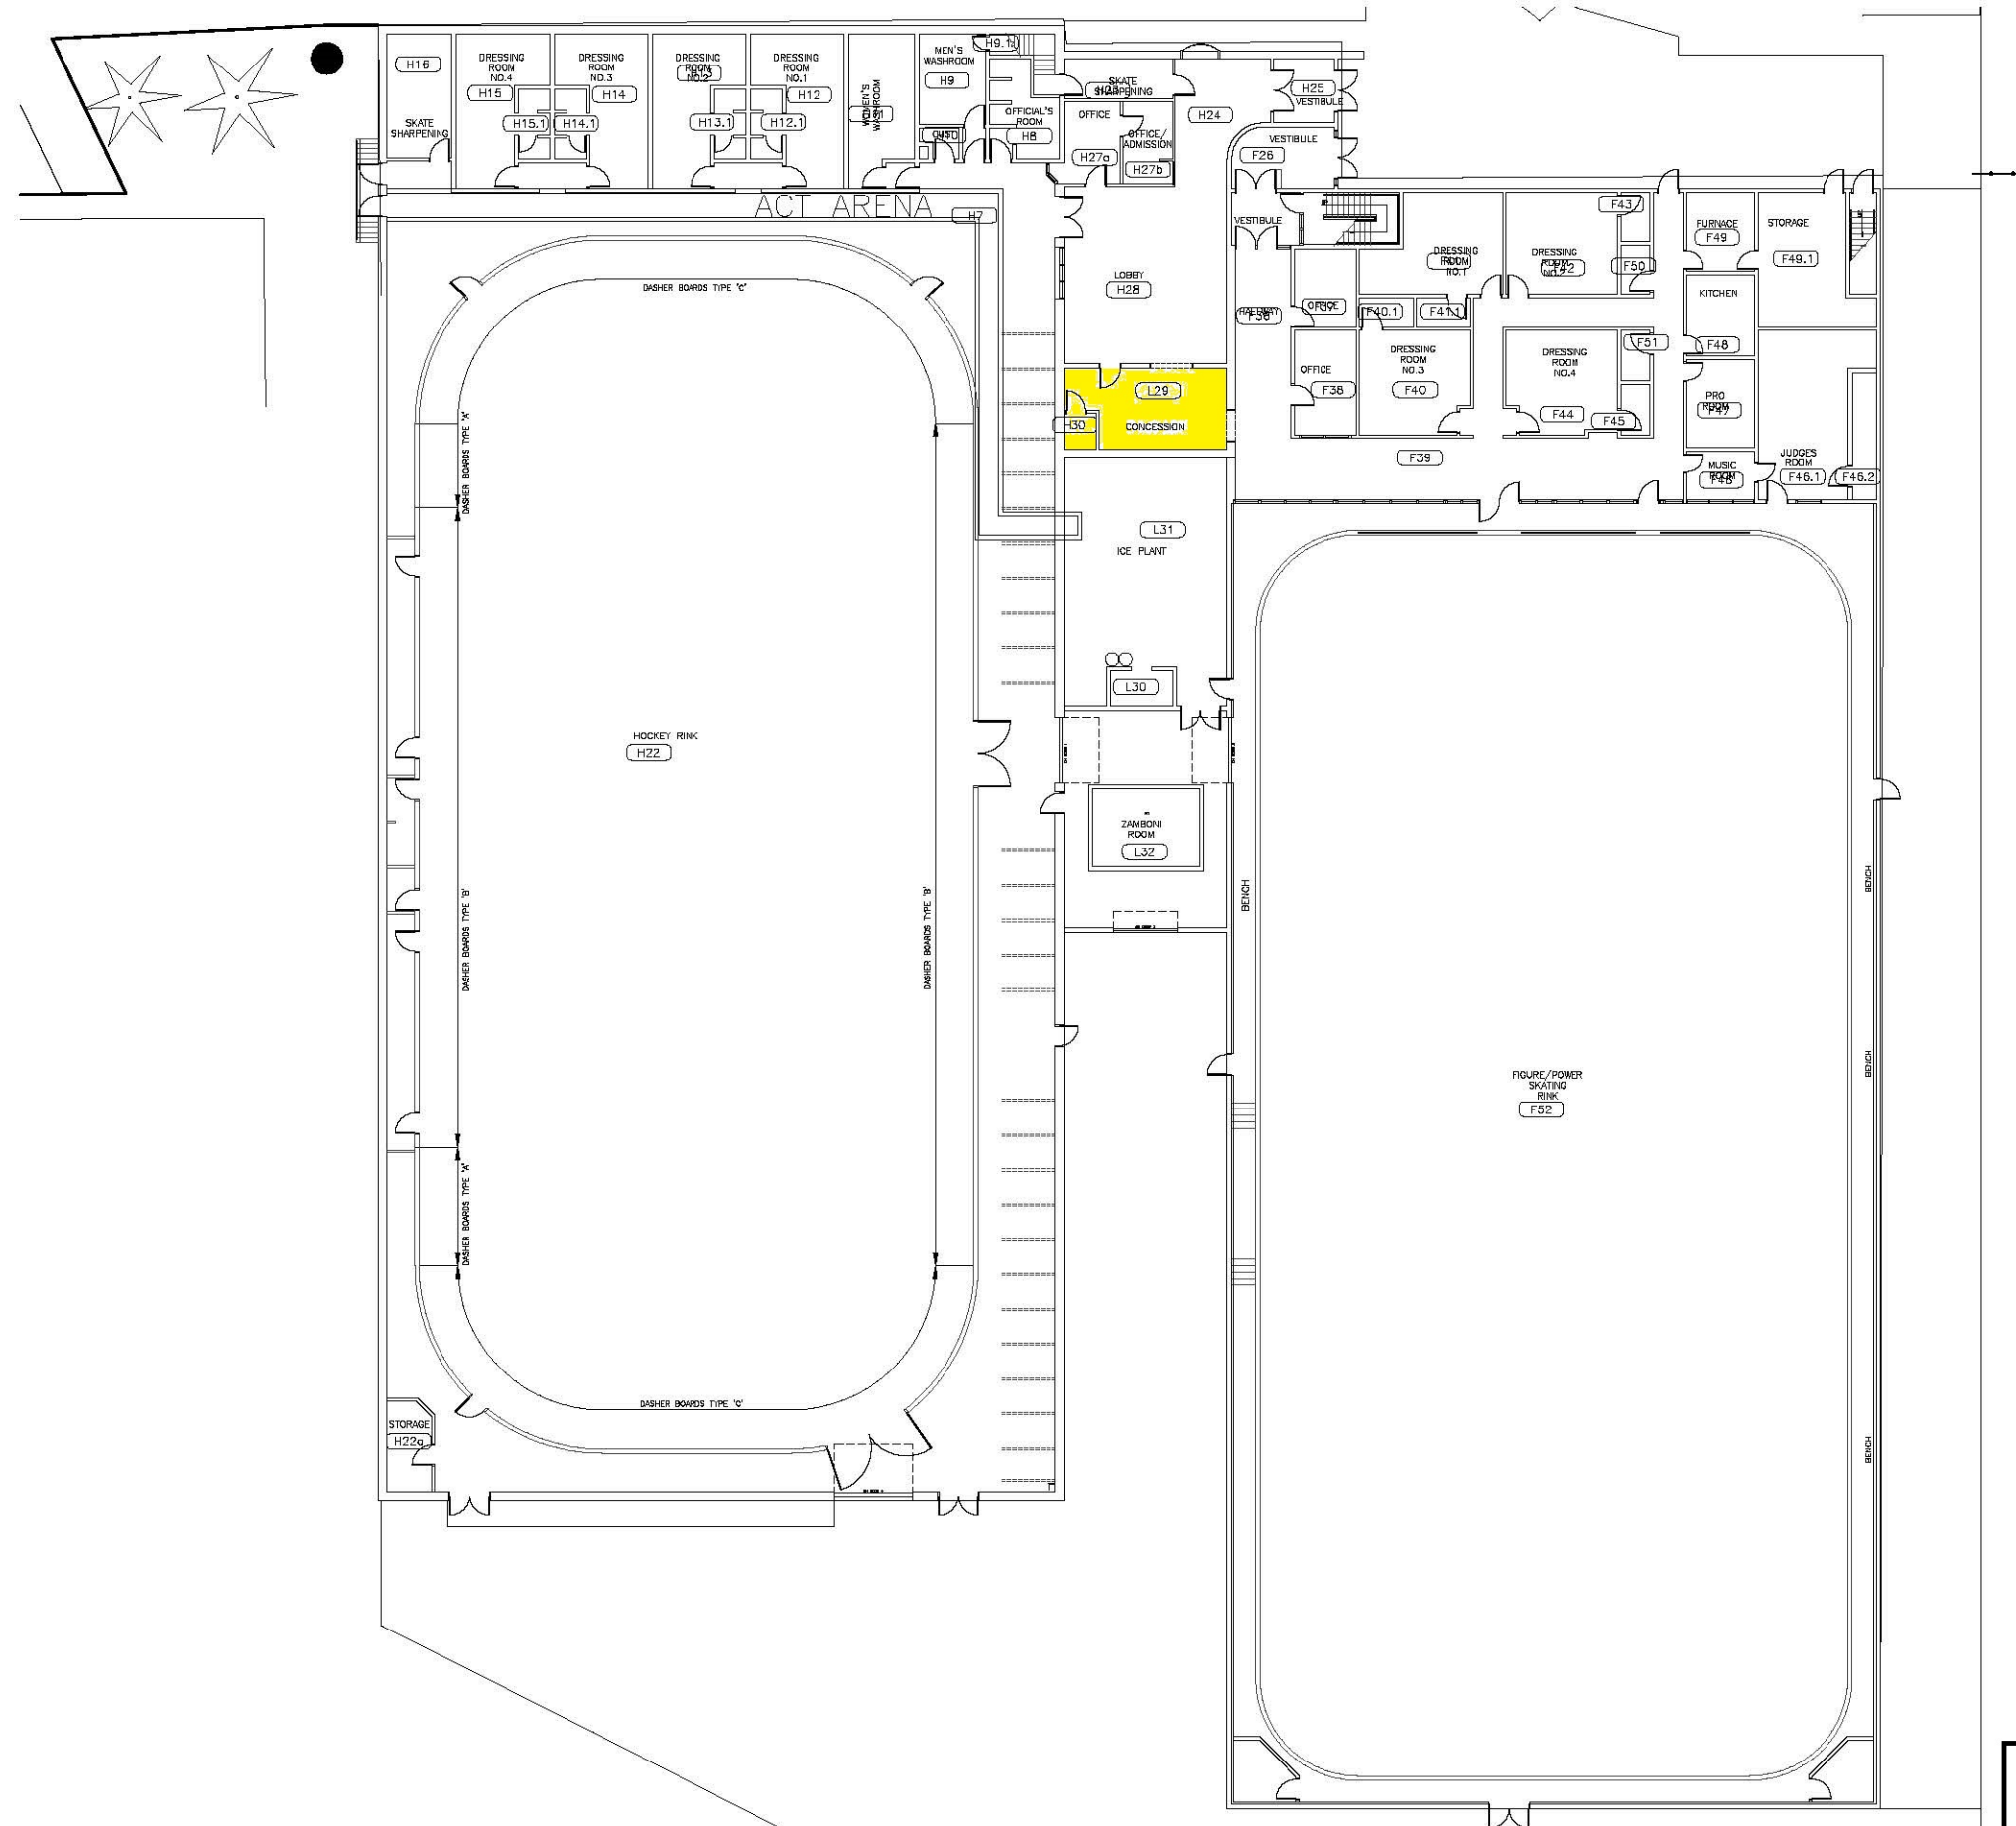
REV	ISSUED FOR	DATE	
DESIGNED BY:	DRAWN BY:	CHECKED BY:	REQUESTED BY:
	JB/DH		
SCALE:	DATE:		
1:350 (11x17)	15/12/2004		
SHEET NAME		Asbuilt	
Main Floor Base Plan			
PROJECT TITLE			
639 ACT Arena			
PROJECT NO.	SHEET		
639			
REV. NO.

- **Vinyl Asbestos Floor Tile** is located in Rooms L29, H30, 206 and 207. The Asbestos Floor Tile is identified on the **Floor Plans** in **Appendix III** of this report.
