CITY OF SASKATOON

Asbestos-Containing Building Materials Assessment Report - Assessors Building

Report Number: 1667963

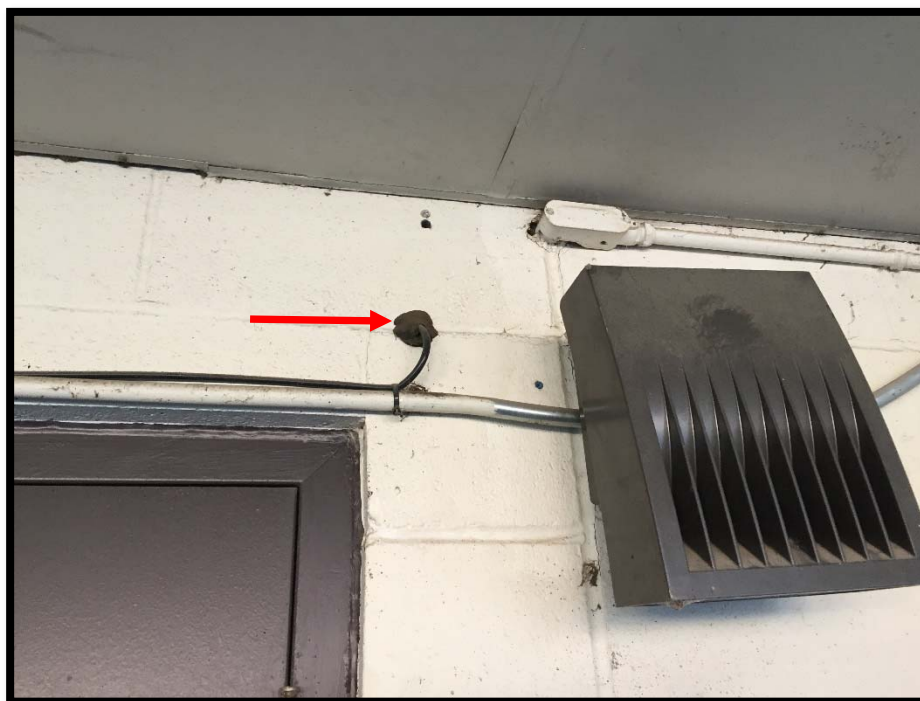
One (1) sample of black firestop was collected during the assessment. The sample collected was found to contain 20% Chrysotile asbestos. Asbestos-containing black firestop (see Photograph 1 in Appendix B) was observed in the following locations:

- Exterior (approximately 1 ft²).

Photograph 1: Asbestos-Containing Black Firestop.

If scheduled for impact, asbestos-containing black firestop should be abated following low-risk abatement work procedures as outlined in the *Saskatchewan Asbestos Abatement Manual* (2017). Alternatively, as the black firestop was observed in good condition, and with a priority rating of 5 (please see the room by room spreadsheet provided in Appendix C for a description of the priority ratings), it can be managed in place if not scheduled for impact.
