August 4, 2017

CITY OF SASKATOON

Asbestos-Containing Building Materials Assessment Report - Avenue W Substation

Report Number: 1667963

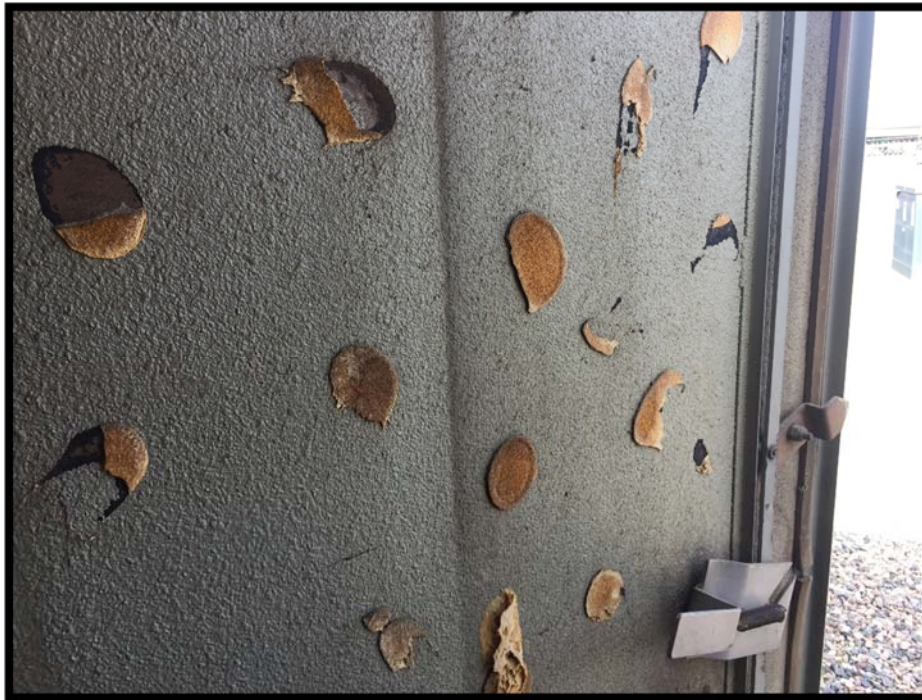
One (1) sample of wall and ceiling mastic was collected during the assessment. The sample collected was found to contain 10% Chrysotile asbestos. Asbestos-containing wall mastic (see Photograph 1 in Appendix B) was observed in the following locations:

- Room 100 (approximately 50 ft²).

Additional asbestos-containing mastic is suspected to be located sporadically below the fibreglass panels on the walls and ceilings and within the interior of the doors throughout Room 100.

Photograph 1: Asbestos-Containing Wall and Ceiling Mastic.

| Included/Excluded | Floor | Room # | Area Description | Elements | Subelements | Material Description | Accessibility | Suspect? | Sampled? | Asbestos Containing Material? | Condition | Field Notes | Sample Type | Sample ID | Sample Date | Asbestos Type | ACM Product | % of asbestos | Friable | Sprayed-on | Maintenance | Inspection | Priority | Potential for Disturbance | Recommended Action | Quantity | Photograph ID | Labelling Type | |
|---|---|---|---|---|---|---|---|---|---|---|---|--|---|---|---|---|---|---|---|---|---|---|---|---|---|---|---|---|--|
| Included | M | 100 | General Room | Walls and Ceiling | Mastic | Mastic | High | Yes | Yes | Yes | Good | Mastic suspected to be located below the fibreglass wall and ceiling panels on Site. | | VS A-002 | | Chrysotile | Mastic | 10% | No | No | N/A | Annually | 5 | Moderate | Manage in Place | Included below. | Photograph 1 | Door Jamb | |
| Included | M | 100 | General Room | Doors | Mastic | Mastic | High | Yes | Yes | Yes | Good | Mastic and Texture Coat located within the interior of the doors on Site. | Bulk | A-002 | 19-Jun-17 | Chrysotile | Mastic | 10% | No | No | N/A | Annually | 5 | Moderate | Manage in Place | 100 ft ² | Photograph 1 | Door Jamb | |

If scheduled for impact, asbestos-containing wall and ceiling mastic should be abated following low-risk abatement work procedures as outlined in the *Saskatchewan Asbestos Abatement Manual* (2017). Alternatively, as the wall and ceiling mastic was observed in good condition, and with a priority rating of 5 (please see the room by room spreadsheet provided in Appendix C for a description of the priority ratings), it can be managed in place if not scheduled for impact.

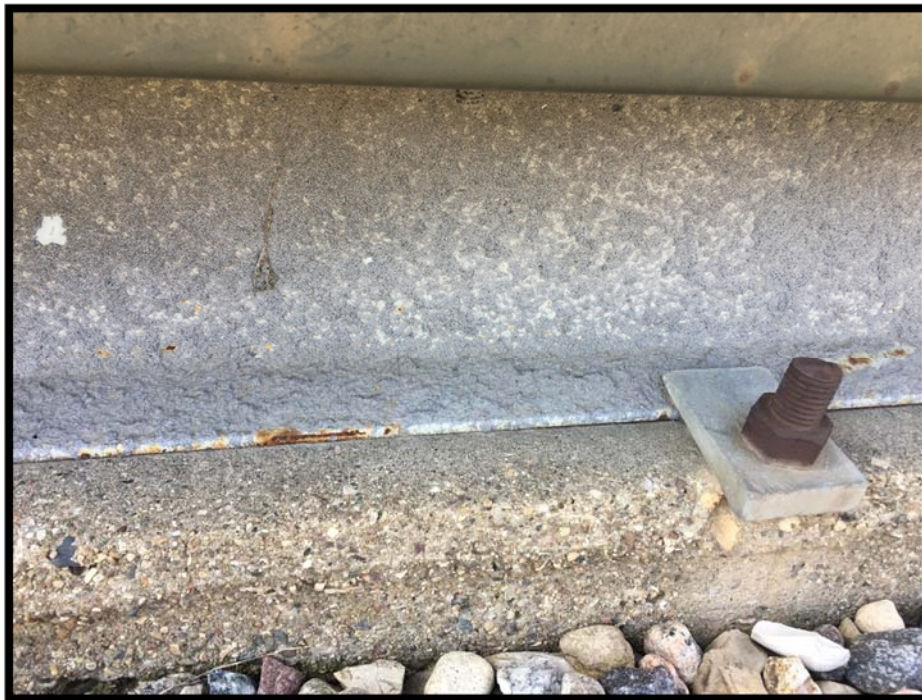
One (1) sample of texture coat was collected during the assessment. The sample collected was found to contain 20% Chrysotile asbestos. Asbestos-containing texture coat (see Photograph 2 in Appendix B) was observed in the following locations:

- Doors and Exterior Structural Steel (approximately 200 ft²).

Photograph 2: Asbestos-Containing Texture Coat.

| Included/Excluded | Floor | Room # | Area Description | Elements | Subelements | Material Description | Accessibility | Suspect? | Sampled? | Asbestos Containing Material? | Condition | Field Notes | Sample Type | Sample ID | Sample Date | Asbestos Type | ACM Product | % of asbestos | Friable | Sprayed-on | Maintenance | Inspection | Priority | Potential for Disturbance | Recommended Action | Quantity | Photograph ID | Labelling Type | |
|---|---|---|---|---|---|---|---|---|---|---|---|--|---|---|---|---|---|---|---|---|---|---|---|---|---|---|---|---|--|
| Included | M | 100 | General Room | Doors | Texture | Texture Coat | High | Yes | Yes | Yes | Good | Mastic and Texture Coat located within the interior of the doors on Site. | | VS A-003 | | Chrysotile | Texture Coat | 20% | Yes | Yes | N/A | Monthly | 4 | Moderate | Manage in Place. Schedule Removal. | 200 ft ² | Photograph 2 | Door Jamb | |
| Included | E | Exterior | Exterior | Structural Steel | Texture | Texture Coat | High | Yes | Yes | Yes | Good | Texture Coat located along the exterior structural steel. | Bulk | A-003 | 19-Jun-17 | Chrysotile | Texture Coat | 20% | Yes | Yes | N/A | Monthly | 4 | High | Manage in Place. Schedule Removal. | Included above. | Photograph 2 | | |

If scheduled for impact, asbestos-containing texture coat should be abated following high-risk abatement work procedures as outlined in the *Saskatchewan Asbestos Abatement Manual* (2017). The texture coat was observed in good condition, however it is located along the exterior structural steel and within a half-dismantled door. Based upon the exposure to the exterior elements, as well as the intent of having the texture concealed behind the door, a priority rating of 4 (please see the room by room spreadsheet provided in Appendix C for a description of the priority ratings) was assigned to the texture. The texture should be managed in place until it can be scheduled for removal in a reasonable timeframe.

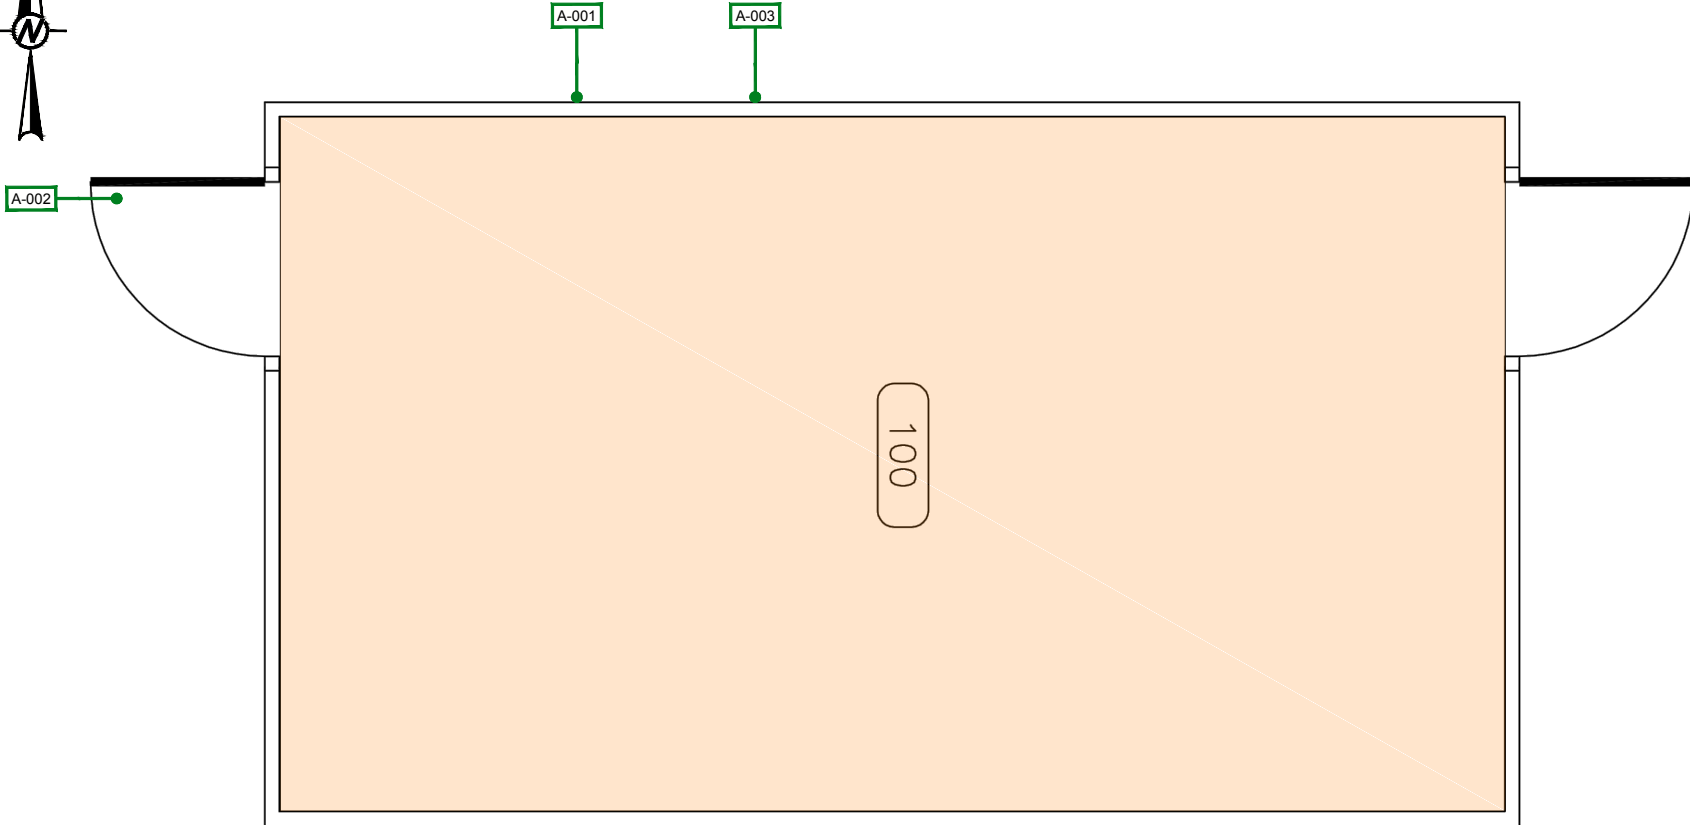
TITLE
MAIN FLOOR

- ASBESTOS IS A CARCINOGEN. DO NOT BREATHE ASBESTOS DUST.
- ASBESTOS-CONTAINING TEXTURE COAT IS LOCATED ON THE EXTERIOR STRUCTURAL STEEL OF THE SITE.
