**CITY OF SASKATOON – BOWERMAN HOUSE
ASBESTOS SURVEY REPORT**

APRIL 2013

Prepared By: Bersch & Associates Ltd.
Project No. : B67SRD29B

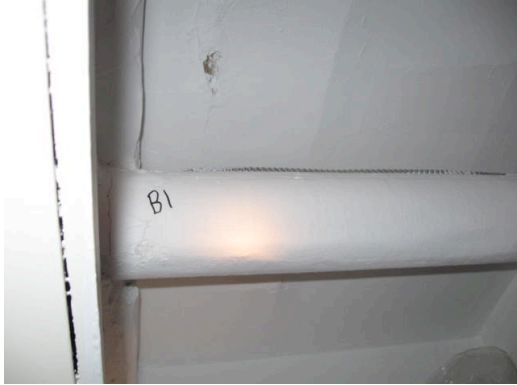
#1) Lineal Pipeline Insulation

Lineal Pipeline Insulation was identified on the section of overhead pipeline within the closet. This material was observed to be in moderate to good condition with a low potential for disturbance. The material may be managed, however due to the quantity present, removal of the insulation may be considered to eliminate all concerns in the future.

THREE
MODERATE TO GOOD
LOW
MANAGE / REMOVE

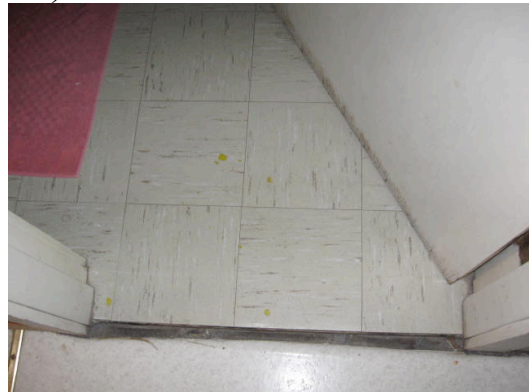
#4) 9" X 9" Floor Tile

9-inch by 9-inch floor tile was identified as containing asbestos. This material was observed to be in good condition with a low potential for disturbance. The material may be managed, however due to the quantity present, removal of the floor tile may be considered to eliminate all concerns in the future.

PRIORITY:	THREE
CONDITION:	GOOD
POTENTIAL FOR DISTURBANCE:	LOW
ACTION:	MANAGE / REMOVE

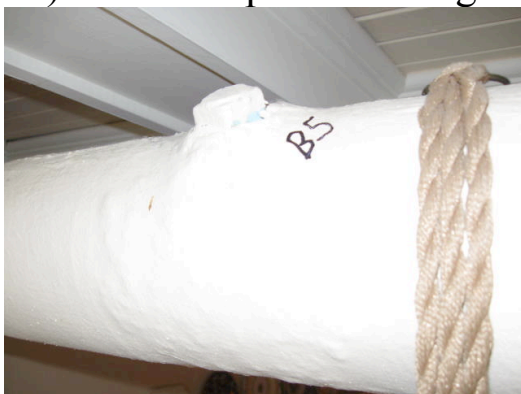
#5) Mud Compound Fitting

Mud compound on the pipeline fittings was identified as containing asbestos. This material was observed to be in good condition with a low potential for disturbance. The material may be managed, however due to the quantity present, removal of the mud compound may be considered to eliminate all concerns in the future.

PRIORITY:	THREE
CONDITION:	GOOD
POTENTIAL FOR DISTURBANCE:	LOW
ACTION:	MANAGE / REMOVE
