CITY OF SASKATOON

Asbestos-Containing Building Materials Assessment Report - C D McGall Substation

Report Number: 1667963

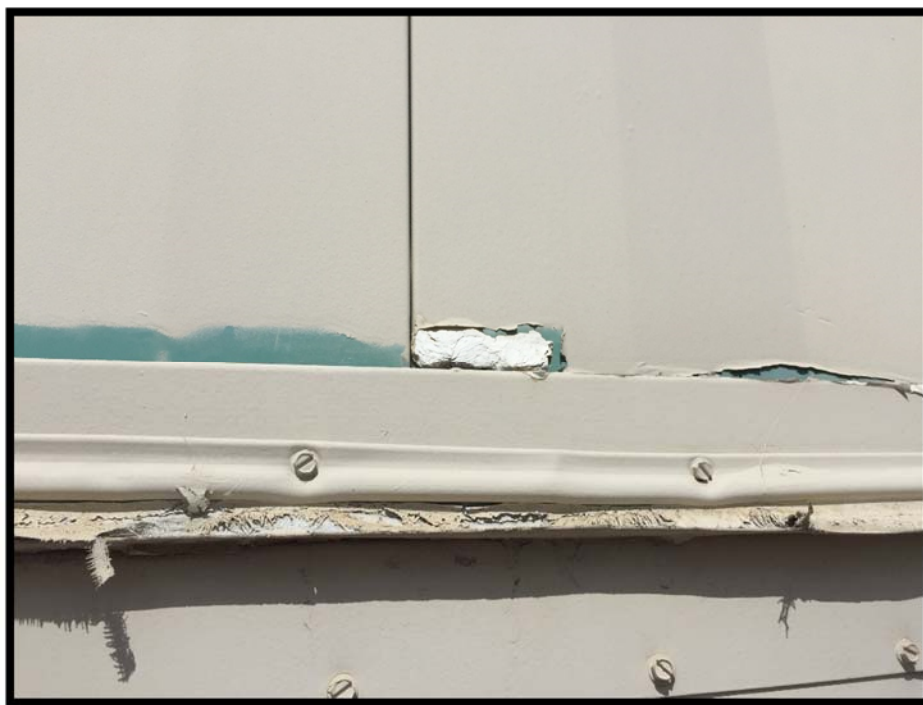
One (1) sample of white exterior building caulking was collected during the assessment. The sample collected was found to contain 4.6% Chrysotile asbestos. Asbestos-containing white exterior building caulking (see Photograph 1 in Appendix B) was observed in the following locations:

- Exterior (approximately 40 linear ft).

Photograph 1: Asbestos-Containing White Exterior Building Caulking.

If scheduled for impact, asbestos-containing white exterior building caulking should be abated following low-risk abatement work procedures as outlined in the *Saskatchewan Asbestos Abatement Manual (2017)*. Alternatively, as the white exterior building caulking was observed in good condition, and with a priority rating of 5 (please see the room by room spreadsheet provided in Appendix C for a description of the priority ratings), it can be managed in place if not scheduled for impact.

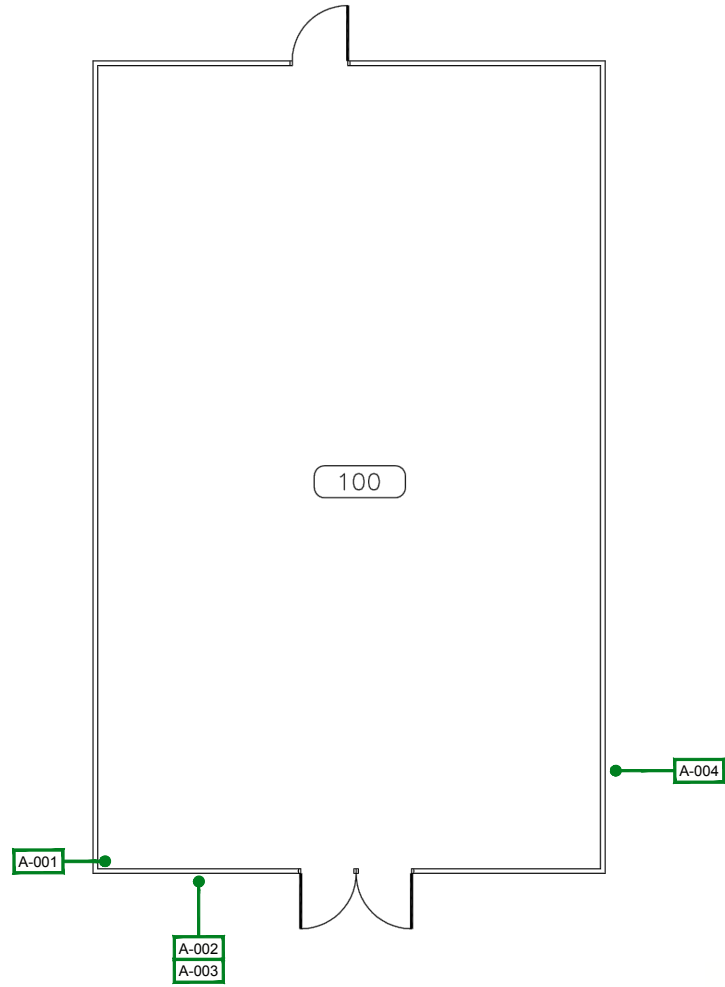
FIGURE
 1

1. ASBESTOS IS A CARCINOGEN. DO NOT BREATHE ASBESTOS DUST.
2. ASBESTOS-CONTAINING WHITE BUILDING CAULKING IS LOCATED SPORADICALLY ON THE EXTERIOR OF THE BUILDING.
