**City Hall North
Asbestos Survey Report**

January 2015

Prepared For: City of Saskatoon Infrastructure Services - Facilities Branch
3130 Laurier Drive, Saskatoon, SK.
Attn: Brent Anderson

Prepared By: Bersch & Associates Ltd.
Project No. : B67SRA16

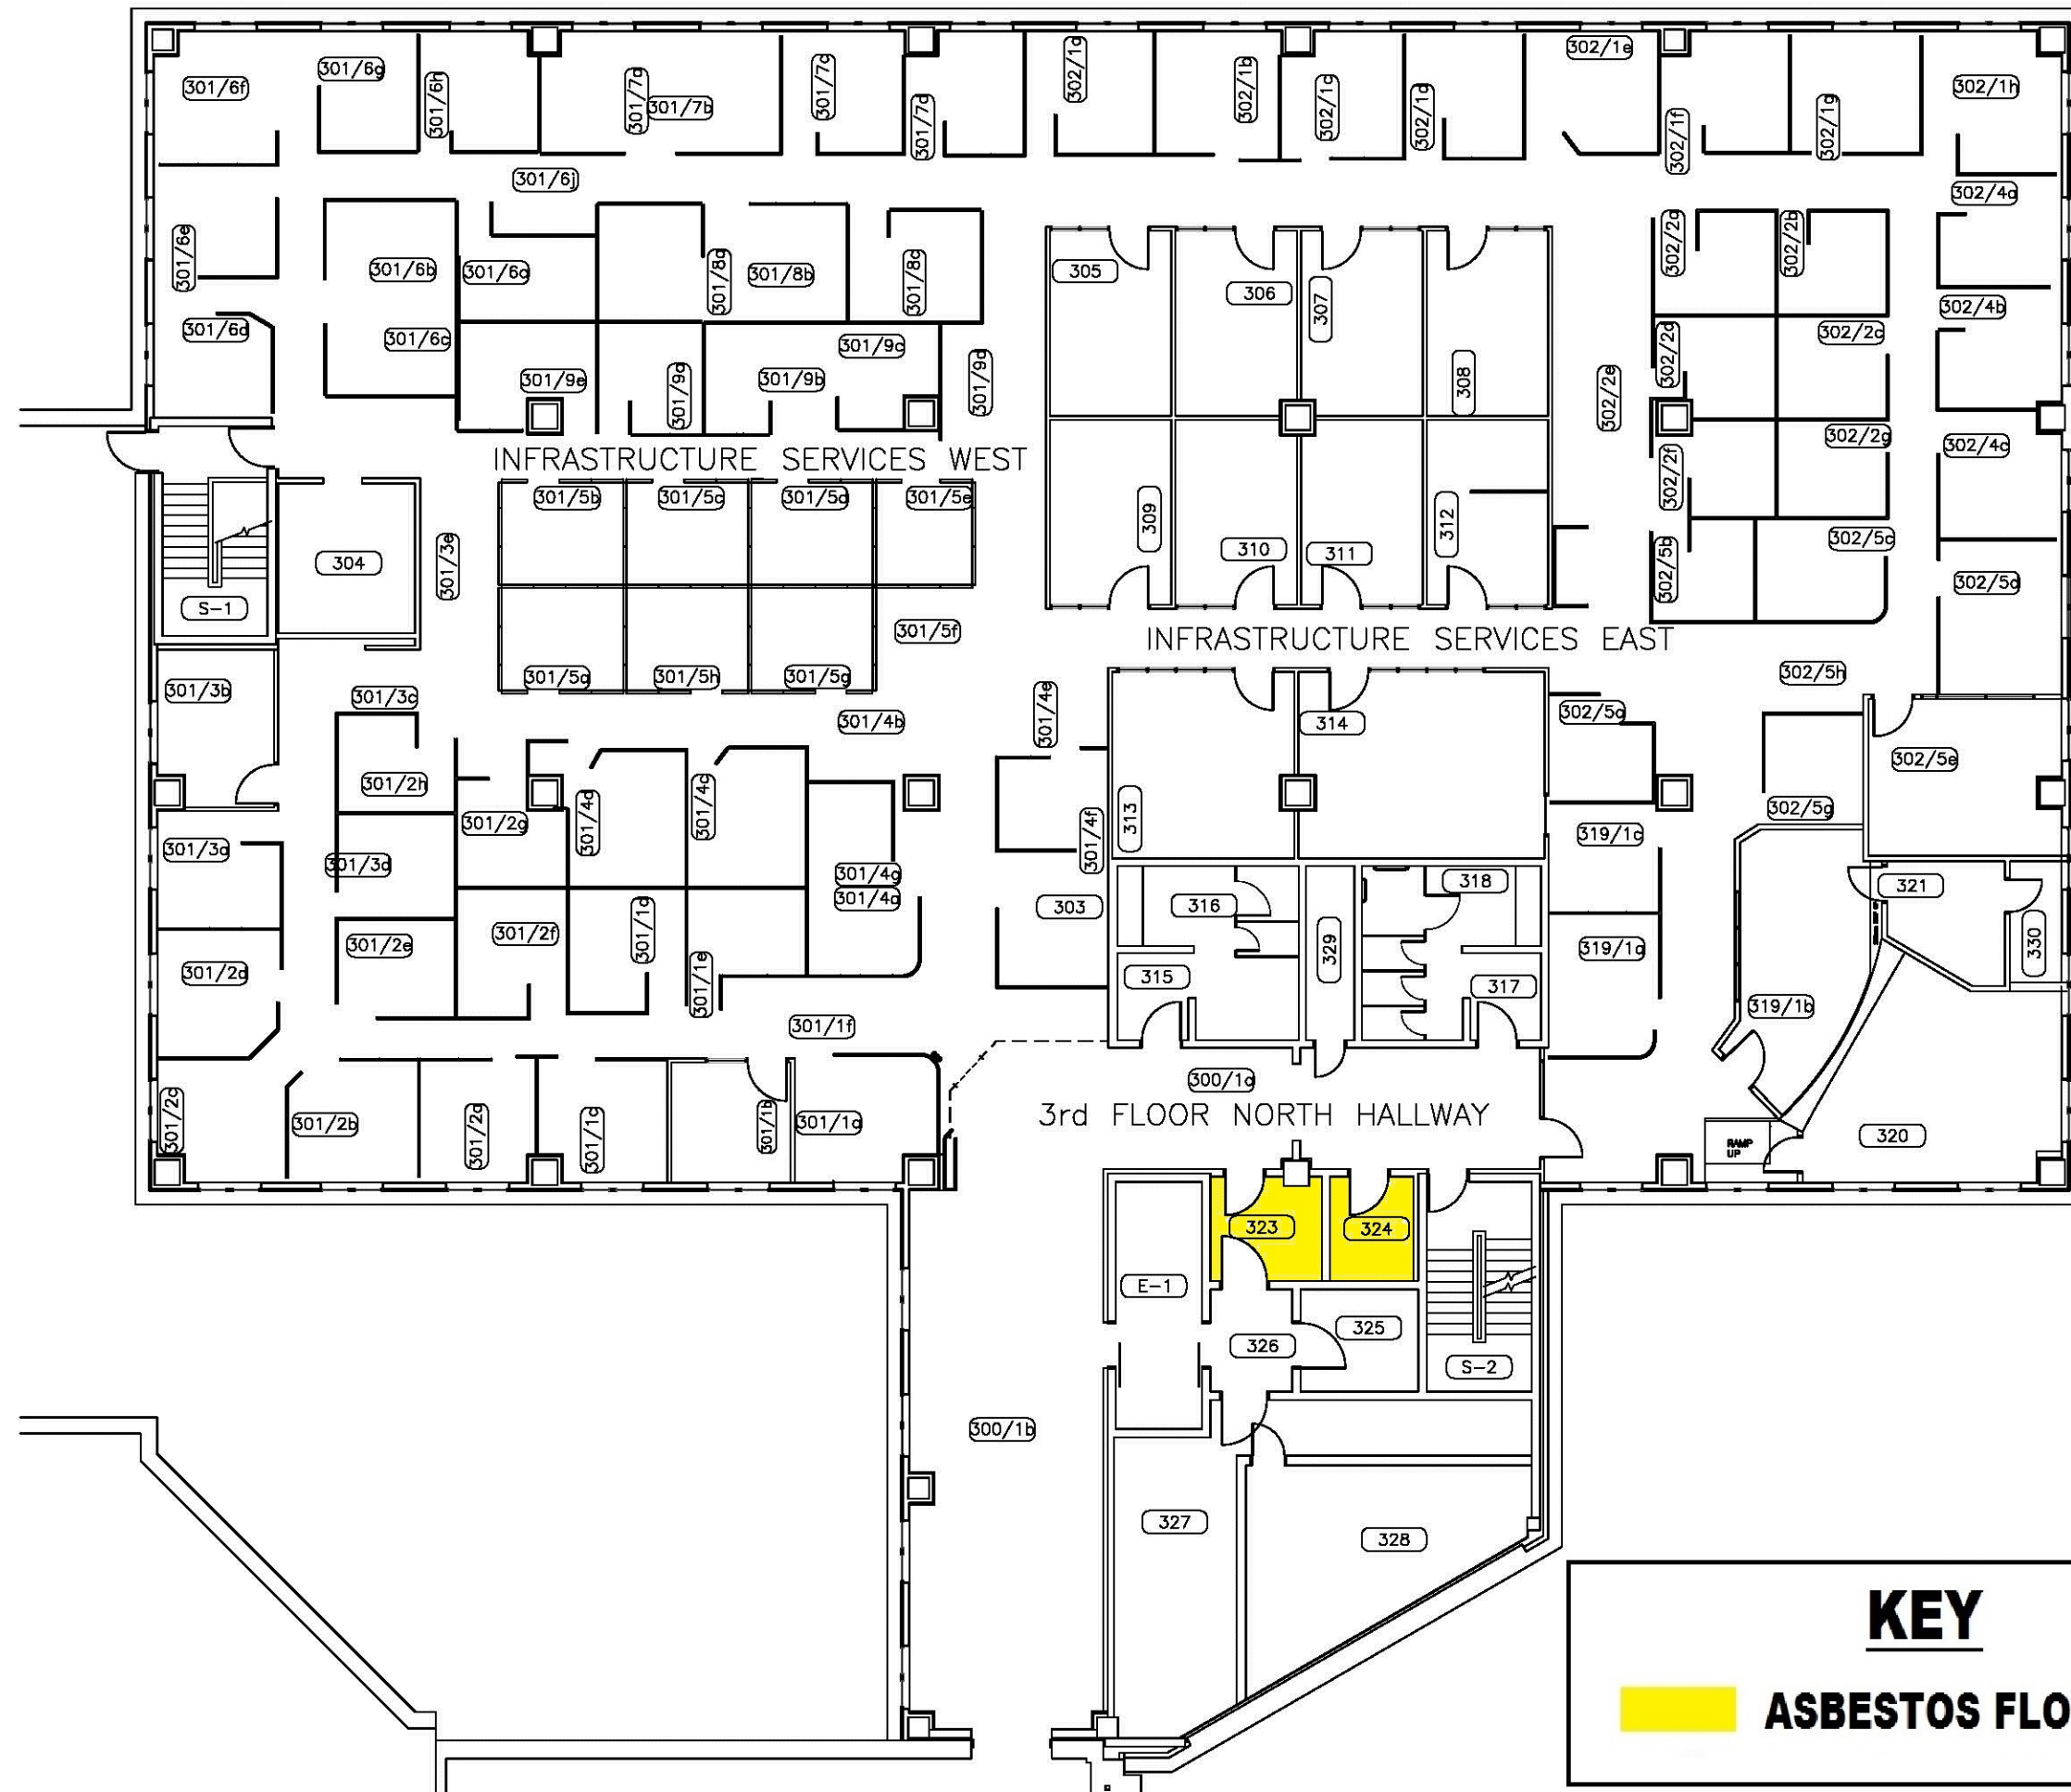
**ASBESTOS FLOOR TILE**

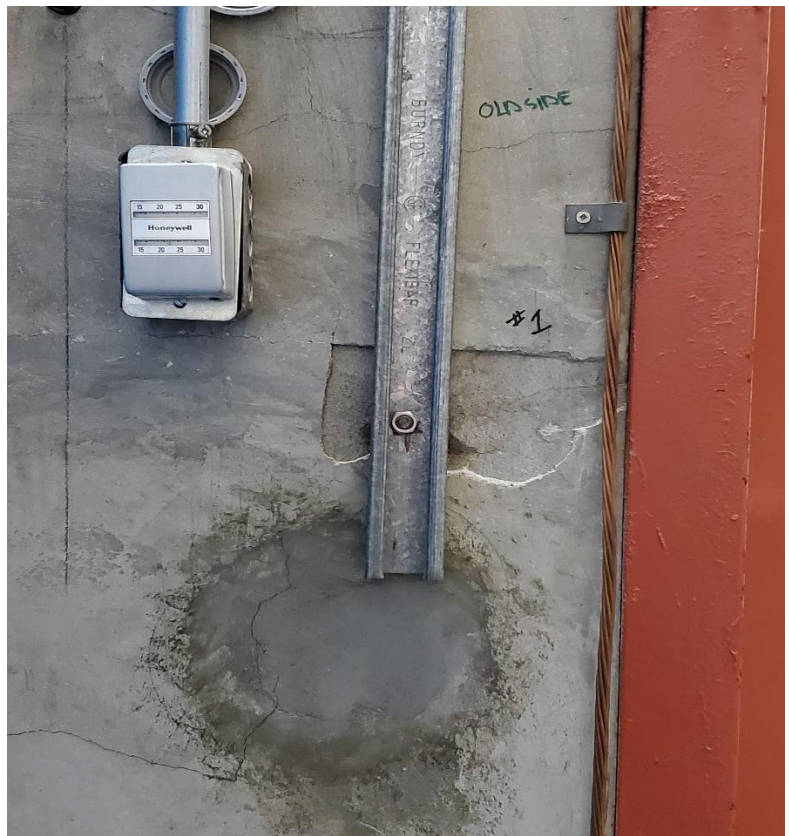
Grey Skim Coat in
Electrical Room adj. Boiler
Room – East Wall adj.
Entrance

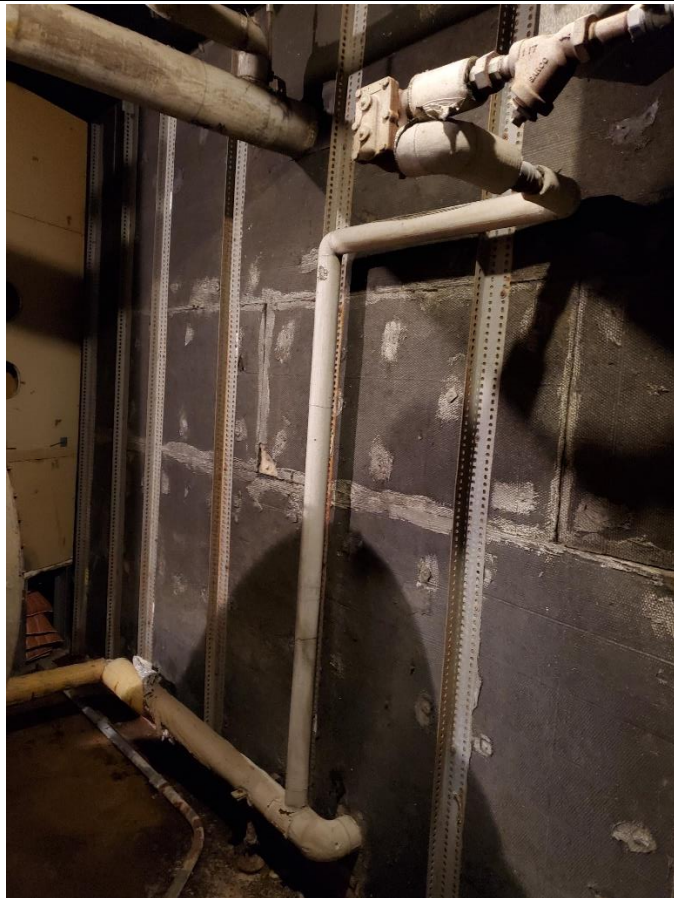
B67PDC24J - 002

- c) The rigid insulation material within the air plenums was identified as containing 8% Chrysotile Asbestos in the black tar coating. The insulation itself is a fibre-glass composition. The black tar coating is also a non-friable material and poses no health-related concern in its present condition and location. The Chrysotile fibres are imbedded in a tar mixture that would require elimination of the tar for the fibres to become airborne. If removal of the rigid insulation is not necessary to accommodate the building improvements, it may remain in place until renovation/demolition activity warrants prior removal.

Black Tar Coating on
Rigid Fibre-glass in F17
Coil Room – North Wall

- d) Any removal of the rigid insulation with black tar coating will be completed as a Low Risk Asbestos Process. This will entail the isolation of any penetrations into the plenum to prevent any airflow through the work area. Isolations will be completed with poly-weave 6 mill sheeting and sealed with duct tape to ensure of an airtight seal. Any black tar coated insulation removed will be disposed of in 6 mil asbestos disposal bags and transported to an approved landfill. Workers involved in the removal activity will be equipped with P100 respirators and wear disposable coveralls. Upon completion of the removal activity all dust/debris from within the work area will be removed using HEPA vacuums. For any areas where the insulation requires removal Bersch Consulting Ltd. will complete inspection and air monitoring prior to deem the area suitable for access by other trades involved in the project and verify that all required work has been completed in accordance with all regulating authorities.
