**City of Saskatoon
Civic Square East
202 4th Ave North, Saskatoon, Sk.**

**Asbestos Survey Report
November 2016**

**Prepared By: Bersch & Associates Ltd.
Project No.: B40SRH29F**

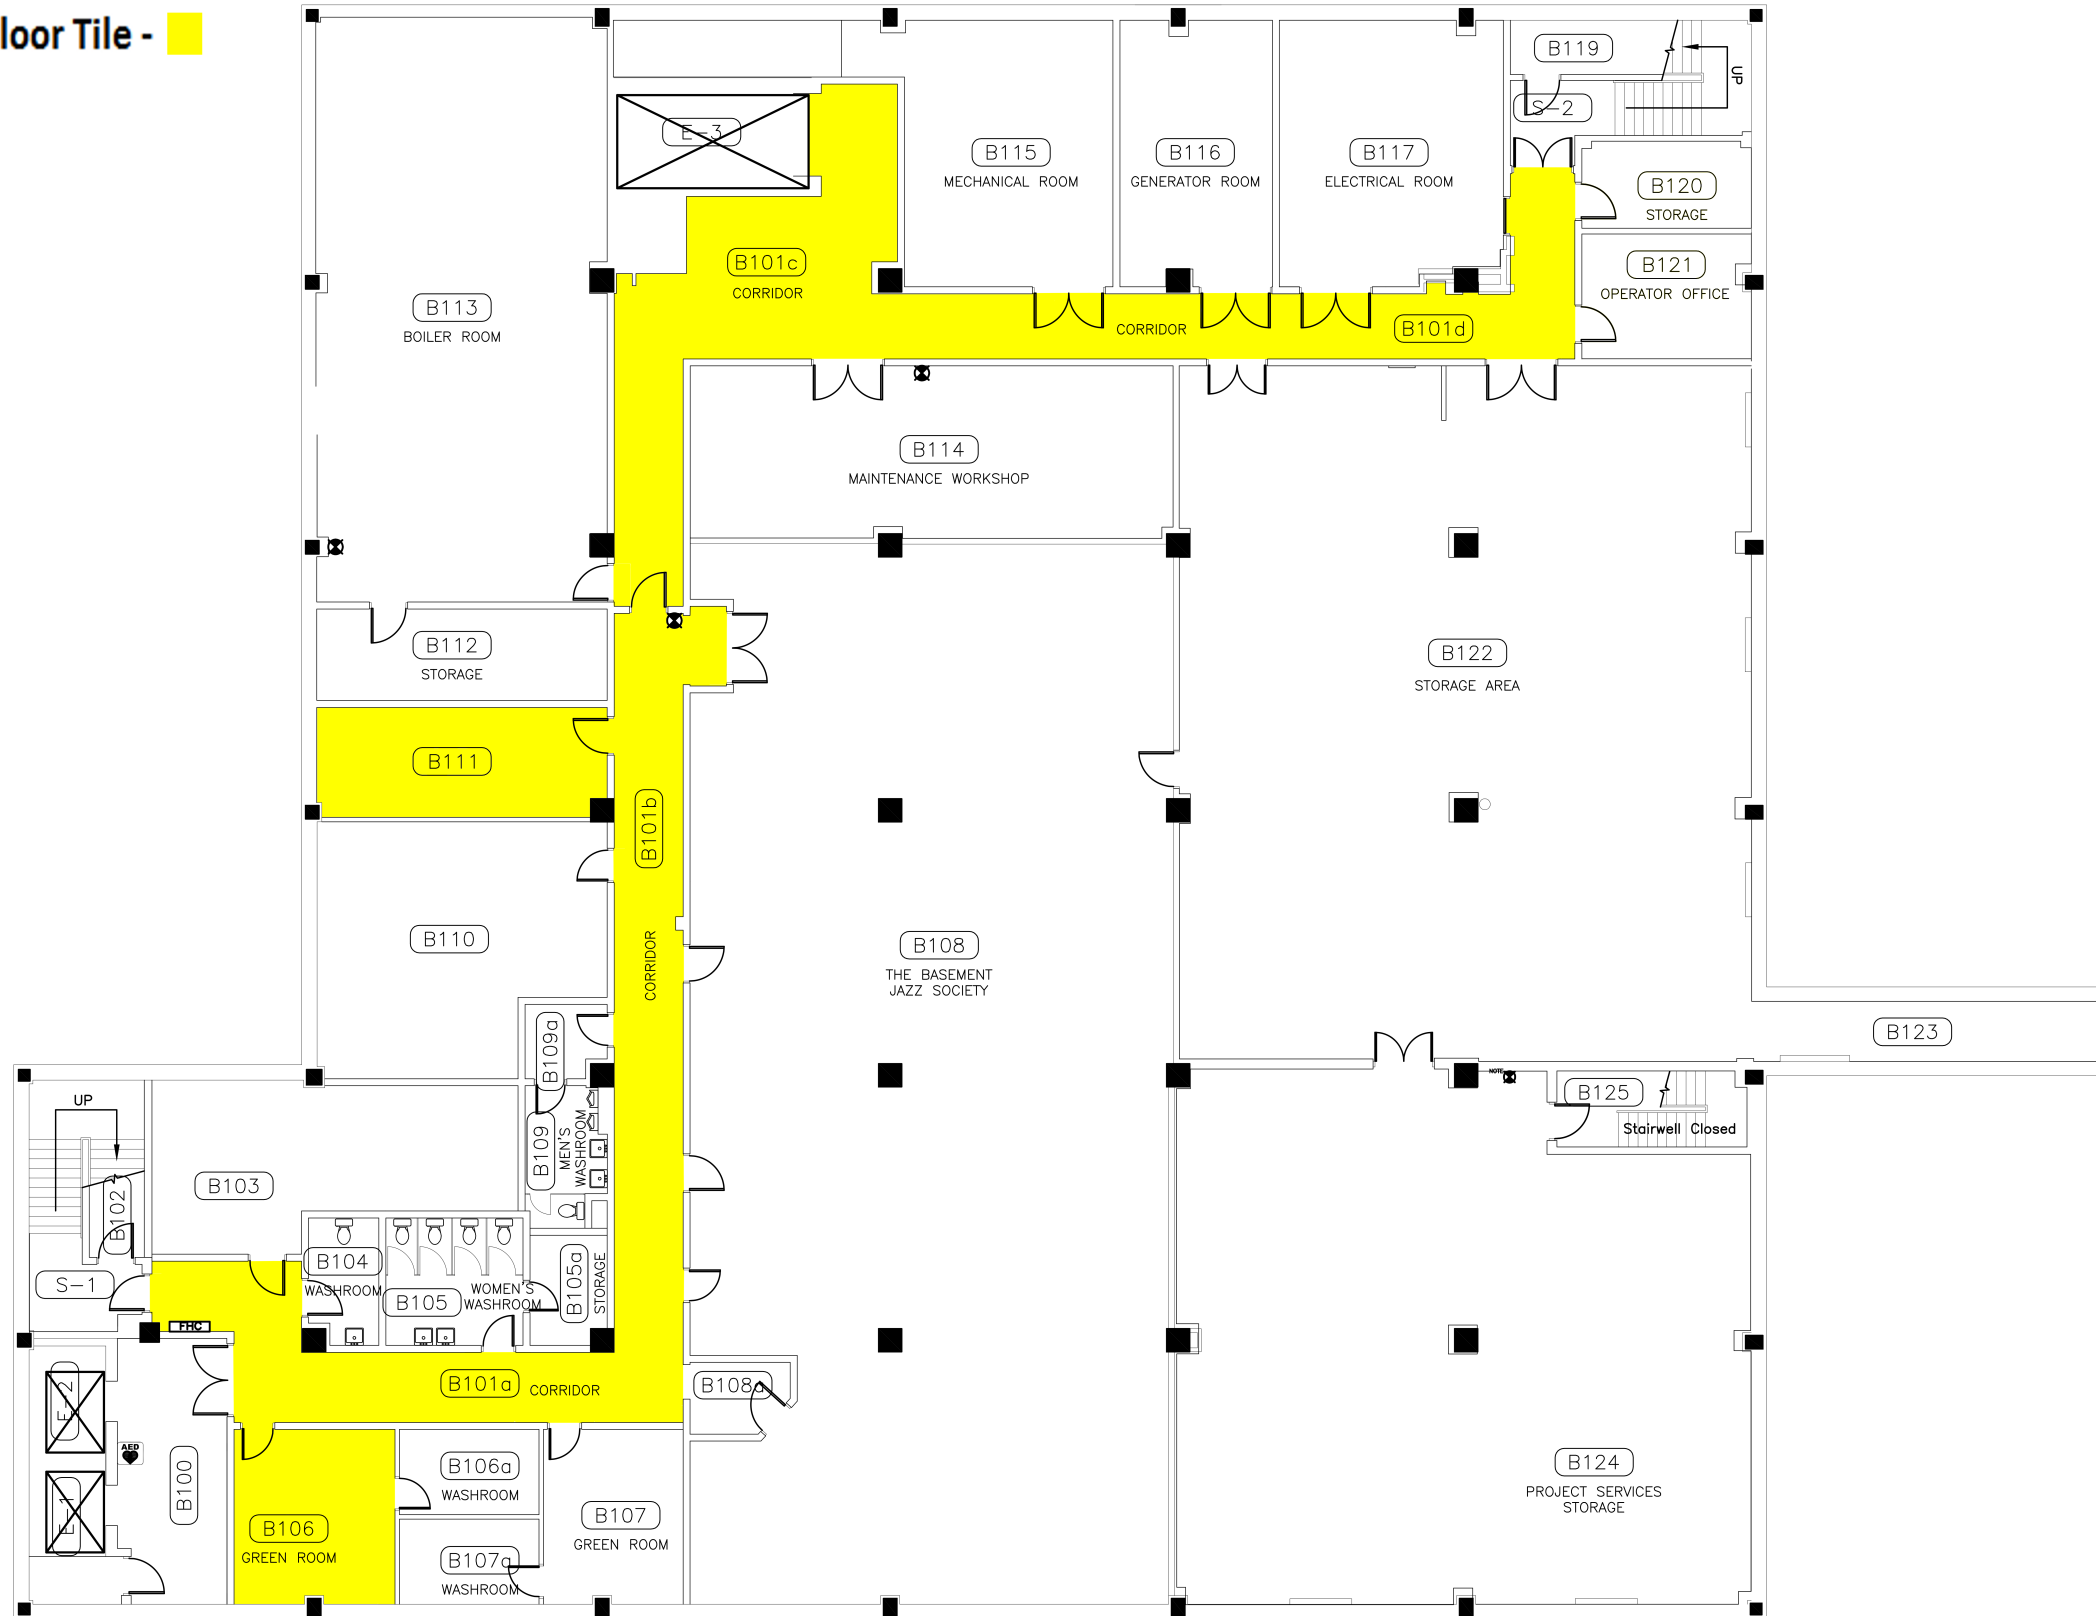
- **Vinyl Asbestos Floor Tile (VAT)** was observed in various areas throughout the basement level of the building. Please refer to **Appendix II & Appendix III** of this report. The VAT is identified on the Floor Plans located in **Appendix III** of this report.

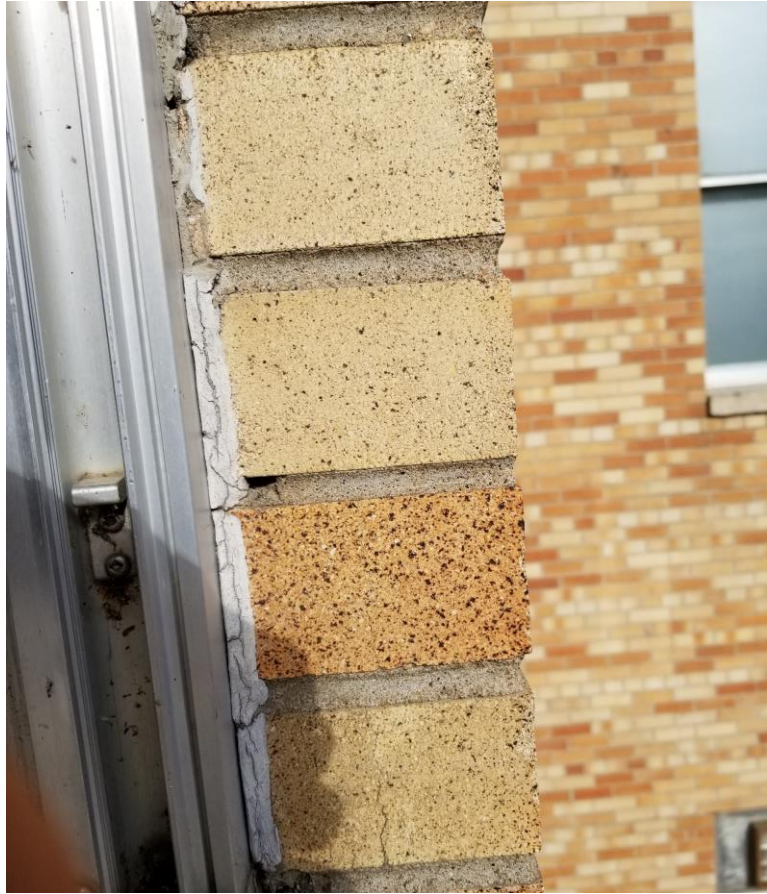
B67PRE25J - 002

345 Staff Lounge Exterior

Caulking Between Window
Frame and Brick.

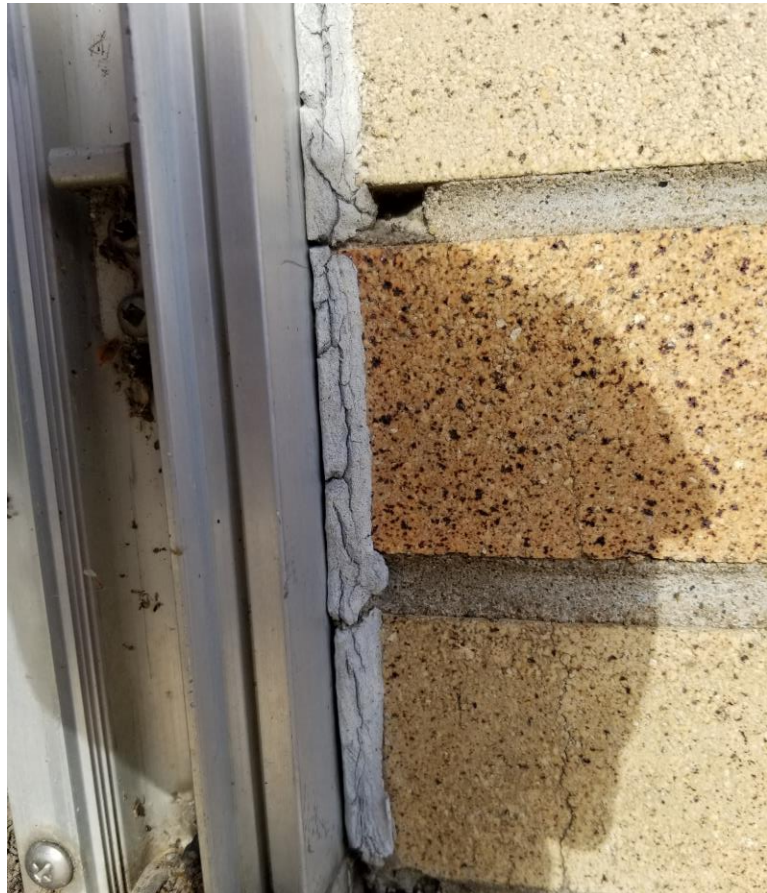
B67PRE25J - 003

345 Staff Lounge Exterior

Exterior Brick Mortar.

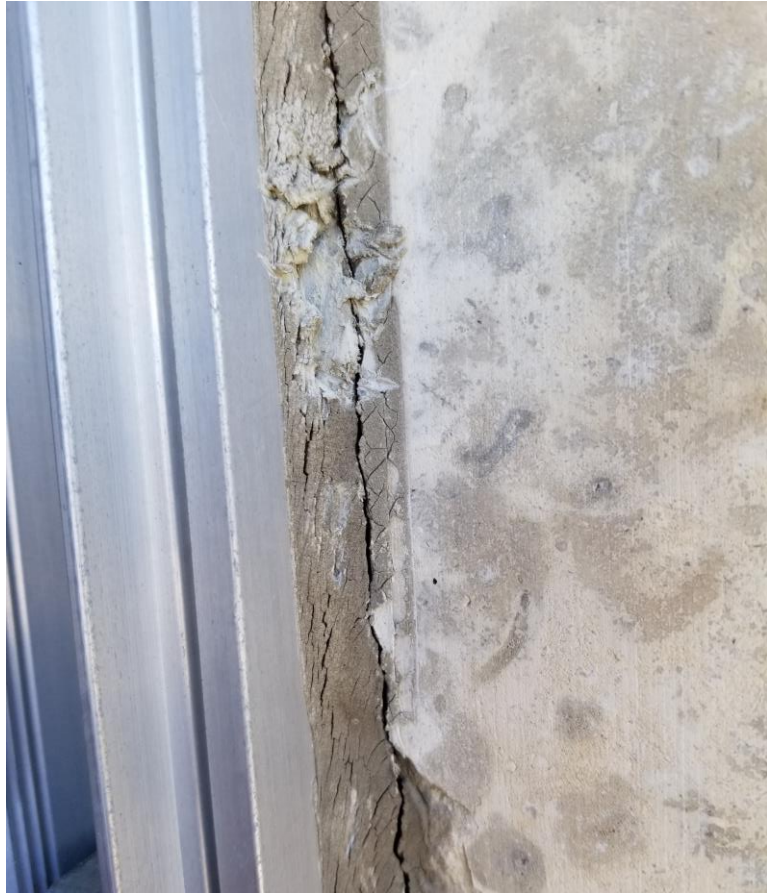
B67PRE25J - 004

316 Office Area Exterior

Caulking Between Window
Frame and Stone.

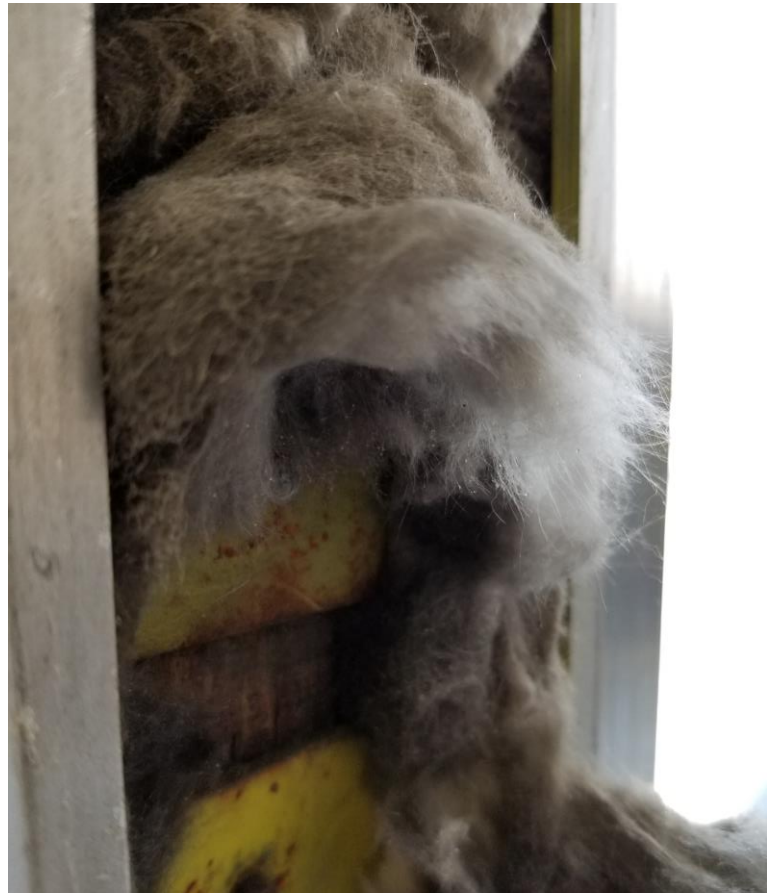
Insulation Behind the Window
Mullions.

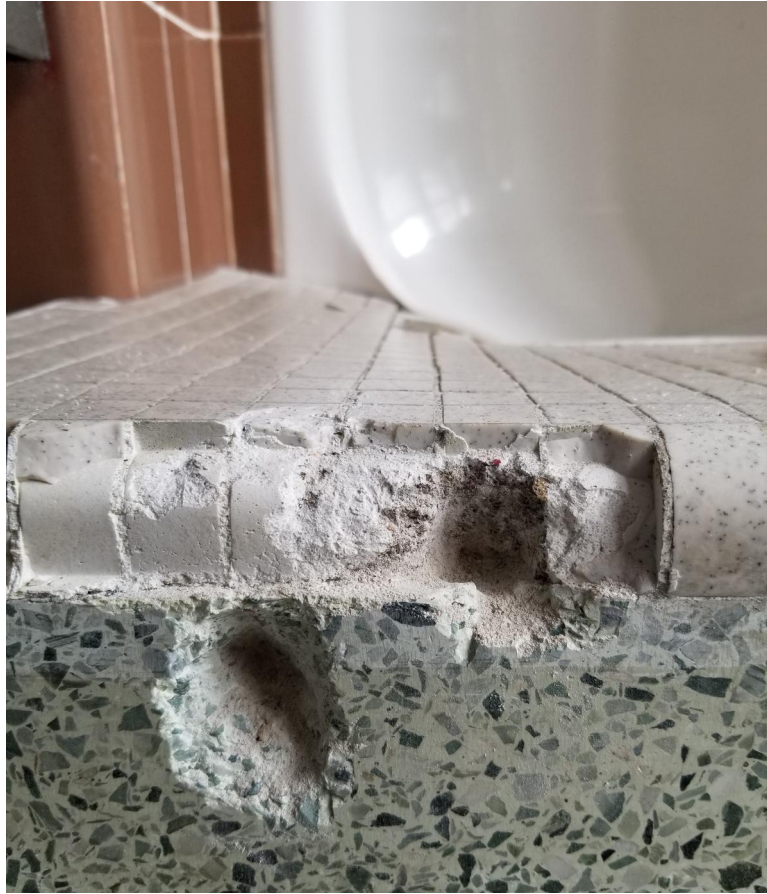
B67PRE21J - 002

Room 430 – Men’s Washroom

Terrazzo Floor and Concrete
Slab in Front of the Urinals.

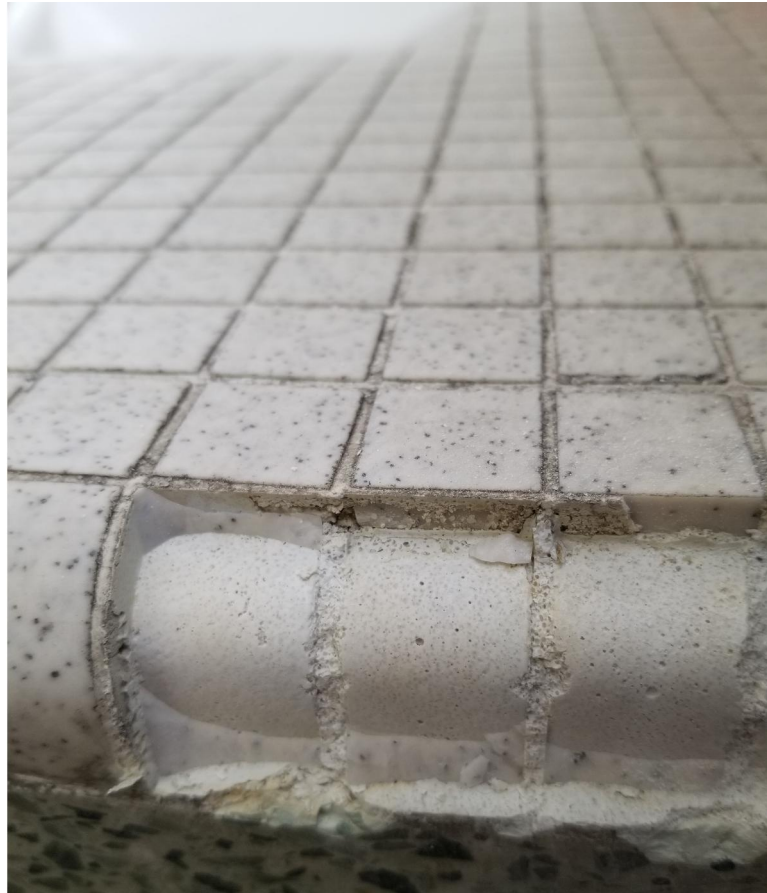
B67PRE21J - 003

Room 430 – Men’s Washroom

1” X 1” Ceramic Floor Tile White
Mortar at the base of the
Urinals.

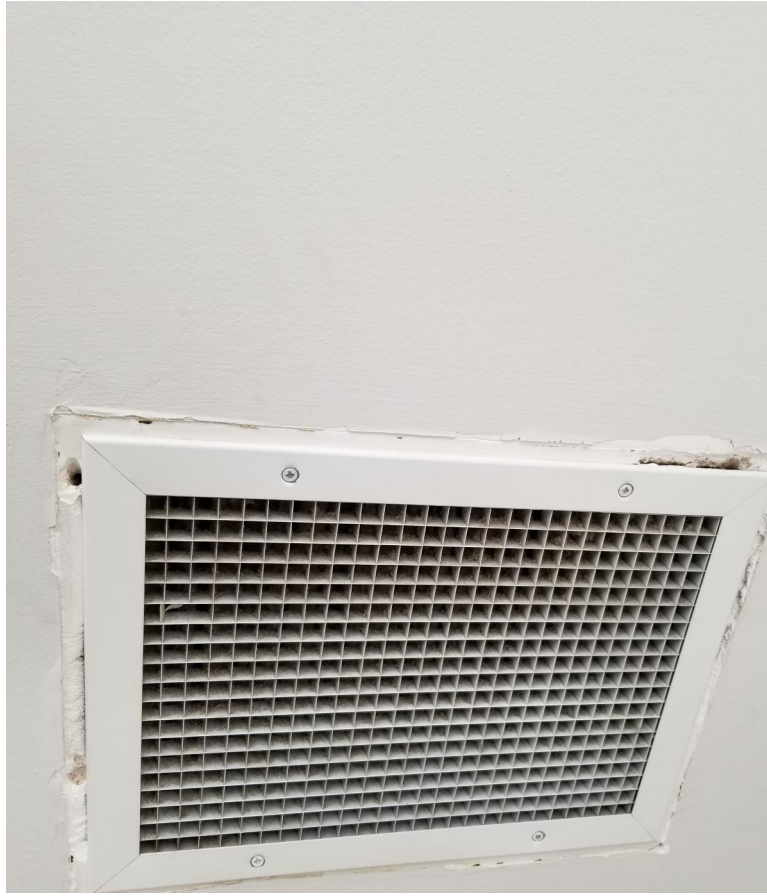
B67PRE21J - 004

Room 430 – Men’s Washroom

Ceiling Skim and Base Coat
Parging Around the Exhaust
Grille.

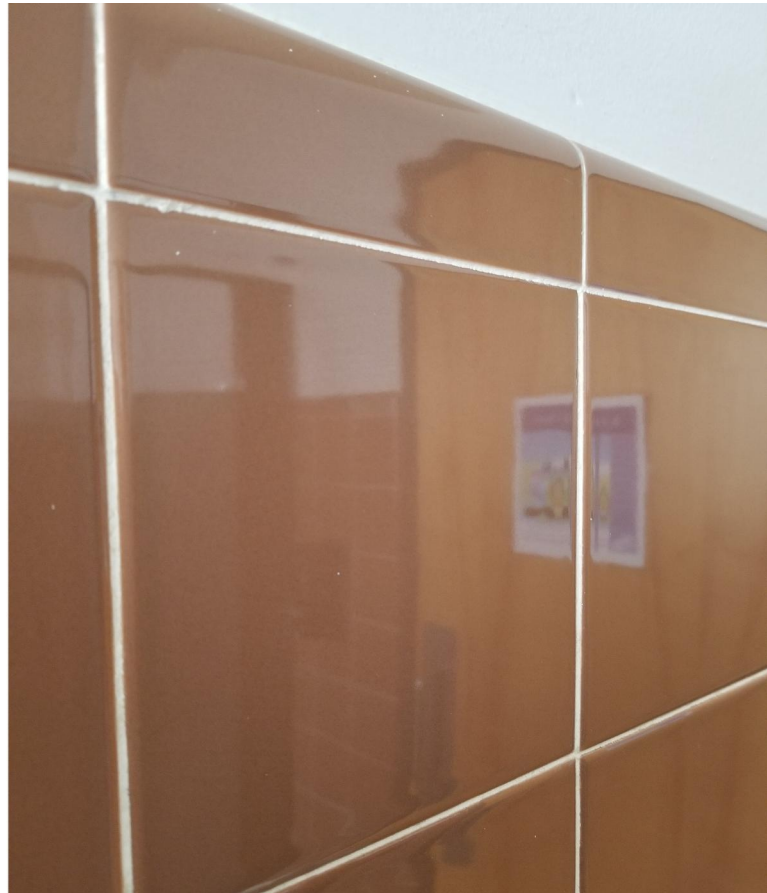
B67PRE21J - 005

Room 430 – Men’s Washroom

White Grout on Brown Ceramic
Wall Tiles.

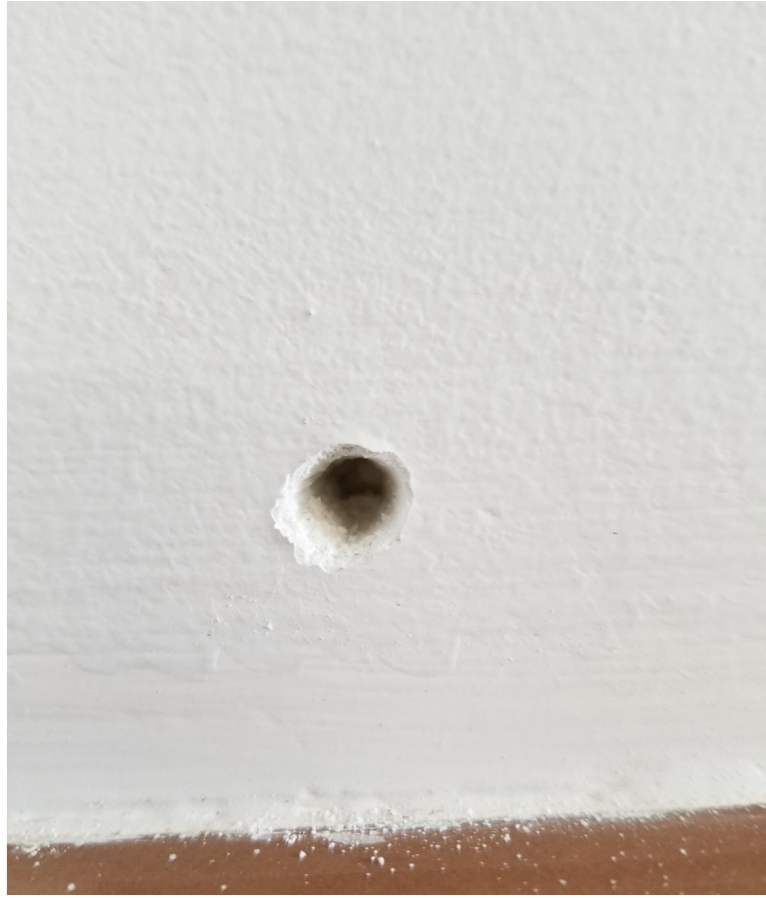
B67PRE21J – 006

Room 430 – Men’s Washroom.

Compilation of Wall Parging
