DERRICK CARROLL ASBESTOS SURVEY REPORT

March 2014

Prepared For: City of Saskatoon – Infrastructure Services Department
1101 Avenue P North, Saskatoon SK, Canada S7L 7K6
Attn: Brent Anderson

Prepared By: Bersch & Associates Ltd.
Project No. : B67SRC06

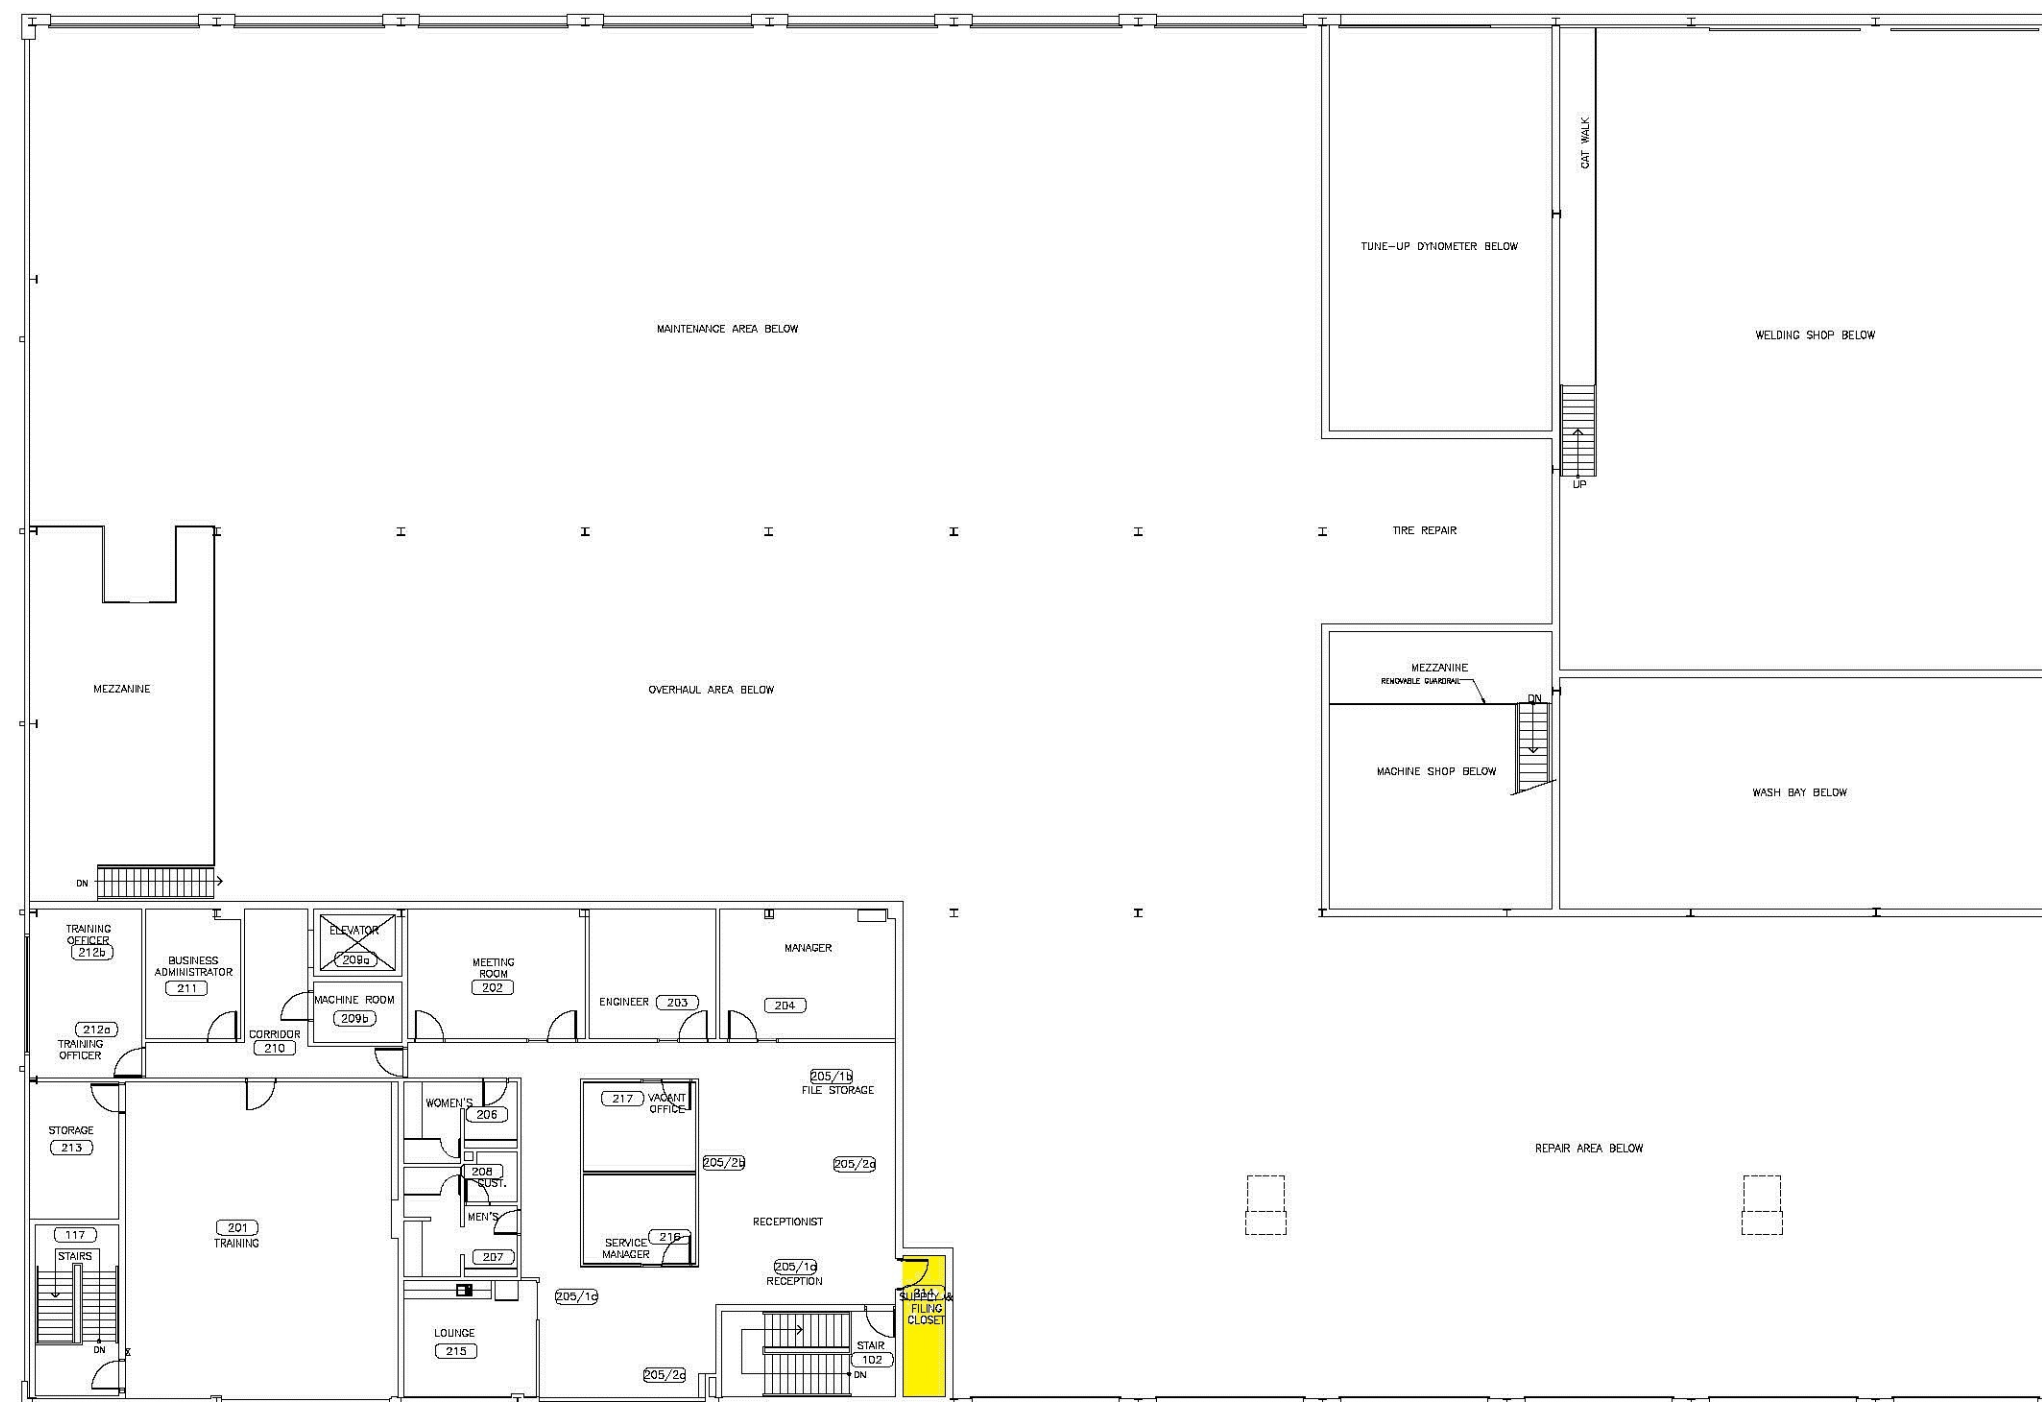
**Second Floor
Base Plan**

- **Vinyl Asbestos Floor Tile** is located within 214 Supply & Filing Closet.
- **Although it is unlikely due to sample results, any material located within ceilings, wall cavities, pipe chases or other inaccessible areas or areas of limited access shall be considered asbestos-containing until testing of the material can determine the presence or absence of asbestos.**

**Vinyl Asbestos Floor Tile**

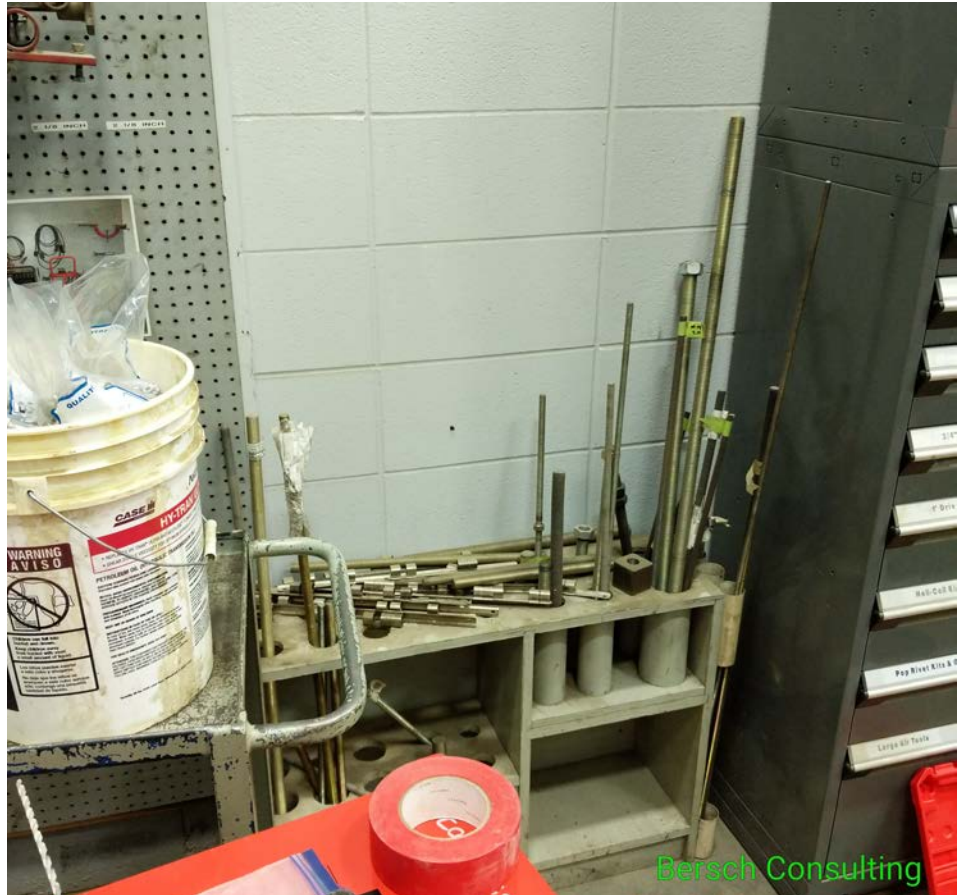
B67PRH19I - 001

Interior cinderblock wall.

Room 121/122 adjacent the
Welding Shop.

Vermiculite was not present
within the wall.

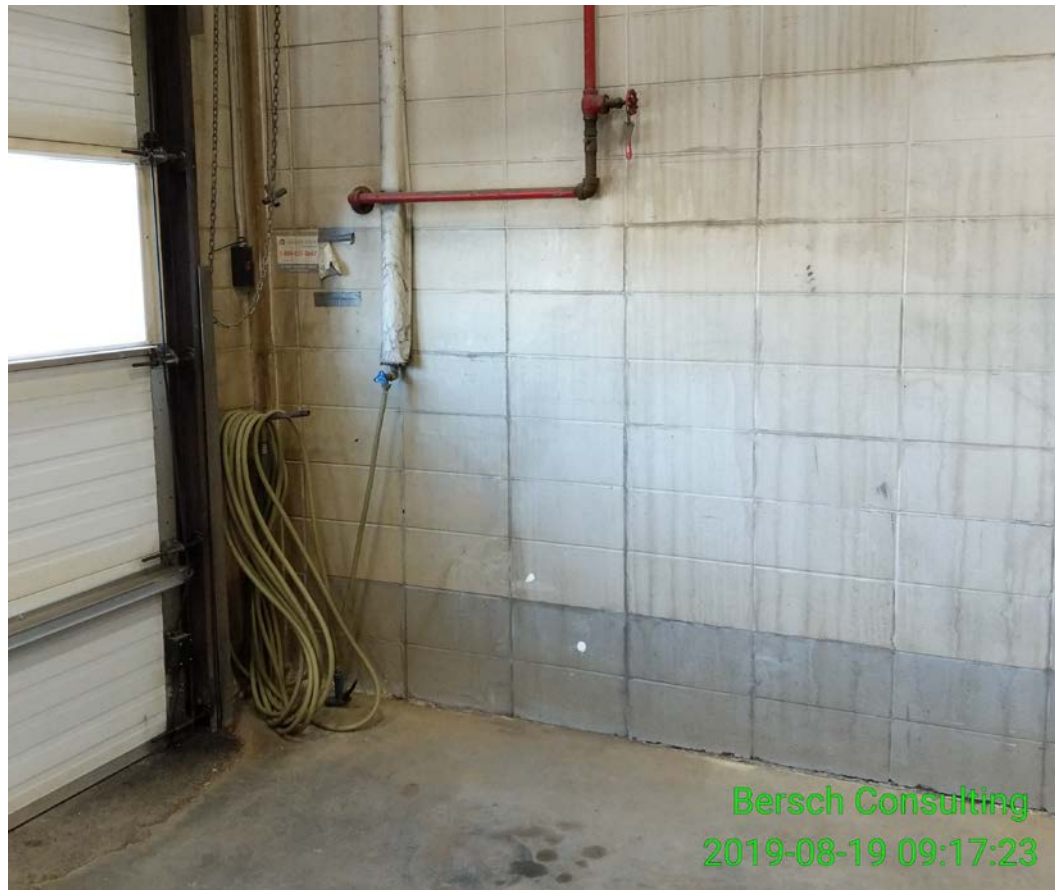
B67PRH19I - 002

Exterior cinderblock wall.

Northwest building wall.

Vermiculite was not present
within the wall.

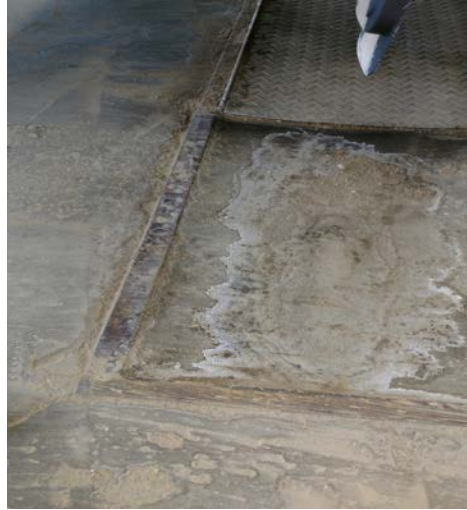
PHOTO 1 – MAIN SHOP AREA – IN-FLOOR HOIST

NO.	DATE	SAMPLE INFORMATION	ASBESTOS	%	ANALYST
1	7-Mar-17	Main Shop Area - Concrete Flooring	No Asbestos Detected		WB

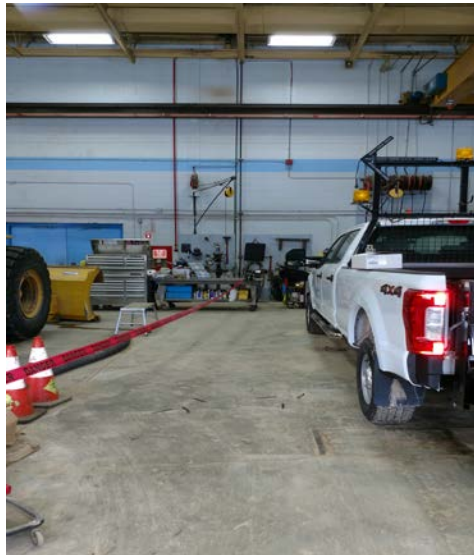
PHOTO 2 – MAIN FLOOR AREA – CONCRETE FLOOR

The Main Shop consists of a concrete slab floor. Refer to the attached photos.

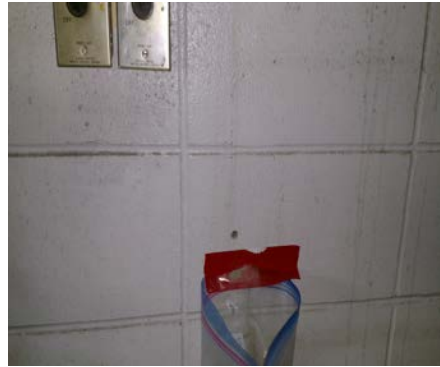
PHOTO 1 – 124 (BAY #10) – NORTH BLOCK WALL

Mitch Webber of Bersch Consulting Ltd. conducted a site visit on March 15th, 2017 to investigate the cindercrete block walls in room 124 (Bay #10) to determine the prescene/absense of vermiculite block wall insulation. The facility is located at City Yards, 75 King Street, Saskatoon, SK. The North, East & South block walls were drilled into resulting in hollow block cavities. No insulation was observed in the block walls. Please refer to the attached photos. There does not appear to be an asbestos concern that would reflect on the renovations proposed for the area.
