## Diefenbaker Maintenance Shop

Saskatoon, SK

May 30, 2023

**Project No.:** B67AAE30M

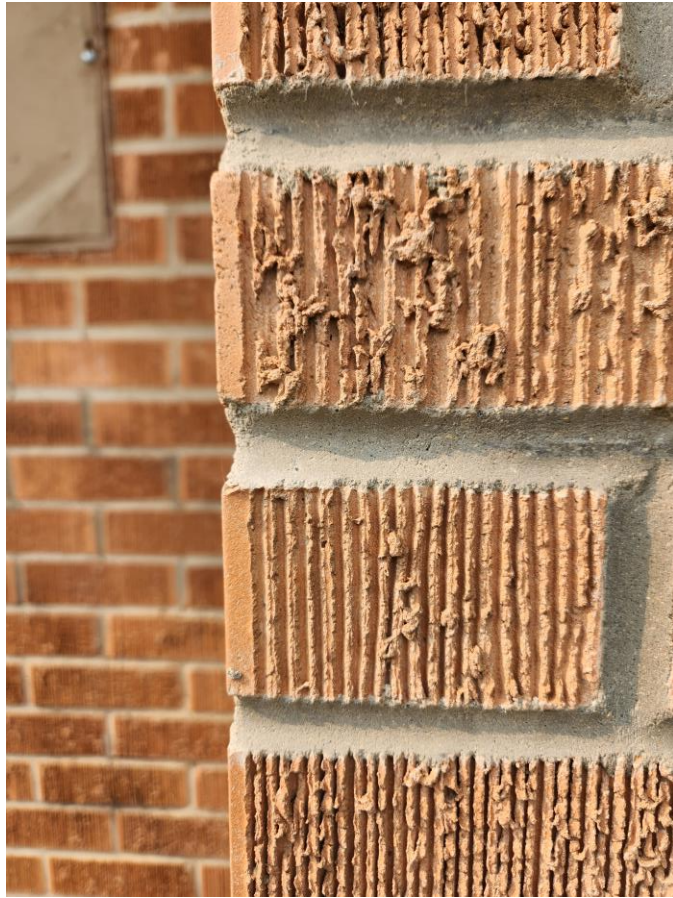
B67AAE30M - 1

Mortar

Exterior

In Between Bricks

Non-Asbestos Containing Material

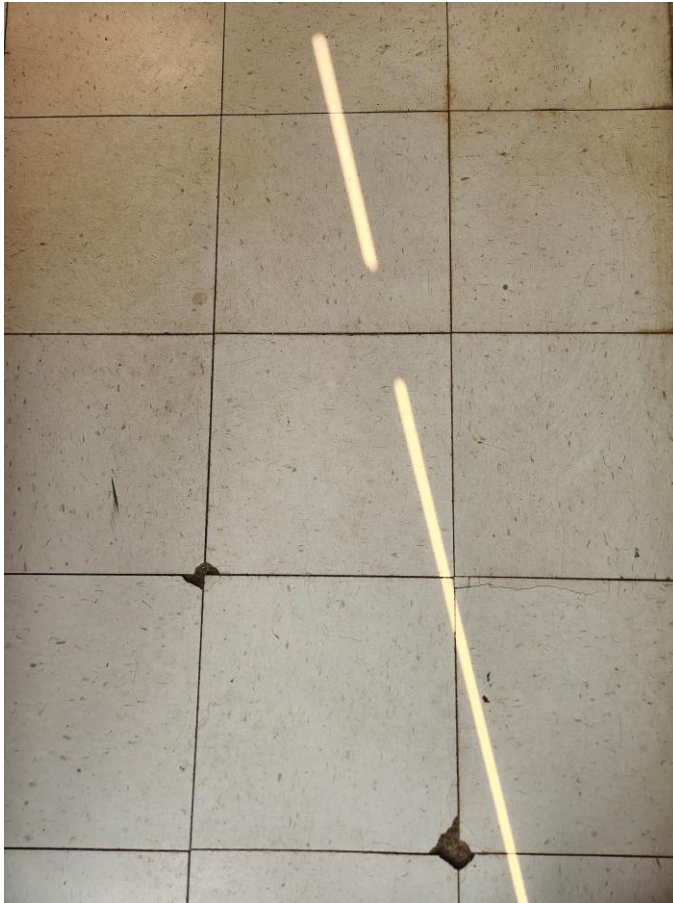
B67AAE30M – 2a/b/c

Floor Tile/Mastic/Leveler

Bathroom

Non-Asbestos Containing Material

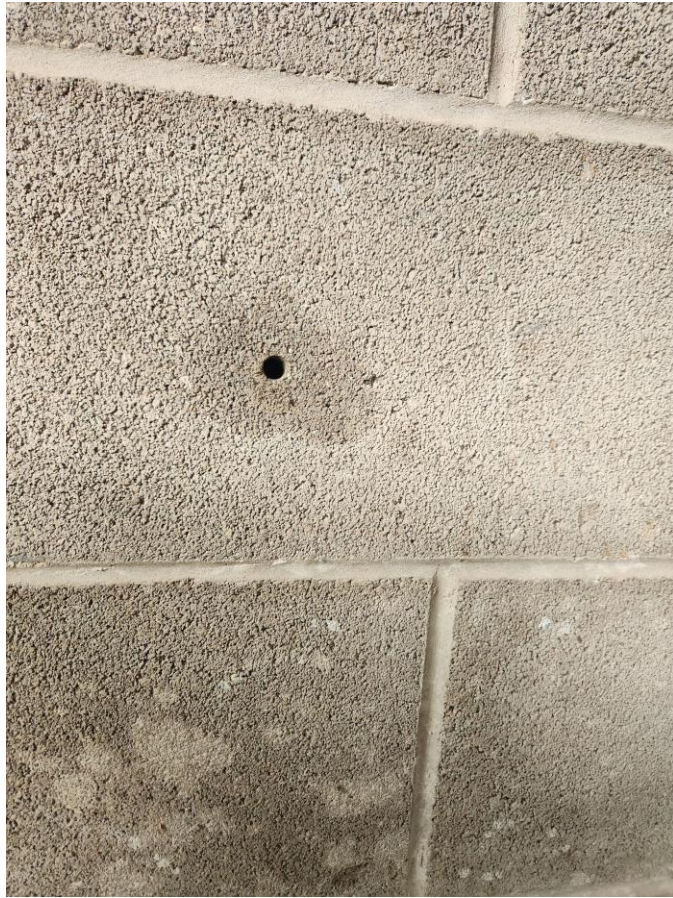
Interior Block Wall  
Checked for Vermiculite

Non-Asbestos Containing Material

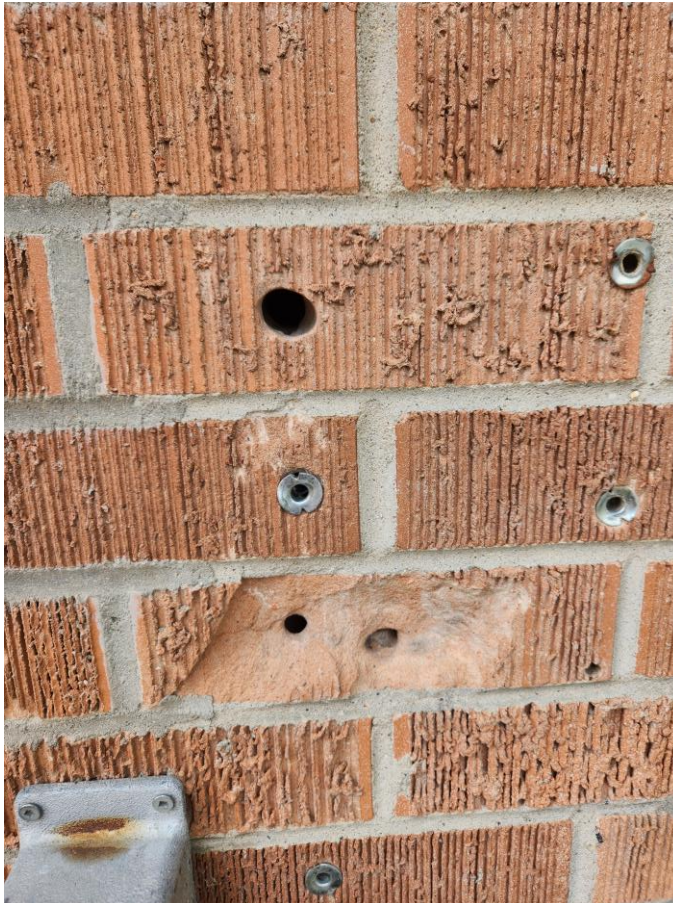
Exterior Wall  
Checked for Vermiculite

Non-Asbestos Containing Material
