October 4, 2017

## CITY OF SASKATOON AND GENERAL MANAGEMENT SERVICES

# Asbestos-Containing Building Materials Assessment Report - Essex Plaza

**Report Number: 1779656**

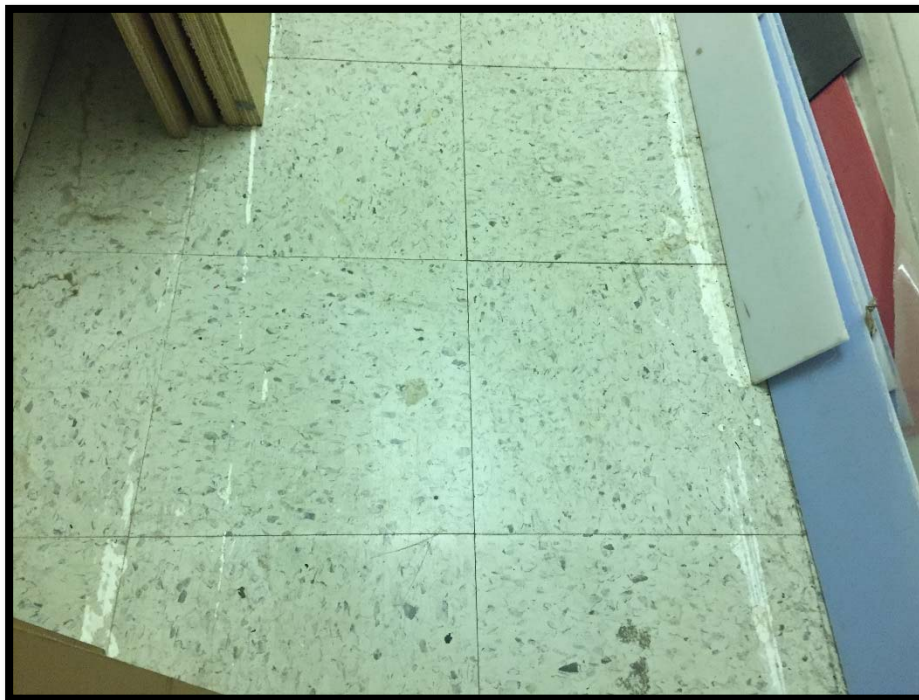
Two (2) samples of 12"x12" off-white floor tile with black flecks were collected during the assessment. Both of the samples collected were found to contain trace to 1.8% Chrysotile asbestos. Asbestos-containing 12"x12" off-white floor tile with black flecks (see Photograph 1 in Appendix B) was observed in the following locations:

**Photograph 1: Asbestos-Containing 12"x12" Off-White Floor Tile with Black Flecks.**

If scheduled for impact, asbestos-containing 12"x12" off-white floor tile with black flecks should be abated following low-risk abatement work procedures as outlined in the *Saskatchewan Asbestos Abatement Manual* (2017). Alternatively, as the 12"x12" off-white floor tile with black flecks was observed in good condition, and with a priority rating of 5 (please see the room by room spreadsheet provided in Appendix C for a description of the priority ratings), it can be managed in place if not scheduled for impact.

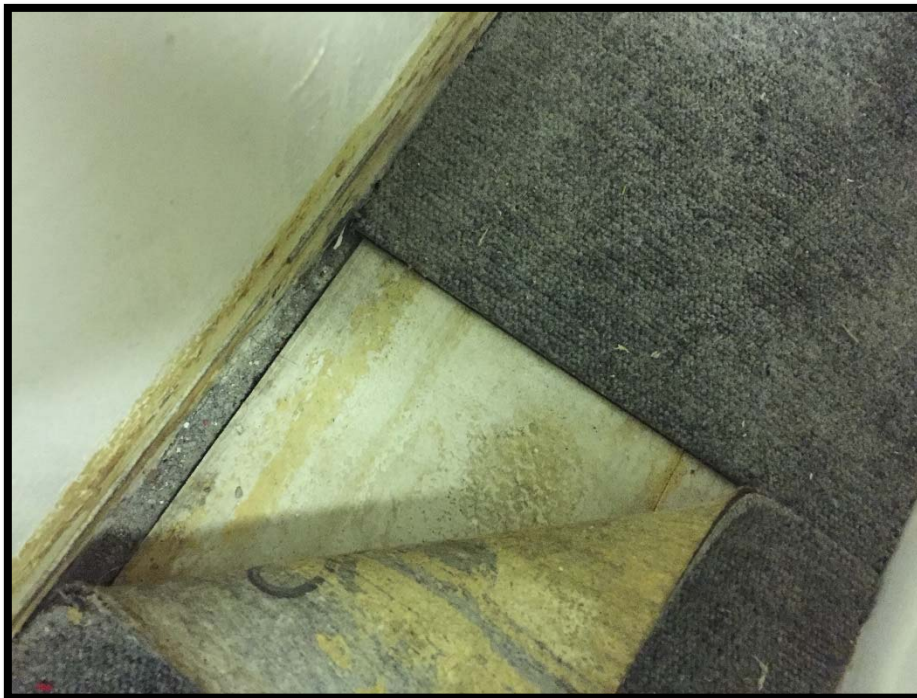
One (1) sample of 12"x12" floor tile with an indistinguishable pattern (due to carpet glue) was collected during the assessment. The sample collected was found to contain trace Chrysotile asbestos. Asbestos-containing floor tile (see Photograph 2 in Appendix B) was observed in the following location:

**Photograph 2: Asbestos-Containing 12"x12" Floor Tile (Indistinguishable Pattern).**

If scheduled for impact, asbestos-containing floor tile (indistinguishable pattern) should be abated following low-risk abatement work procedures as outlined in the *Saskatchewan Asbestos Abatement Manual* (2017). Alternatively, as the floor tile (indistinguishable pattern) was observed in good condition, and with a priority rating of 5 (please see the room by room spreadsheet provided in Appendix C for a description of the priority ratings), it can be managed in place if not scheduled for impact.

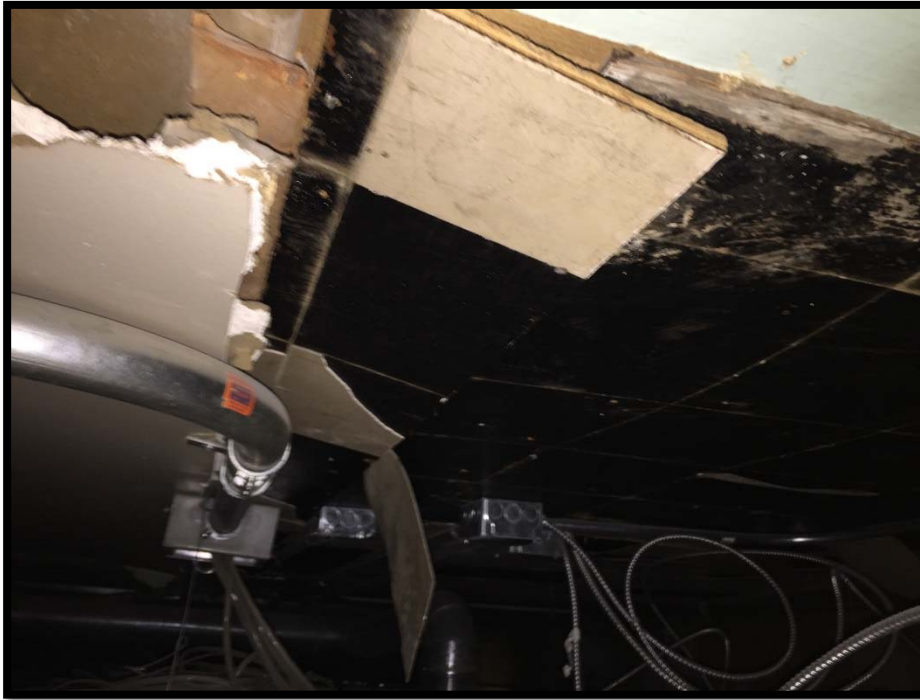
One (1) sample of 9"x9" floor tile installed on an upper plywood ceiling was collected during the assessment. The sample collected was found to contain 0.5% Chrysotile asbestos. Asbestos-containing floor tile on an upper plywood ceiling (see Photograph 3 in Appendix B) was observed in the following location:

**Photograph 3: Asbestos-containing 9"x9" Floor Tile on Upper Plywood Ceiling.**

If scheduled for impact, asbestos-containing 9"x9" floor tile on upper plywood ceiling should be abated following low-risk abatement work procedures as outlined in the *Saskatchewan Asbestos Abatement Manual* (2017). Alternatively, as the 9"x9" floor tile on upper plywood ceiling was observed in good condition, and with a priority rating of 5 (please see the room by room spreadsheet provided in Appendix C for a description of the priority ratings), it can be managed in place if not scheduled for impact.

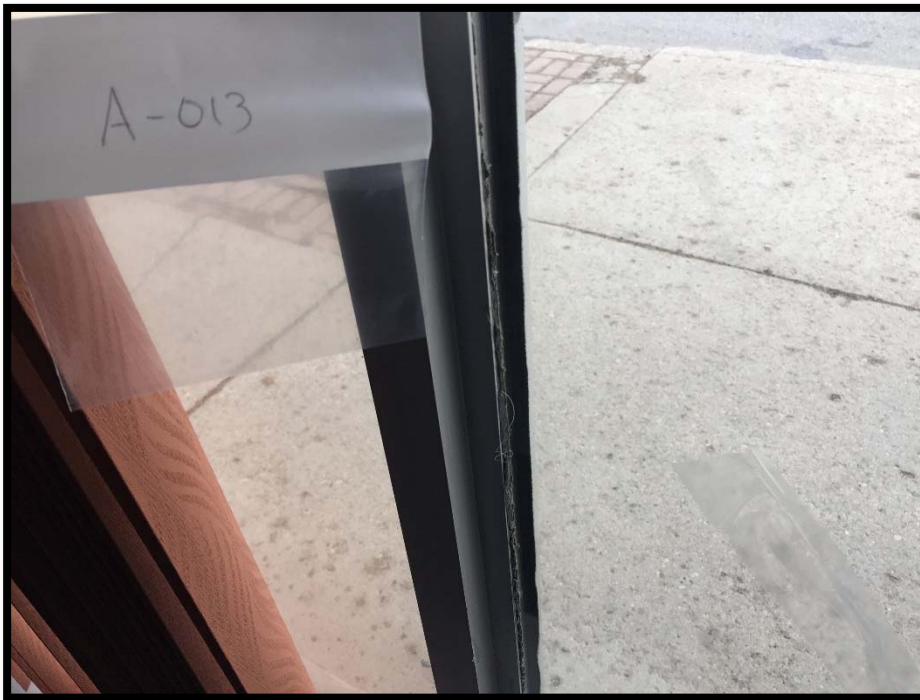
Seven (7) samples of black window caulking were collected during the assessment. One of the samples collected was found to contain 7.1% Chrysotile asbestos. Asbestos-containing black window caulking (see Photograph 4 in Appendix B) was observed in the following location:

**Photograph 4: Asbestos-containing Black Window Caulking.**

If scheduled for impact, asbestos-containing black window caulking should be abated following low-risk abatement work procedures as outlined in the *Saskatchewan Asbestos Abatement Manual* (2017). Alternatively, as the black window caulking was observed in good condition, and with a priority rating of 5 (please see the room by room spreadsheet provided in Appendix C for a description of the priority ratings), it can be managed in place if not scheduled for impact.

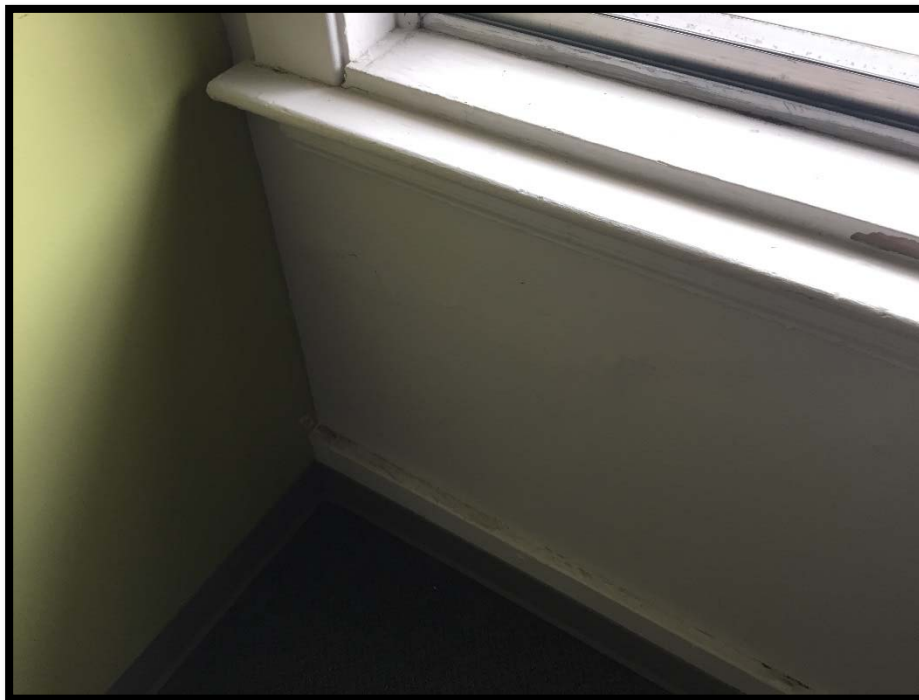
Five (5) samples of plaster were collected during the assessment. Two of the samples collected were found to contain 0.25% to 2.4% Chrysotile asbestos. Asbestos-containing plaster (see Photograph 5 in Appendix B) was observed in the following locations:

Based upon our observations during the assessment, the majority of the walls throughout the Site were observed to be drywall. It is suspected that additional plaster is located in concealed locations (behind solid walls, suspended and solid ceilings, shafts, etc.) throughout the Site.

**Photograph 5: Asbestos-Containing Plaster.**

If scheduled for impact, asbestos-containing plaster should be abated following high-risk abatement work procedures as outlined in the *Saskatchewan Asbestos Abatement Manual* (2017). Alternatively, as the plaster was observed in good condition, and with a priority rating of 5 (please see the room by room spreadsheet provided in Appendix C for a description of the priority ratings), it can be managed in place if not scheduled for impact.

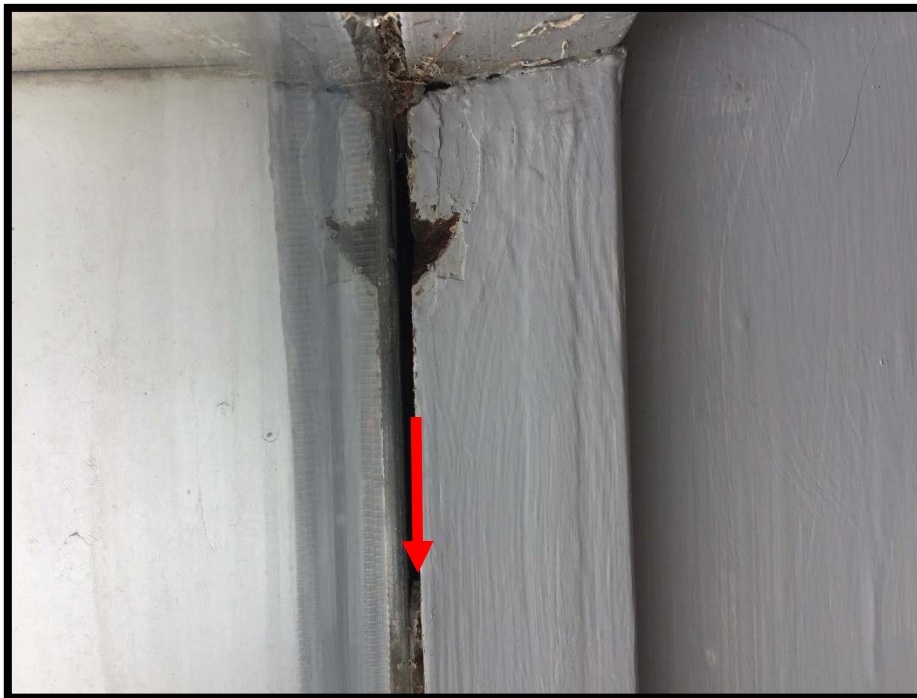
One (1) sample of white window caulking was collected during the assessment. The sample collected was found to contain 20% Chrysotile asbestos. Asbestos-containing white window caulking (see Photograph 6 in Appendix B) was observed in the following location:

**Photograph 6: Asbestos-Containing White Window Caulking.**

If scheduled for impact, asbestos-containing white window caulking should be abated following low-risk abatement work procedures as outlined in the *Saskatchewan Asbestos Abatement Manual* (2017). Alternatively, as the white window caulking was observed in good condition, and with a priority rating of 5 (please see the room by room spreadsheet provided in Appendix C for a description of the priority ratings), it can be managed in place if not scheduled for impact.

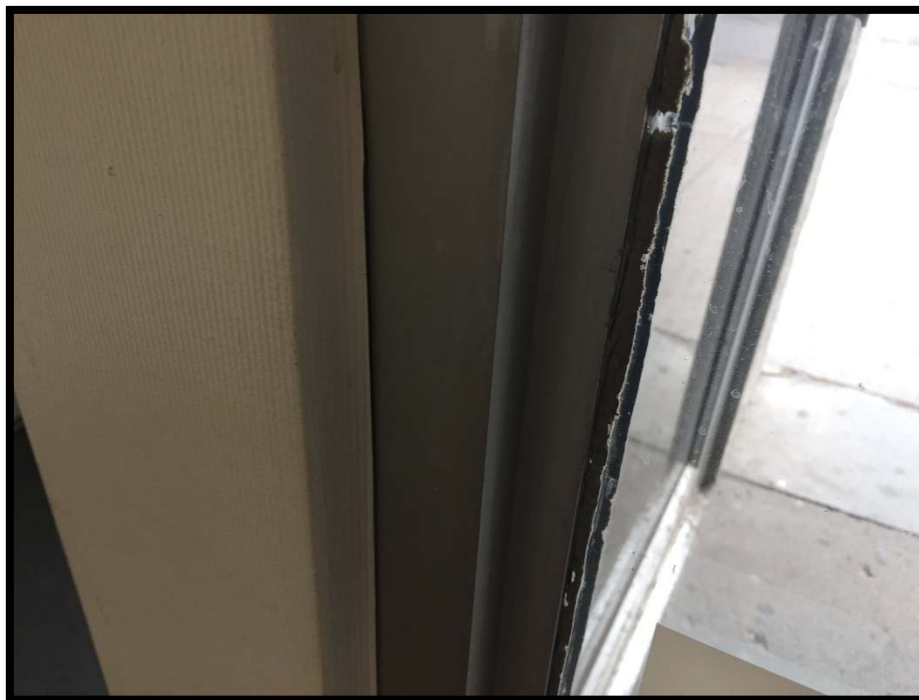
One (1) sample of grey window caulking was collected during the assessment. The sample collected was found to contain 2.1% Chrysotile asbestos. Asbestos-containing grey window caulking (see Photograph 8 in Appendix B) was observed in the following location:

**Photograph 8: Asbestos-Containing Grey Window Caulking.**

If scheduled for impact, asbestos-containing grey window caulking should be abated following low-risk abatement work procedures as outlined in the *Saskatchewan Asbestos Abatement Manual* (2017). Alternatively, as the grey window caulking was observed in good condition, and with a priority rating of 5 (please see the room by room spreadsheet provided in Appendix C for a description of the priority ratings), it can be managed in place if not scheduled for impact.

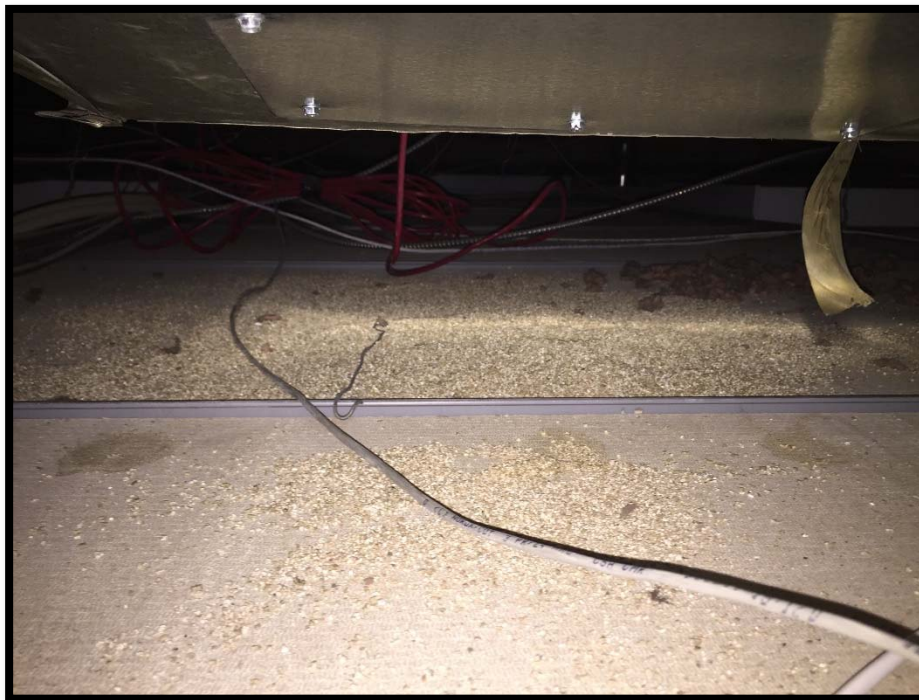
One (1) sample of loose vermiculite insulation on top of a suspended ceiling tile (see Photograph 9 in Appendix B) was collected during the assessment. The sample collected was found to not contain asbestos, however due to the inability to collect a thorough representative sample of the vermiculite insulation with an adequate volume, the material should be treated as a suspect asbestos-containing materials until further sampling can be conducted. Based upon the observations on Site, suspect asbestos-containing vermiculite is suspected to be located above the solid ceilings throughout the Site. Additionally, sporadic spills of the suspect vermiculite insulation are suspected on the various ceilings throughout the Site.

**Photograph 10: Suspect Asbestos-Containing Vermiculite Insulation.**

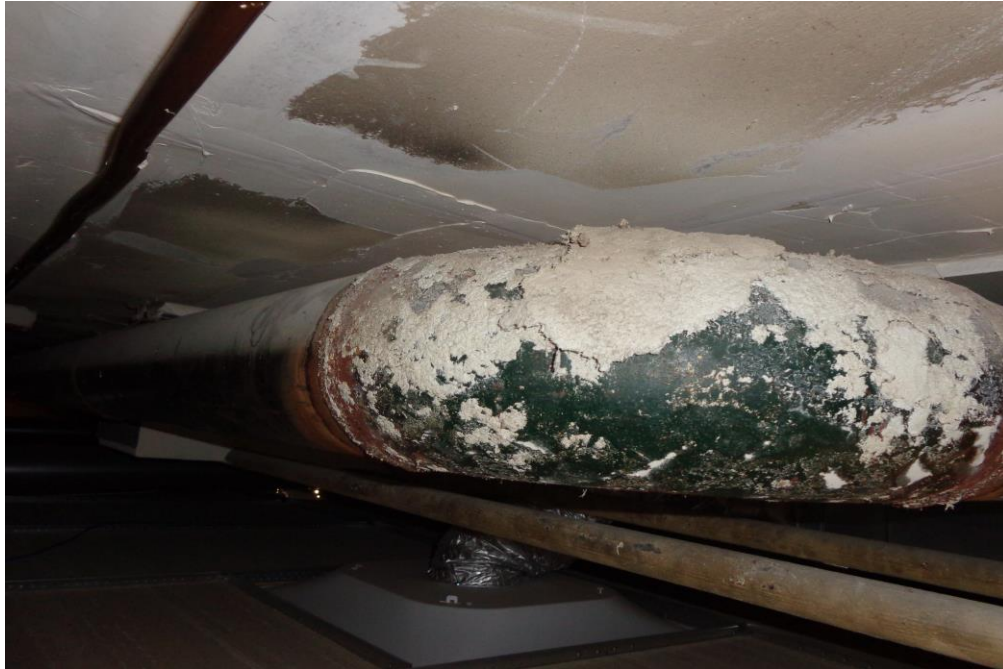
- 1) The ceiling space within the area “Potential to Raise Entire Ceiling” currently poses no issue for accessing the ceiling space or removing the suspended ceiling. The drywall ceiling surface above the suspended ceiling has been fire-taped and sealed from the space above the drywall. It is suspected the vermiculite identified in other areas of the building is present above the drywall. Refrain from puncturing through the drywall. If any activity is performed that will require penetrating the drywall, special precautions are recommended. See photo 1 on page 3 of this report to view the ceiling throughout the space.

- 2) Two large pipeline fittings were observed and sampled within the ceiling space. The mud compound was removed leaving remnants on the pipeline fittings. The glovebag removal is recommended to remove the material from the pipeline surface prior to removing the ceiling tile throughout the area. See photo 1.

**PHOTO 1 – Fire-tape on Drywall Ceiling and Remnants of Asbestos Mud Compound on Pipeline Fitting.**

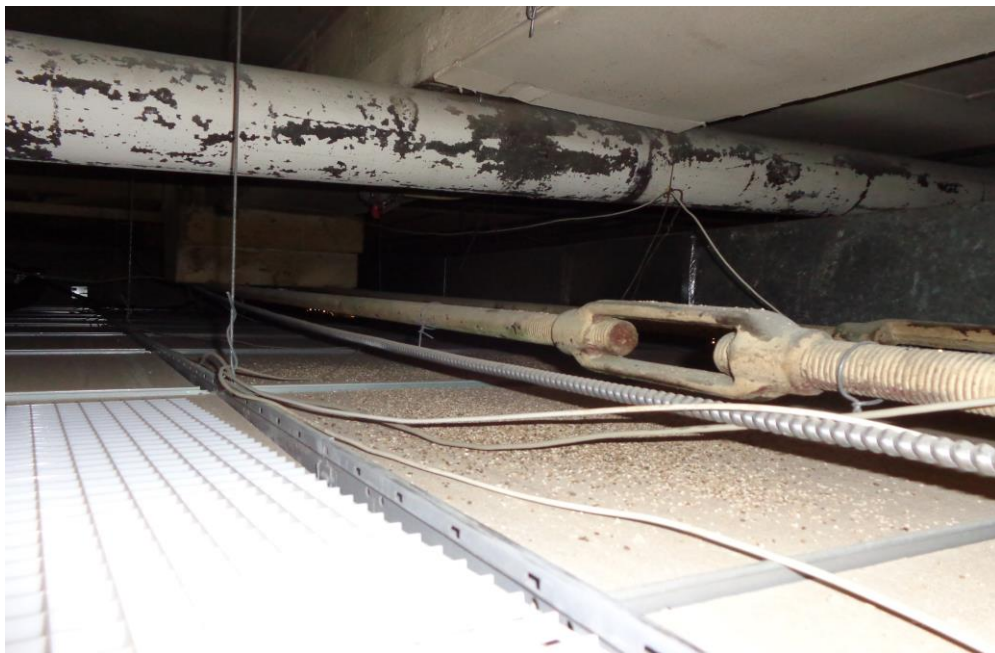
- 4) The ceiling space directly to the north of the meter readers area and east of the area mentioned above, reveals vermiculite insulation within the ceiling space above the drywall as well as debris throughout the ceiling grid and on the ceiling tile surfaces. We recommend a thorough HEPA vacuuming of the suspended ceiling system throughout this area either in conjunction with this renovation or in future planning. The seams / penetrations in the drywall ceiling above the suspended ceiling systems should be sealed with caulking to prevent the vermiculite from falling on the surfaces below the drywall. See photo 2.

**PHOTO 2 – Vermiculite Debris Within the Ceiling Space North of Meter Readers Area.**
