Pre- Renovation Assessment

File Number: B67PRH29H- Fire Hall Dryer Installation

Project: Fire Halls #3, #6, #7, #8, #9 – Asbestos Inspection for Upcoming Dryer Installations

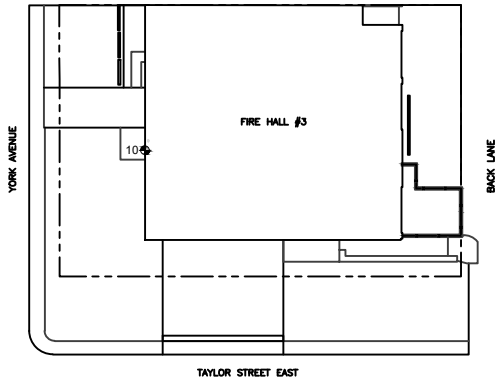
1 FIRE HALL #3 SITE PLAN
SCALE 1:500

The dryer in Fire Hall #3 is to be installed on the east wall immediately adjacent the overhead door. This wall is composed of two layers of brick masonry with one cavity between the two layers. One (1) hole (location 10) was cored through the interior layer of brick into the wall cavity. The cavity was found to be empty of any insulation or suspect material and no concerns were noted.

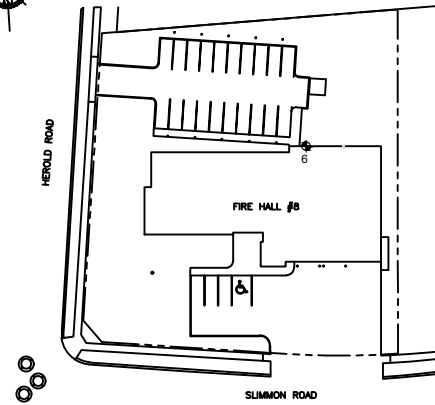
3 FIRE HALL #8 SITE PLAN
SCALE 1:1000

The dryer in Fire Hall #8 is to be installed near the north wall of the building adjacent the hose room. The dryer is to be vented out the north wall immediately adjacent the installation area. This wall is composed of cinderblock interior and silver tin exterior siding. The interior cinderblock wall was cored (location 6) and found to be empty. The exterior siding was not able to be removed without destructive methods. Based on the age of the building Bersch Consulting Ltd. does not have any concerns regarding the installation of the dryer within Fire Hall #8.

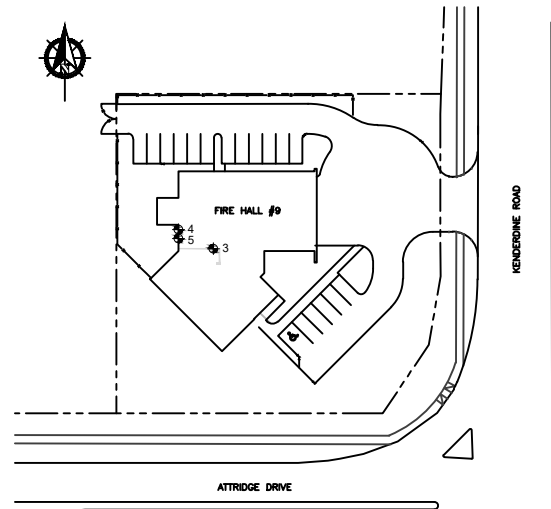
5 FIRE HALL #9 SITE PLAN
SCALE 1:1000

The dryer in Fire Hall #9 is to be installed opposite the SCBA mask washing station. The dryer will be vented through the north wall of this room proceeding along the wall through the east exterior wall. The north cinderblock wall adjacent the mask washing station was cored (location 3) and found to be empty. The east exterior wall is composed of cinderblock interior wall and brick exterior with a cavity in between. The east wall was cored from both the interior and exterior (locations 4 and 5). Both the cinderblock cavity and cavity between the cinderblock and brick was found to be empty. There are no concerns regarding the dryer installation in Fire Hall #9.
