December 5, 2017

CITY OF SASKATOON

Asbestos-Containing Building Materials Assessment Report - Fire Station No. 2

Report Number: 1667963

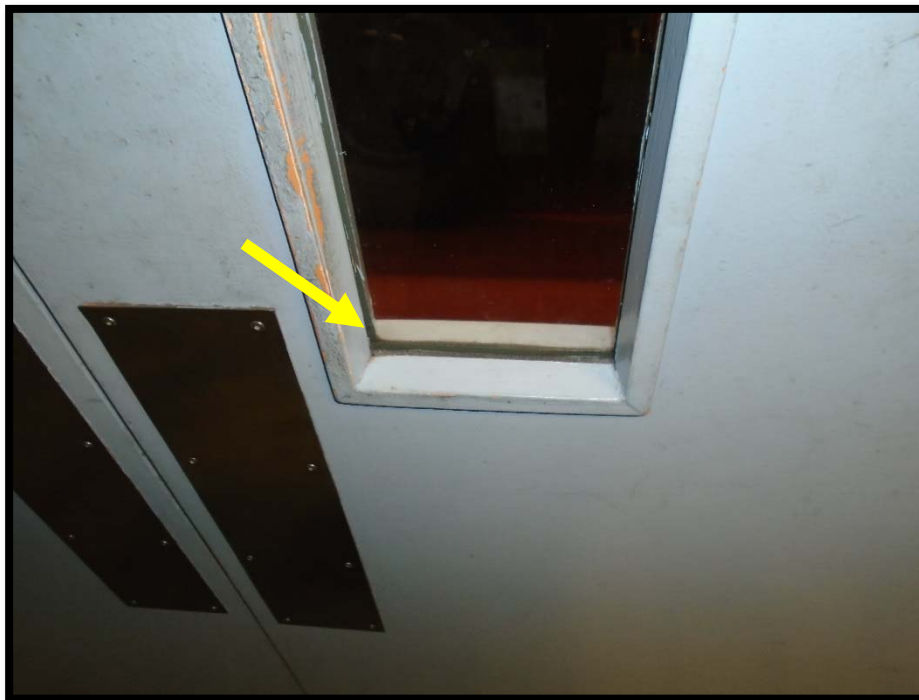
One (1) sample of grey window caulking was collected during the assessment. The sample collected was found to contain 10% Chrysotile asbestos. Asbestos-containing grey window caulking (see Photograph 1 in Appendix B) was observed in the following locations:

- Room 101 (approximately 60 linear ft); and
- Room 114 (approximately 15 linear ft).

Photograph 1: Asbestos-Containing Grey Window Caulking.

If scheduled for impact, asbestos-containing grey window caulking should be abated following low-risk abatement work procedures as outlined in the *Saskatchewan Asbestos Abatement Manual (2017)*. Alternatively, as the caulking was observed in good condition, and with a priority rating of 5 (please see the room by room spreadsheet provided in Appendix C for a description of the priority ratings), the caulking can be managed in place if not scheduled for impact.

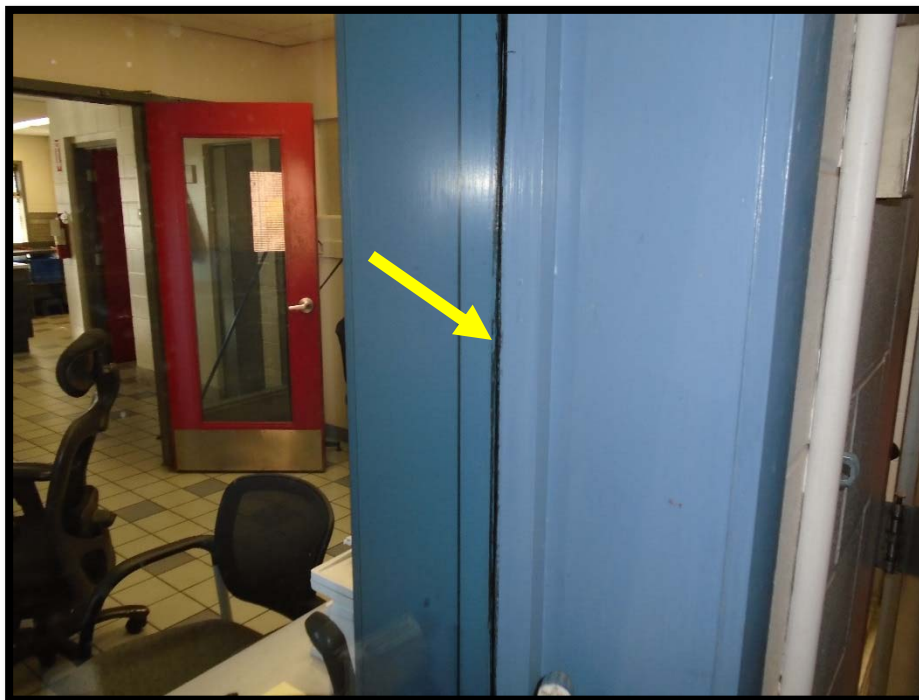
One (1) sample of black window caulking was collected during the assessment. The sample collected was found to contain 4.3% Chrysotile asbestos. Asbestos-containing black window caulking (see Photograph 2 in Appendix B) was observed in the following locations:

- Room 102 (approximately 15 linear ft); and
- Room 118 (approximately 15 linear ft).

Photograph 2: Asbestos-Containing Black Window Caulking.

If scheduled for impact, asbestos-containing black window caulking should be abated following low-risk abatement work procedures as outlined in the *Saskatchewan Asbestos Abatement Manual (2017)*. Alternatively, as the caulking was observed in good condition, and with a priority rating of 5 (please see the room by room spreadsheet provided in Appendix C for a description of the priority ratings), the caulking can be managed in place if not scheduled for impact.

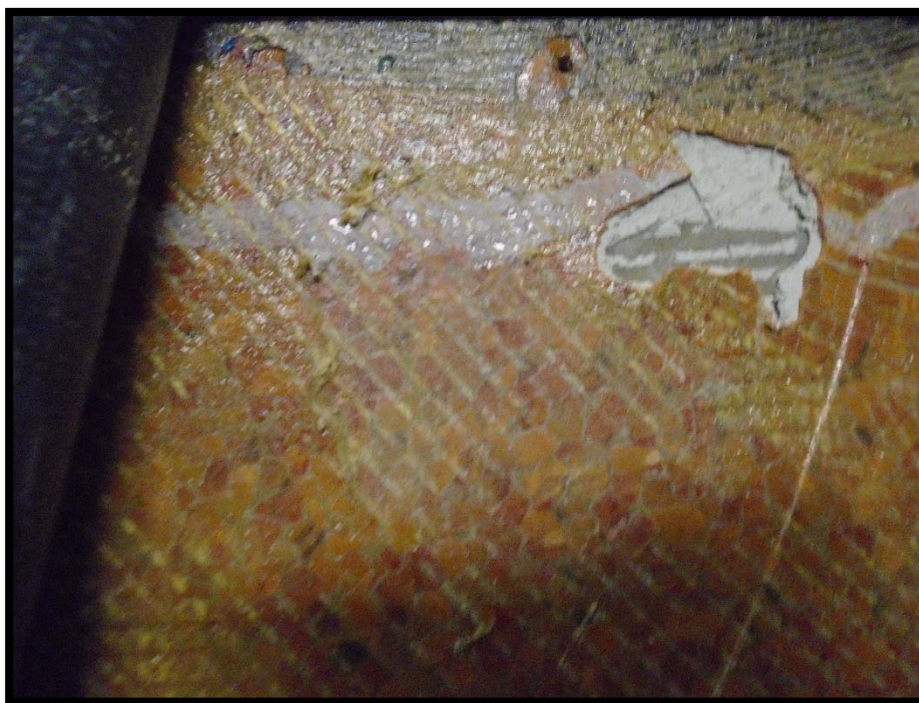
One (1) sample of orange and red vinyl sheet flooring was collected during the assessment. The sample collected was found to contain 20% Chrysotile asbestos. Asbestos-containing orange and red vinyl sheet flooring (see Photograph 3 in Appendix B) was observed in the following locations:

- Room 112 (approximately 420 ft²); and
- Room 116 (approximately 100 ft²).

Photograph 3: Asbestos-Containing Vinyl Sheet Flooring, Orange and Red.

If scheduled for impact, asbestos-containing orange and red vinyl sheet flooring should be abated following high-risk abatement work procedures as outlined in the *Saskatchewan Asbestos Abatement Manual (2017)*. Alternatively, as the sheet flooring was observed in good condition, below existing flooring, and with a priority rating of 5 (please see the room by room spreadsheet provided in Appendix C for a description of the priority ratings), the vinyl sheet flooring can be managed in place if not scheduled for impact.

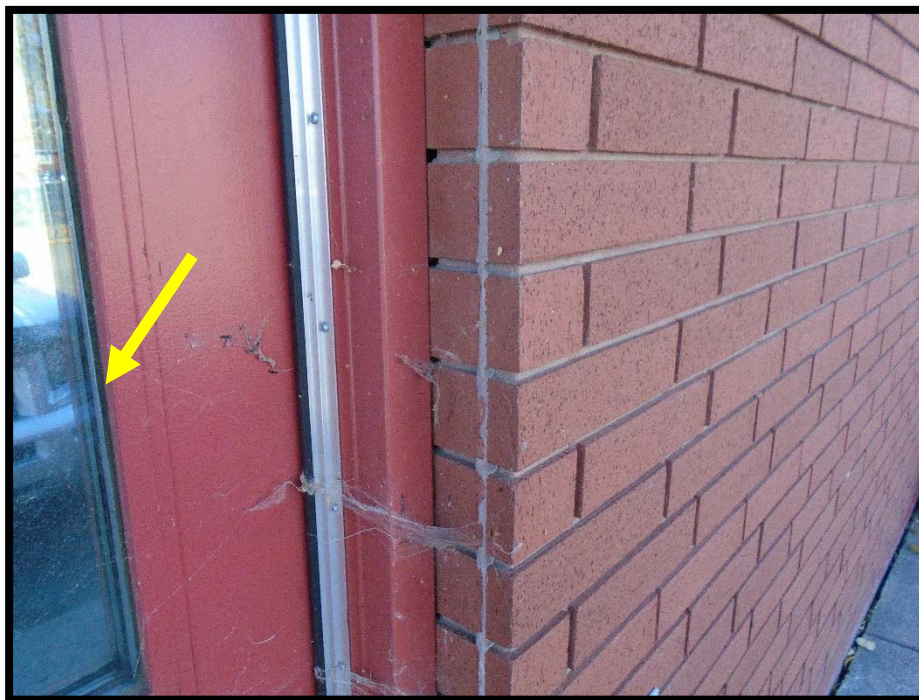
One (1) sample of exterior black window caulking was collected during the assessment. The sample collected was found to contain 5.7% Chrysotile asbestos. Asbestos-containing exterior black window caulking (see Photograph 4 in Appendix B) was observed in the following locations:

- Exterior (approximately 100 linear ft).

Lab No.: 6369351
Client No.: A-026
Description: Black Glazing
Facility:
Location: Exterior
Percent Asbestos:
PC 5.7 Chrysotile
Percent Non-Asbestos Fibrous Material:
None Detected
Percent Non-Fibrous Material:
94.3

Photograph 4: Asbestos-Containing Exterior Black Window Caulking.
