**Fire Hall #5  
Asbestos Survey Report**

**February 2014**

**Prepared For: City Of Saskatoon- Infrastructure Services Department**  
1101 Avenue P North, Saskatoon, SK.  
Attn: Brent Anderson

**Prepared By: Bersch & Associates Ltd.**  
**Project No. : B67SRE06**

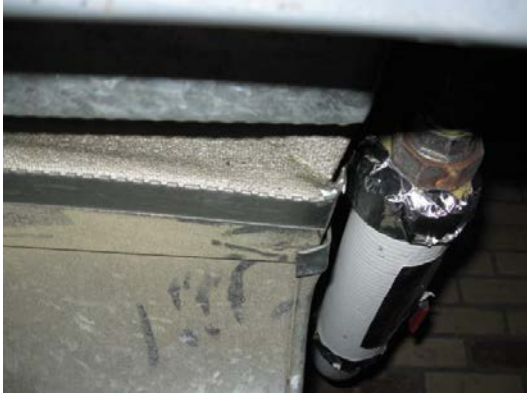
#5) Duct Expansion Gasket

- **Duct Expansion Gasket** is located within the ceiling space of the 106 vestibule.
- *Note: An inaccessible pipeline fitting was found in the northeast corner of room 101A behind the lockers. It is suspect that this fitting is ACM and should be treated as until testing can prove otherwise. Consider all pipeline fitting mud compound concealed in inaccessible areas to be ACM.*

<b>NO.</b>	<b>DATE</b>	<b>SAMPLE INFORMATION</b>	<b>ASBESTOS</b>	<b>%</b>	<b>ANALYST</b>
1	6-May-13	108 - 2`by 4`ceiling tile, textured with pin holes	None detected		WB
2	6-May-13	108 - Lineal Pipe insulation above ceiling tile	None detected		WB
3	6-May-13	108 - Sheet flooring, multi tone blue and green spec	None detected		WB
4	6-May-13	107 - Bulletin board on the east wall	None detected		WB
5	6-May-13	106 - Duct expansion gasket above ceiling	Chrysotile	80	WB
