SUBJECT: Fire Hall #3 - Asbestos Registry Report

PROJECT NO. B67.13**CLIENT: City of Saskatoon****Infrastructure Services - Facilities Branch****Contact: Brent Anderson****Location: Fire Hall #3 - 1906 York Avenue, Saskatoon, SK.**

BULK SAMPLE ANALYSIS REPORT

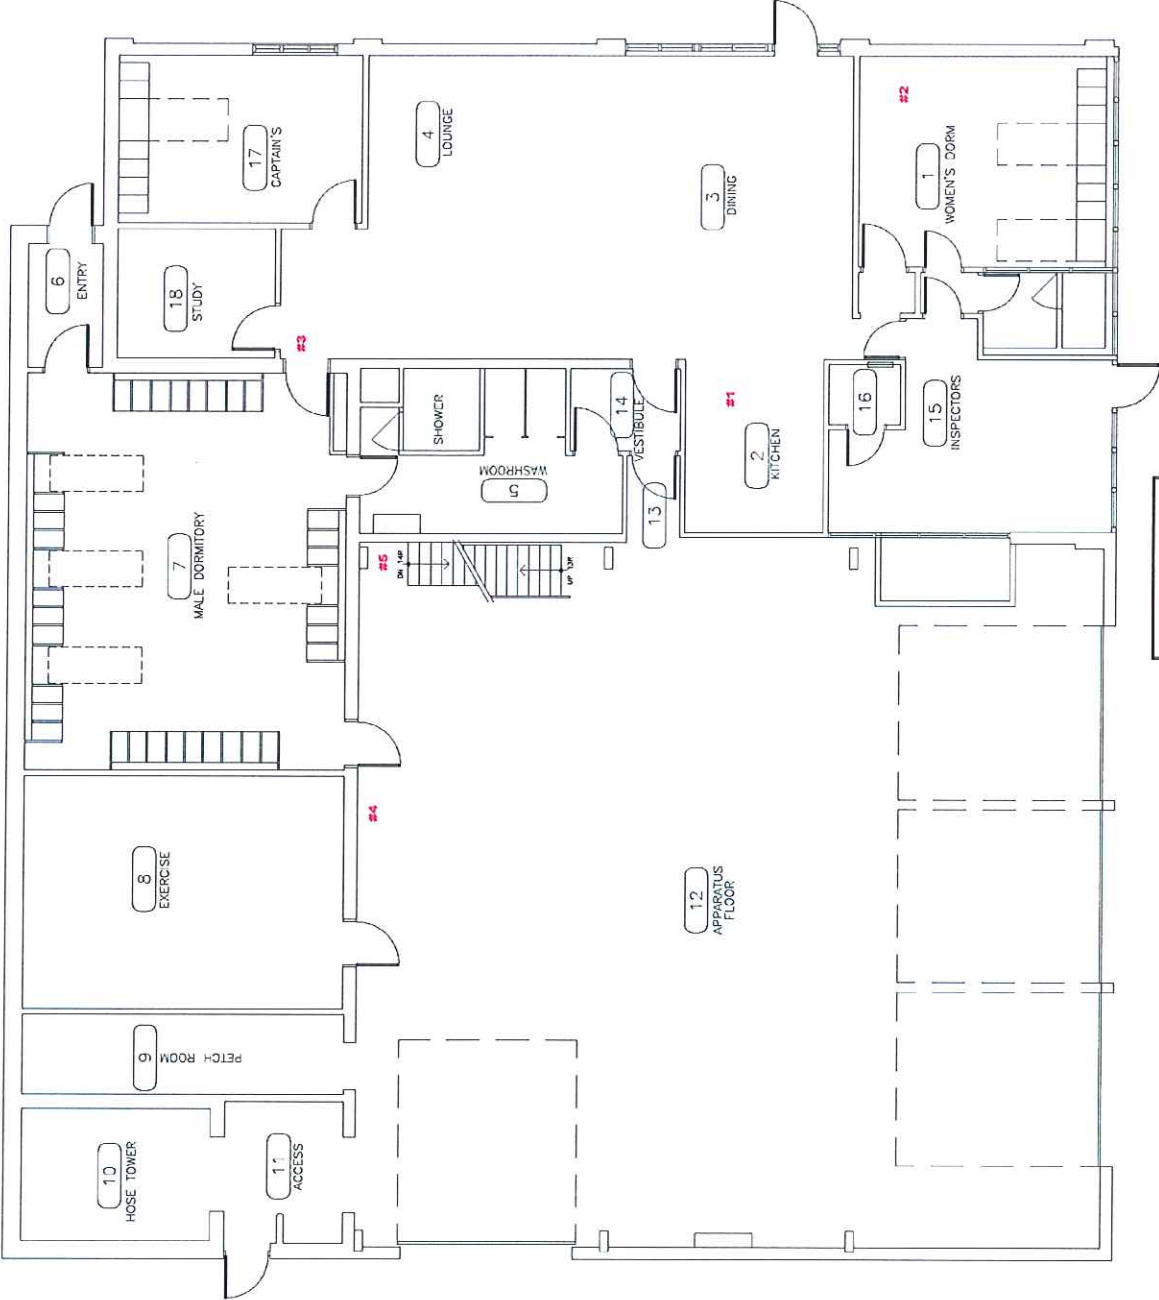
Included is a floor plan of the facility identifying the bulk sample locations. Photos of suspect materials sampled are also included following the floor plans.

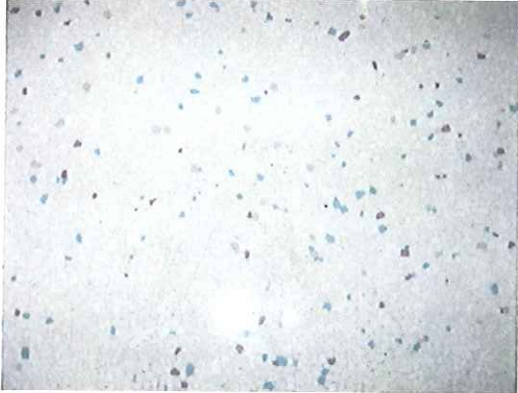
#1) Sheet Flooring

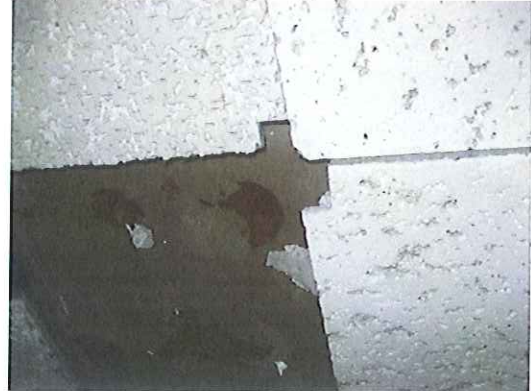
#2) 1' x 1' Ceiling Tile

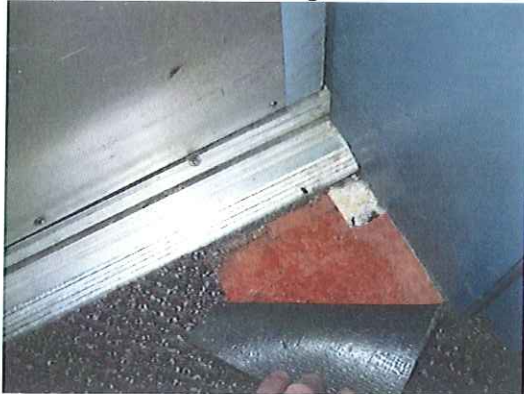
#3) Sheet Flooring Beneath Carpet

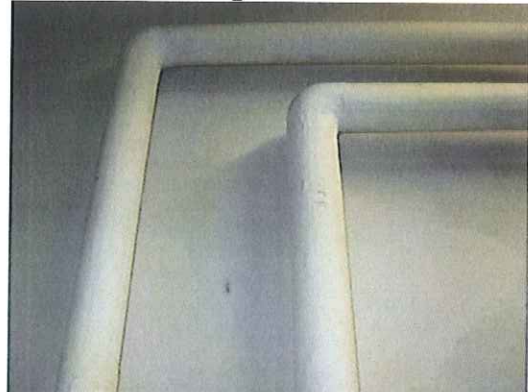
#4) Lineal Pipeline Insulation

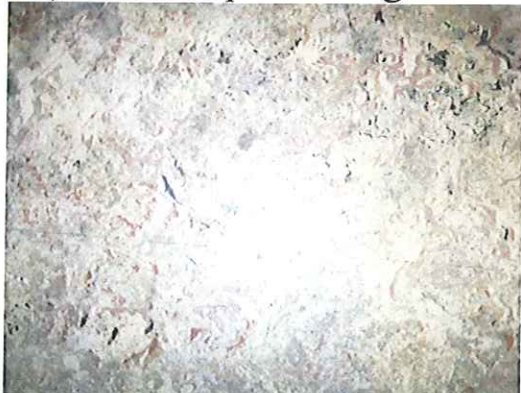
#5) Battleship Flooring
