**FRANCES MORRISON LIBRARY**

**ASBESTOS SURVEY  
REPORT**

**APRIL 2013**

**Prepared by: Bersch & Associates Ltd.  
Prepared for: City of Saskatoon  
Project No. B67.13**

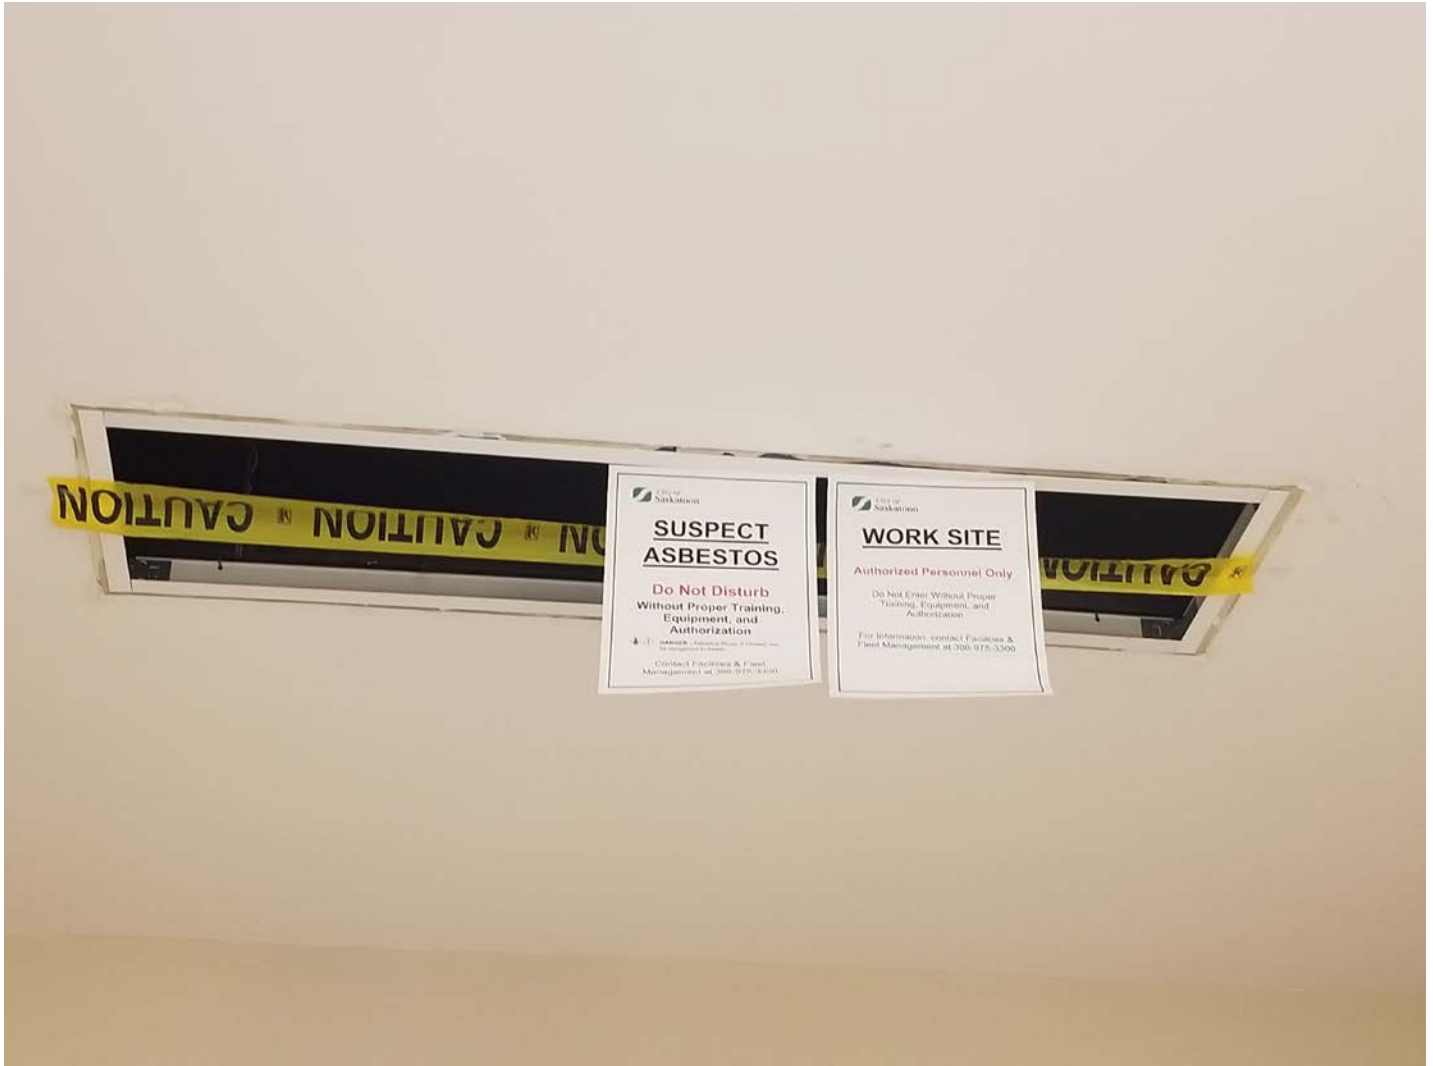
Figure 1. Removed Light Fixture. Access to Ceiling Space.

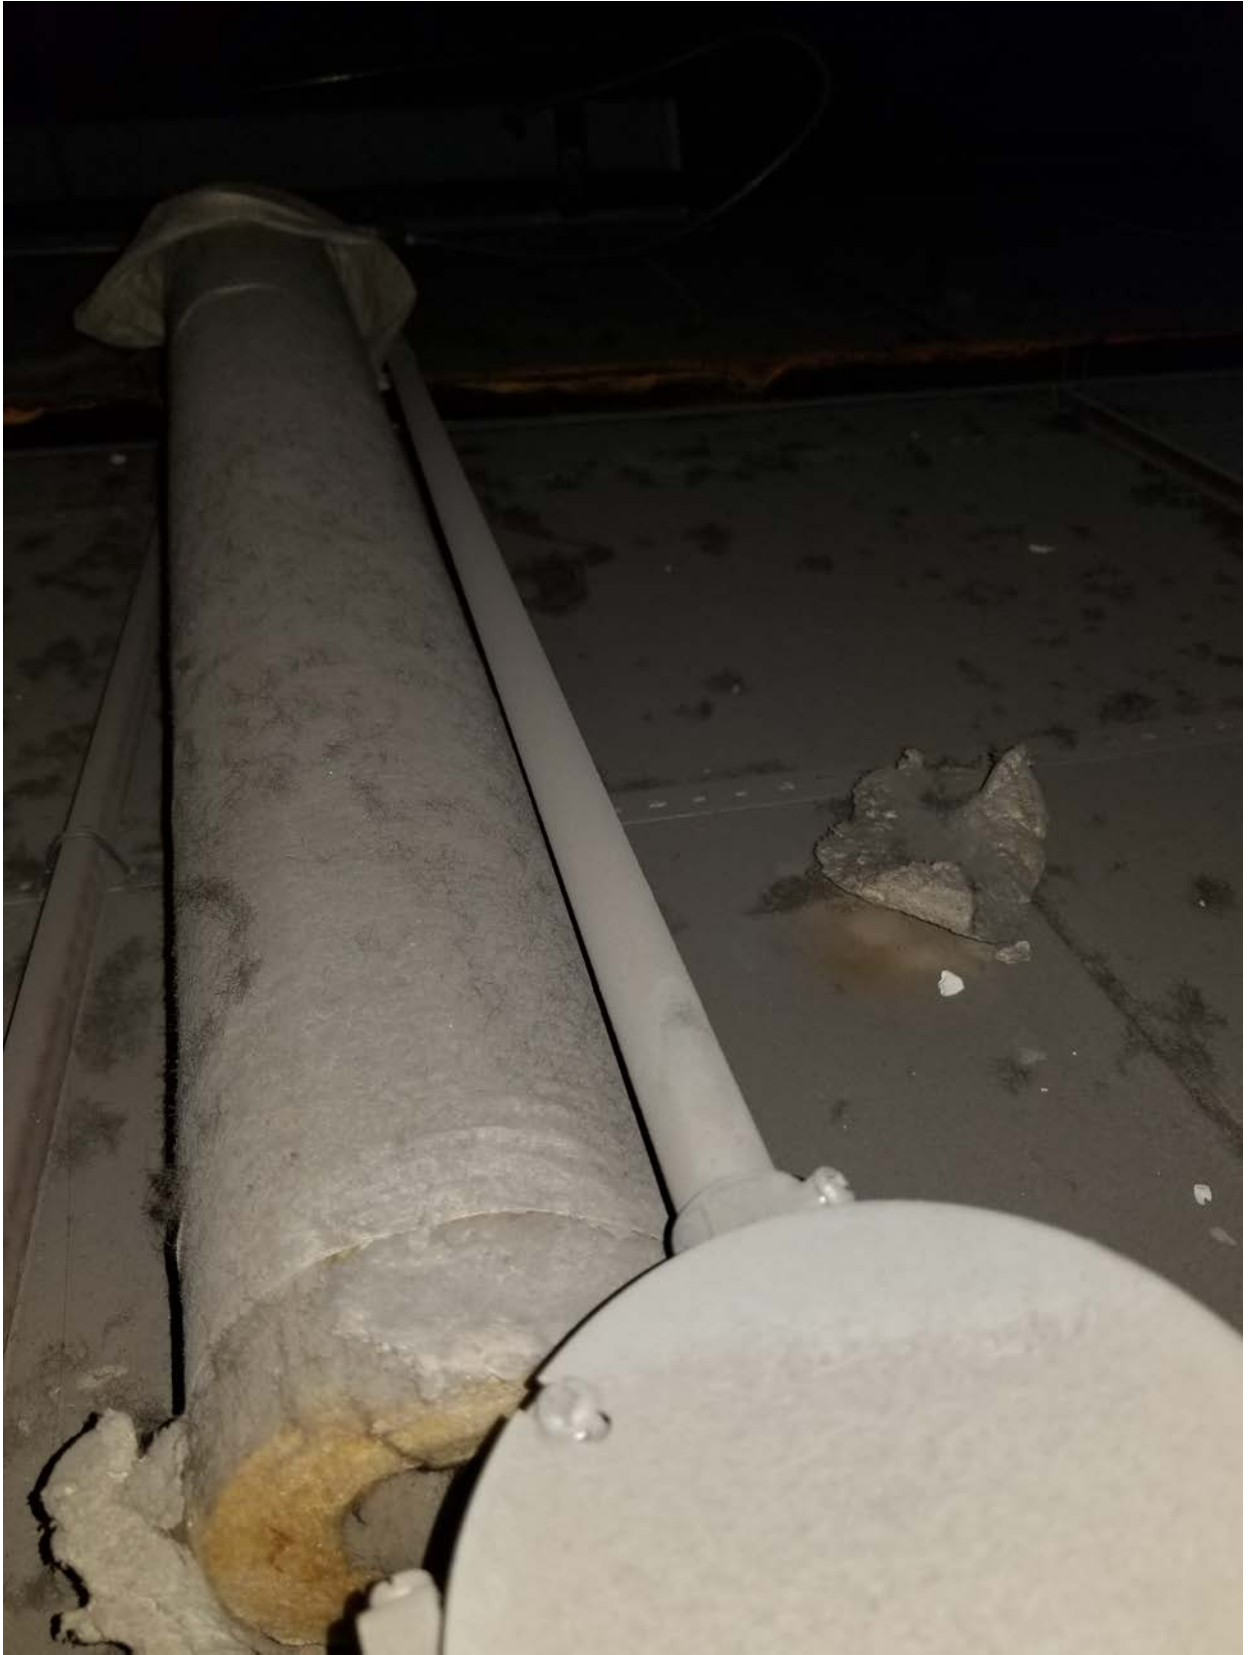
**Figure 2. Fibreglass Pipe Insulation Laying on Ceiling Surface.**

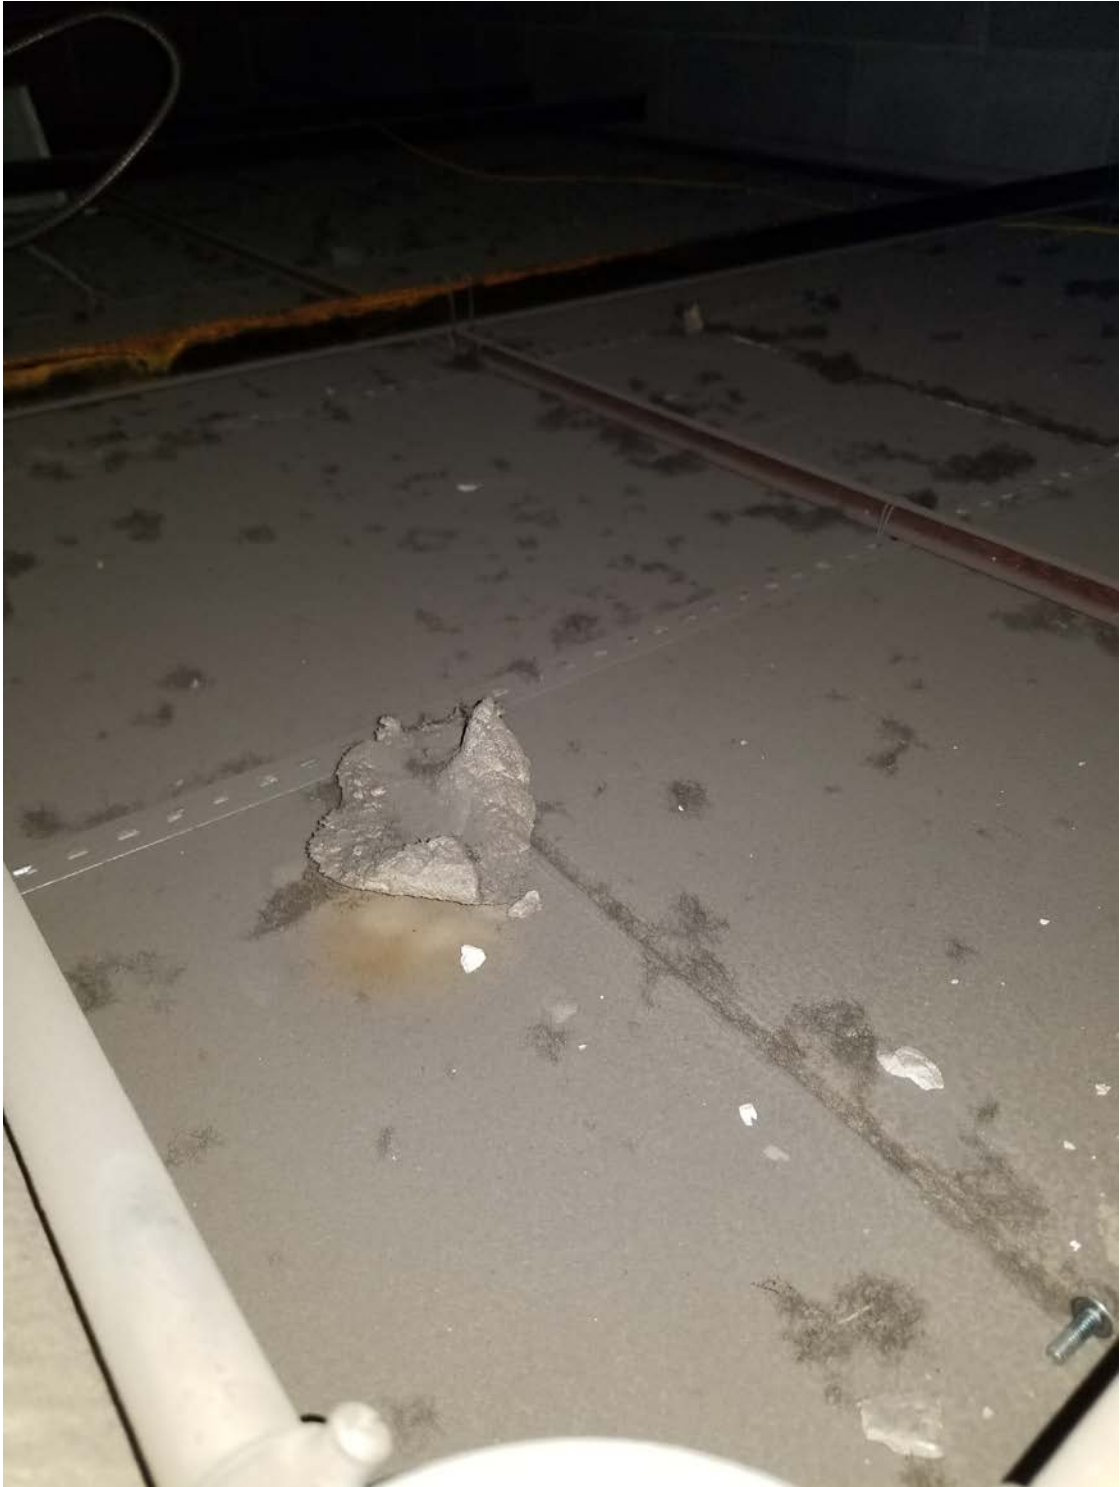
**Figure 3. Damaged Pipefitting Compound from Above Elbow Laying on Ceiling Surface.**

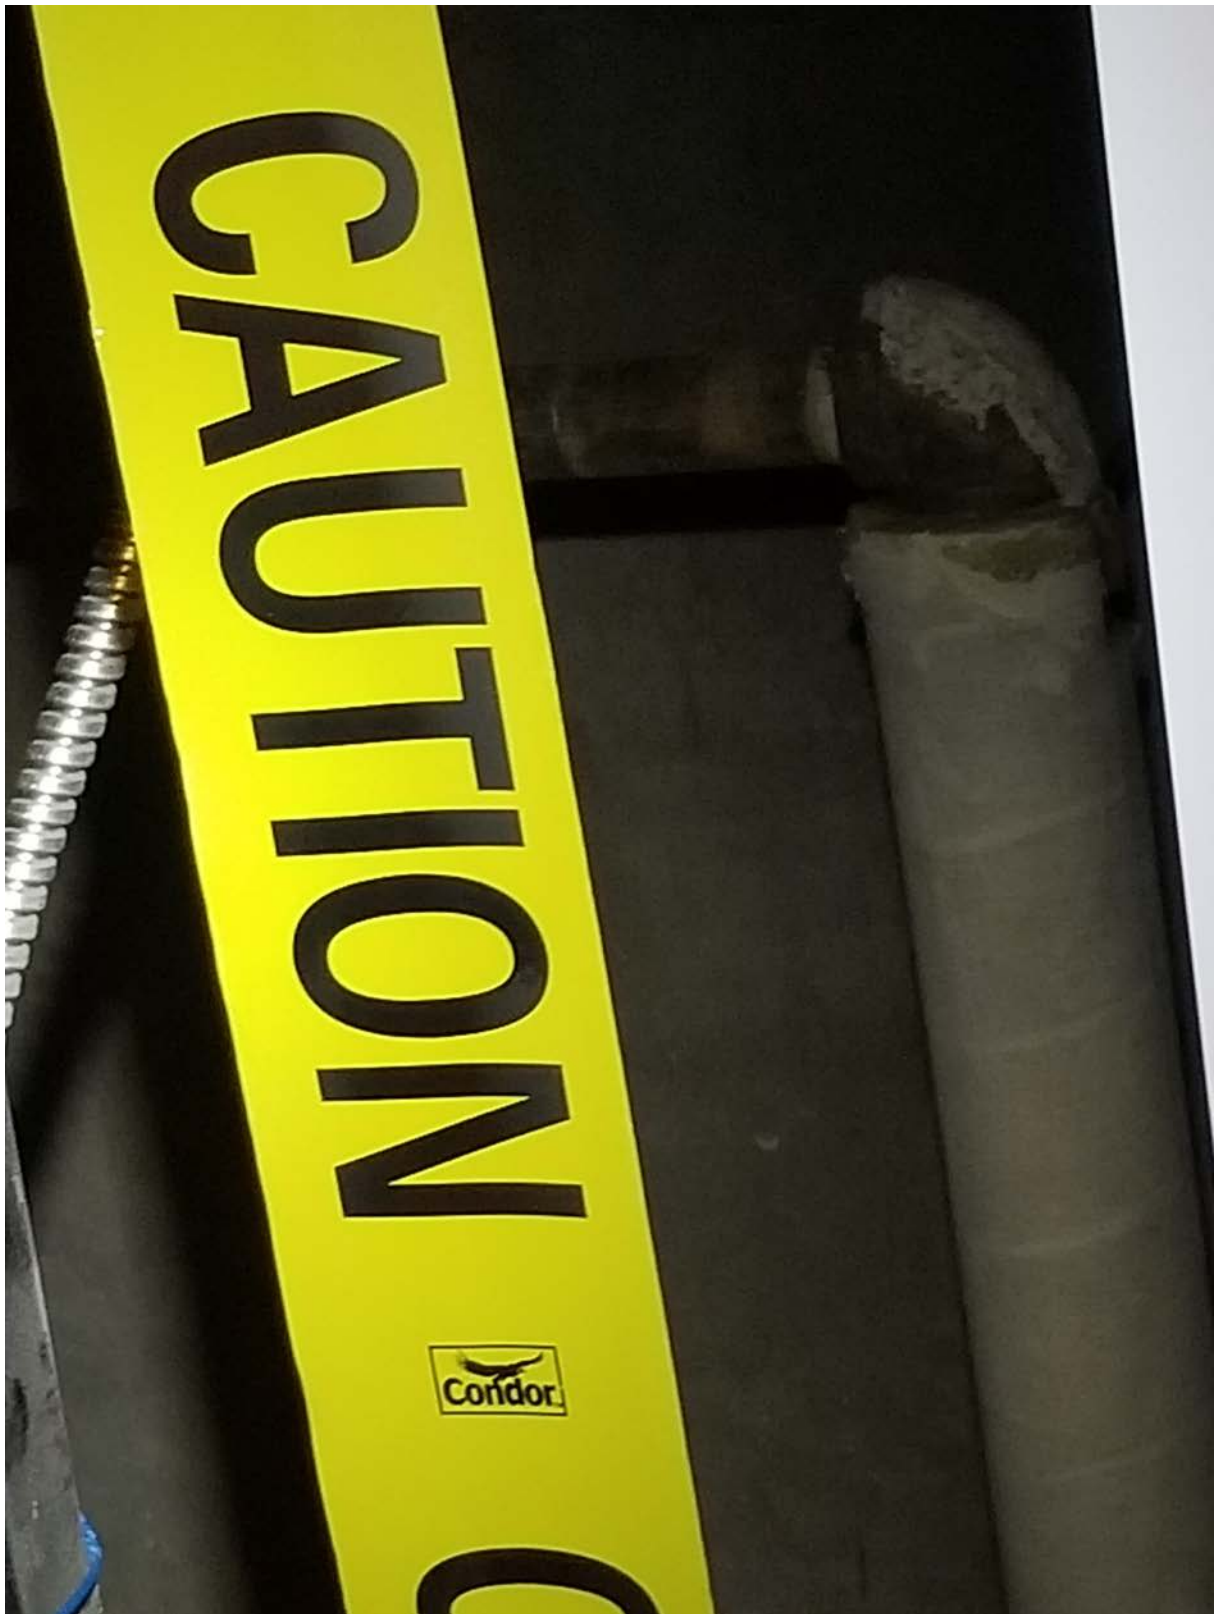
Figure 4. Elbow with Damaged Pipefitting Compound Within Ceiling Space.
