December 12, 2017

CITY OF SASKATOON

Asbestos-Containing Building Materials Assessment Report - Gabriel Dumont Park Shelter Washrooms

Report Number: 1667963

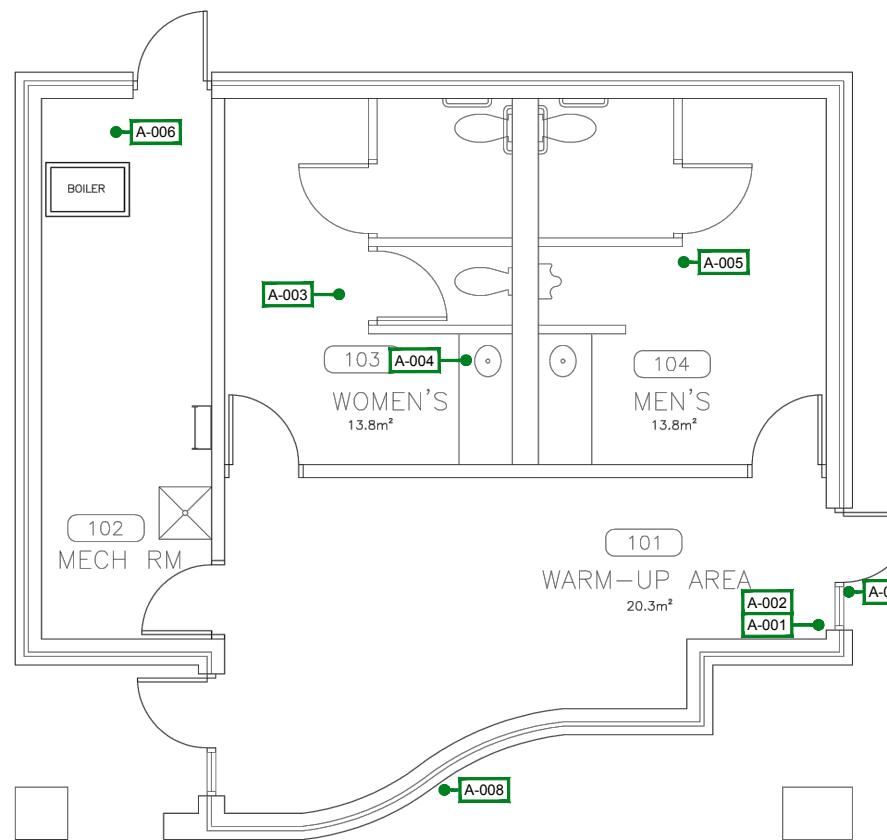
TITLE
MAIN FLOOR

1. ASBESTOS IS A CARCINOGEN. DO NOT BREATHE ASBESTOS DUST.
2. ASBESTOS-CONTAINING MATERIALS WERE NOT OBSERVED WITHIN THE BUILDING AT THE TIME OF THE ASSESSMENT.
