CITY OF SASKATOON

Asbestos-Containing Building Materials Assessment Report - Marr Residence

Report Number: 1667963

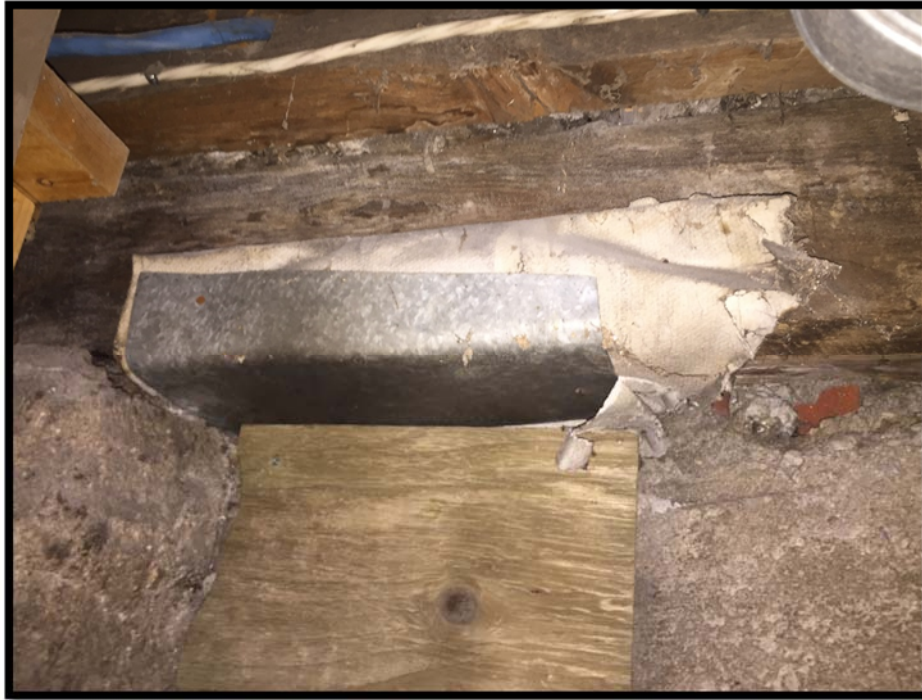
One (1) sample of chimney paper wrap was collected during the assessment. The sample collected was found to contain 80% Chrysotile asbestos. Asbestos-containing chimney paper wrap (see Photograph 1 in Appendix B) was observed in the following locations:

- Room B100/B101/B102 (approximately 5 ft²).

Based on information provided by the Client, the visible asbestos-containing chimney paper wrap was removed from within the above location. Additional asbestos-containing chimney paper wrap may be located within concealed locations along the chimney.

Photograph 1: Asbestos-Containing Chimney Paper Wrap.

If scheduled for impact, asbestos-containing chimney paper wrap should be abated following low or moderate-risk (based on square footage impacted) abatement work procedures as outlined in the *Saskatchewan Asbestos Abatement Manual* (2017). Based on information provided by the Client, the visible chimney paper wrap was removed from Rooms B100/B101/B102.

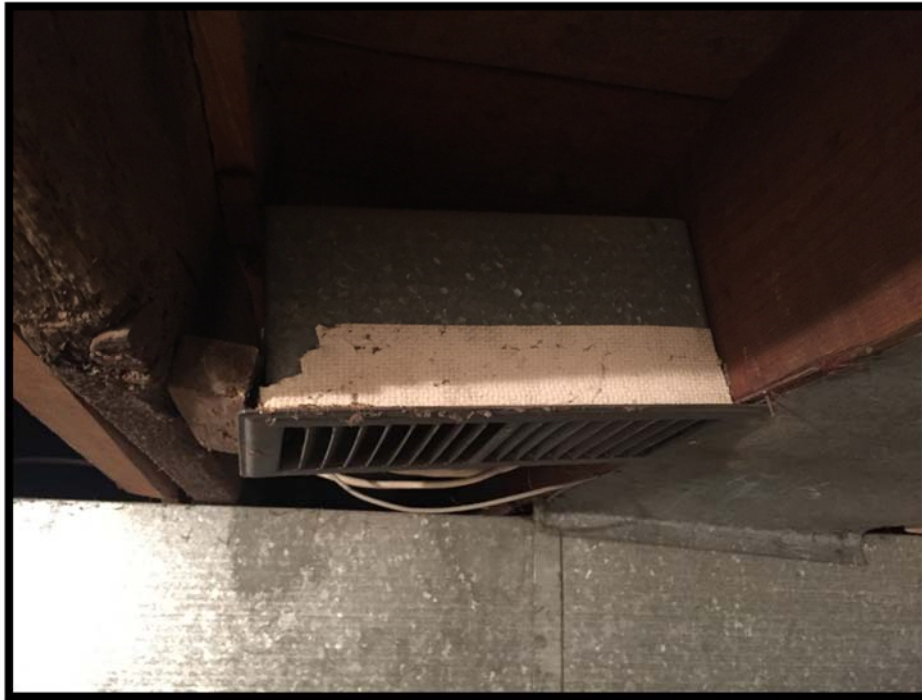
One (1) sample of duct paper wrap was collected during the assessment. The sample collected was found to contain 80% Chrysotile asbestos. Asbestos-containing duct paper wrap (see Photograph 2 in Appendix B) was observed in the following locations:

- Room B100/B101/B102 (approximately 5 ft²).

Additional asbestos-containing duct paper wrap may be located within concealed locations along the duct work throughout the Site.

Photograph 2: Asbestos-Containing Duct Paper Wrap.

If scheduled for impact, asbestos-containing duct paper wrap should be abated following low or moderate-risk (based on square footage impacted) abatement work procedures as outlined in the *Saskatchewan Asbestos Abatement Manual* (2017). Alternatively, as the duct paper wrap was observed in good condition, and with a priority rating of 4 (please see the room by room spreadsheet provided in Appendix C for a description of the priority ratings), it can be managed in place if not scheduled for impact however removal should be conducted in a reasonable timeframe.

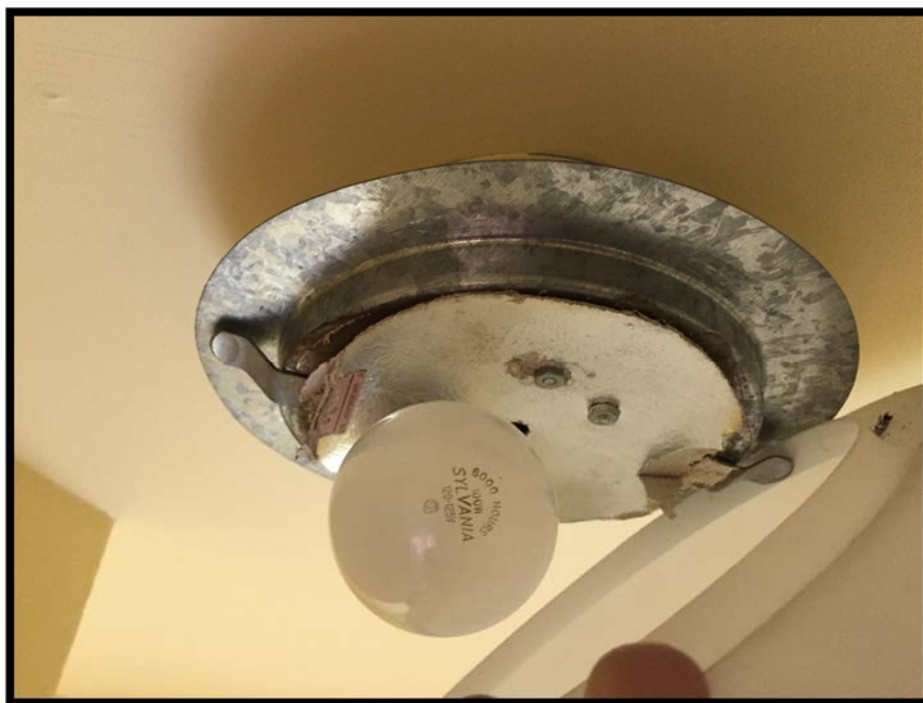
One (1) sample of incandescent light fixture paper was collected during the assessment. The sample collected was found to contain 80% Chrysotile asbestos. Asbestos-containing incandescent light fixture paper (see Photograph 3 in Appendix B) was observed in the following locations:

- Room 104 (approximately 1 light).

Photograph 3: Asbestos-Containing Incandescent Light Fixture Paper.

If scheduled for impact, asbestos-containing incandescent light fixture paper should be abated following low-risk abatement work procedures as outlined in the *Saskatchewan Asbestos Abatement Manual* (2017). Alternatively, as the duct paper wrap was observed in good condition, and with a priority rating of 4 (please see the room by

room spreadsheet provided in Appendix C for a description of the priority ratings), it can be managed in place if not scheduled for impact however removal should be conducted in a reasonable timeframe.
