November 24, 2017

CITY OF SASKATOON

# Asbestos-Containing Building Materials Assessment Report - Water Treatment 11th Street Reservoir Valve House

**Report Number: 1667963**

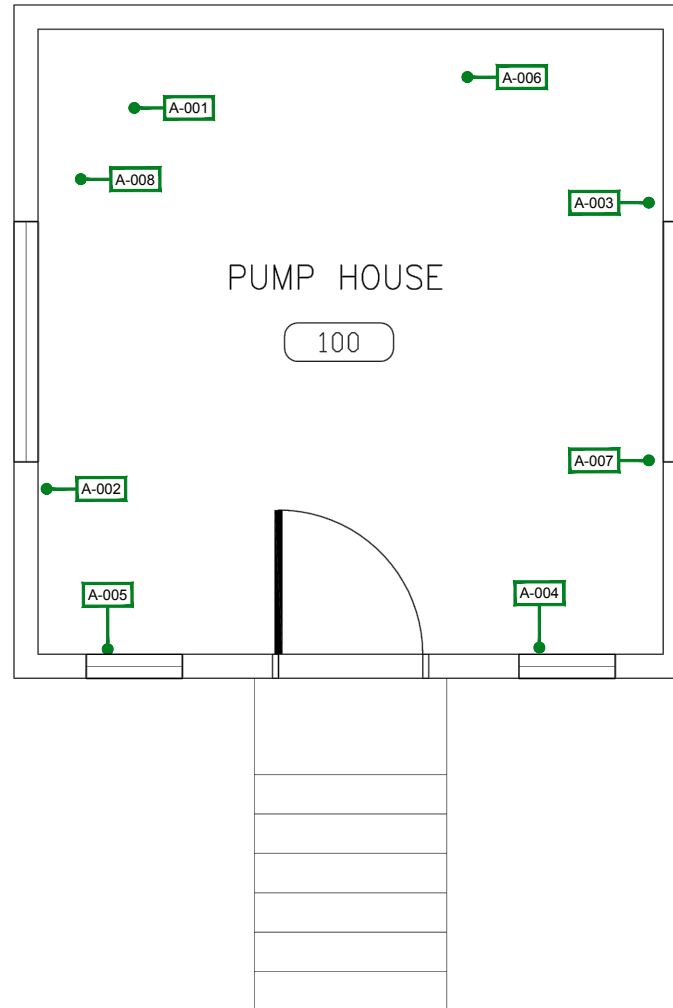
FIGURE  
 1

**NOTE(S)**  
 1. ASBESTOS IS A CARCINOGEN. DO NOT BREATHE ASBESTOS DUST.  
 2. ASBESTOS-CONTAINING MATERIALS WERE NOT OBSERVED ON SITE DURING THE ASSESSMENT.
