November 28, 2017

CITY OF SASKATOON

# Asbestos-Containing Building Materials Assessment Report - Water Treatment Acadia Pumphouse

**Report Number: 1667963**

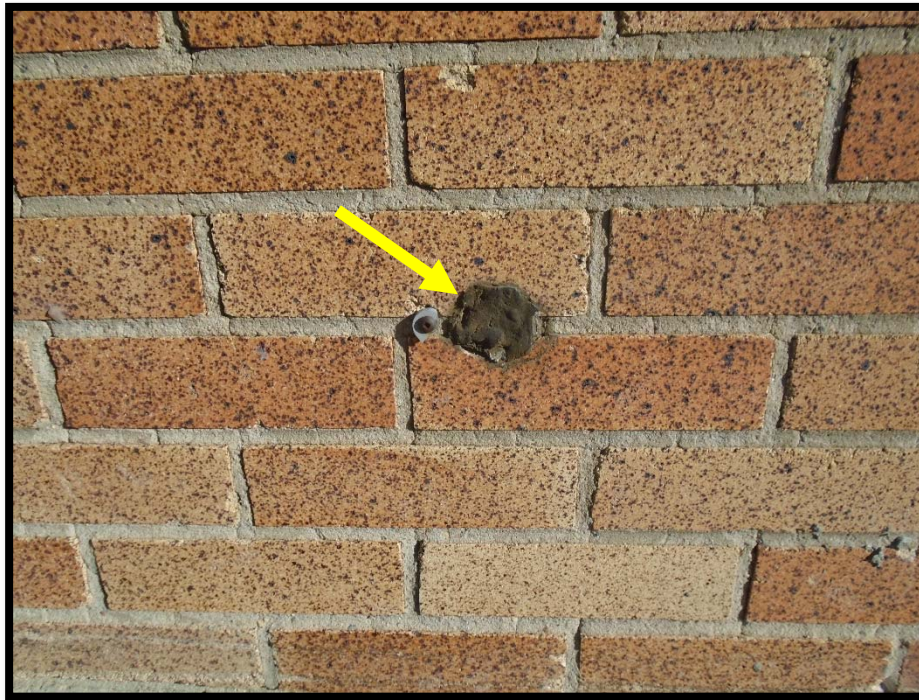
One (1) sample of grey firestop putty was collected during the assessment. The sample collected was found to contain 8.7% Chrysotile asbestos. Asbestos-containing grey firestop putty (see Photograph 1 in Appendix B) was observed in the following locations:

- Exterior (1 ft<sup>2</sup>).

Asbestos was positively identified within the exterior grey firestop putty on Site. Asbestos was not identified in the remaining samples collected and analyzed.

**Photograph 1: Asbestos-Containing Grey Firestop Putty**

If scheduled for impact, asbestos-containing exterior grey firestop putty should be abated following low-risk abatement work procedures as outlined in the *Saskatchewan Asbestos Abatement Manual (2017)*. Alternatively, as the firestop was observed in good condition, and with a priority rating of 5 (please see the room by room spreadsheet provided in Appendix C for a description of the priority ratings), the firestop can be managed in place if not scheduled for impact.
