December 5, 2017

CITY OF SASKATOON

Asbestos-Containing Building Materials Assessment Report - Water Treatment Reservoir B

Report Number: 1667963

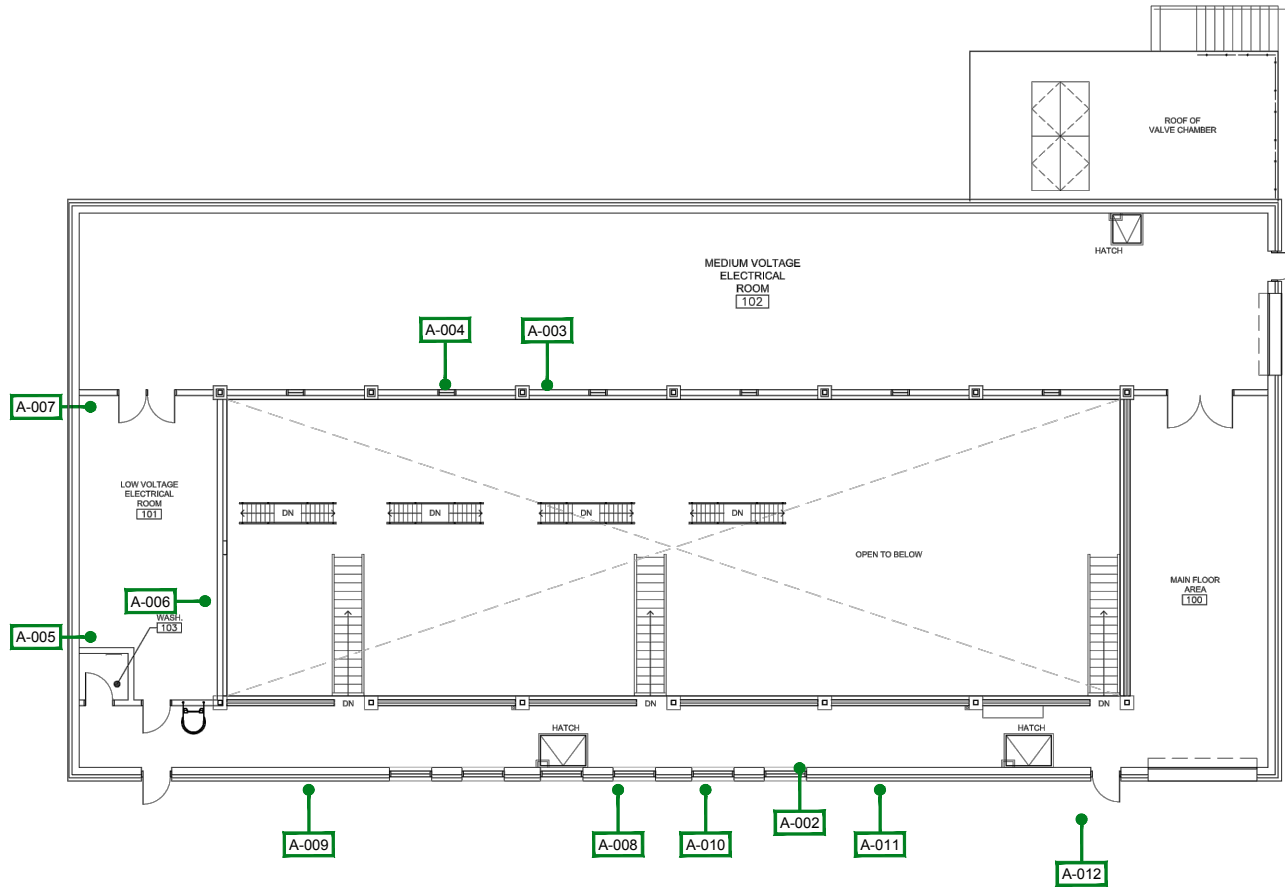
TITLE
MAIN FLOOR

- NOTE(S)**
1. ASBESTOS IS A CARCINOGEN. DO NOT BREATHE ASBESTOS DUST.
 2. SAMPLES A-013 AND A-014 WERE COLLECTED FROM THE ADJACENT RESERVOIRS.
 3. ASBESTOS-CONTAINING MATERIALS WERE NOT OBSERVED ON SITE DURING THE ASSESSMENT.

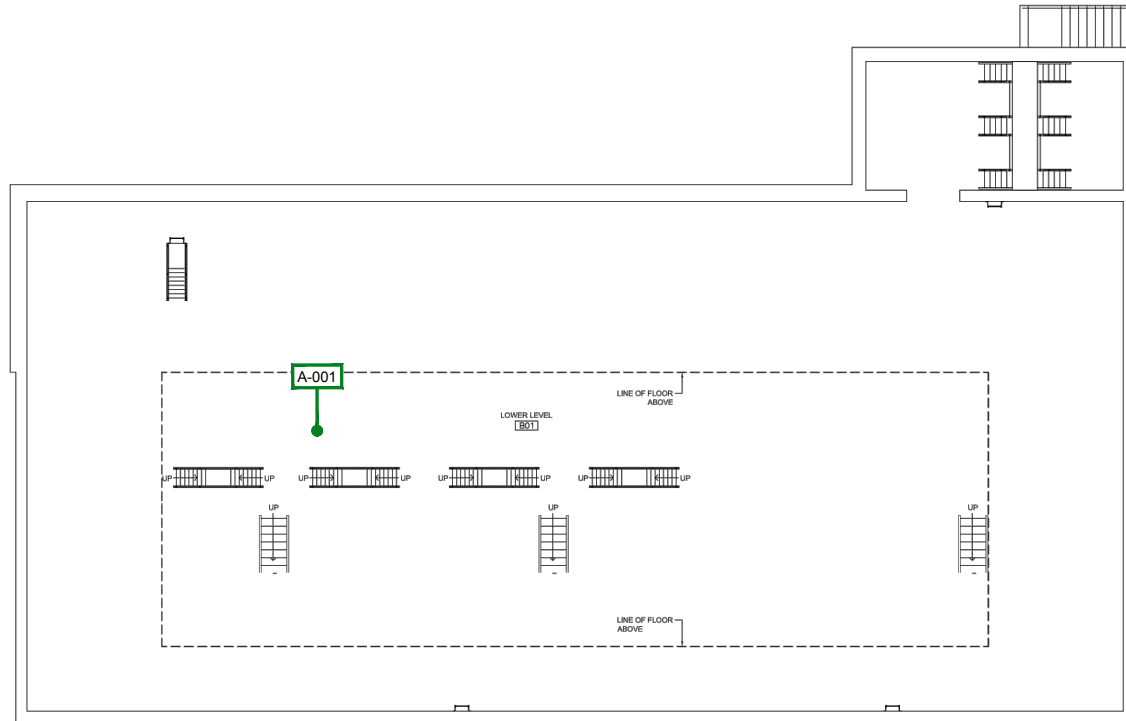
1. ASBESTOS IS A CARCINOGEN. DO NOT BREATHE ASBESTOS DUST.
2. SAMPLES A-013 AND A-014 WERE COLLECTED FROM THE ADJACENT RESERVOIRS.
3. ASBESTOS-CONTAINING MATERIALS WERE NOT OBSERVED ON SITE DURING THE ASSESSMENT.
