SLOPE INSTABILITY STUDY  
SOUTH SASKATCHEWAN RIVER BANKS  
SASKATOON, SASKATCHEWAN

MEEWASIN VALLEY AUTHORITY

FINAL REPORT

23 DECEMBER 1985

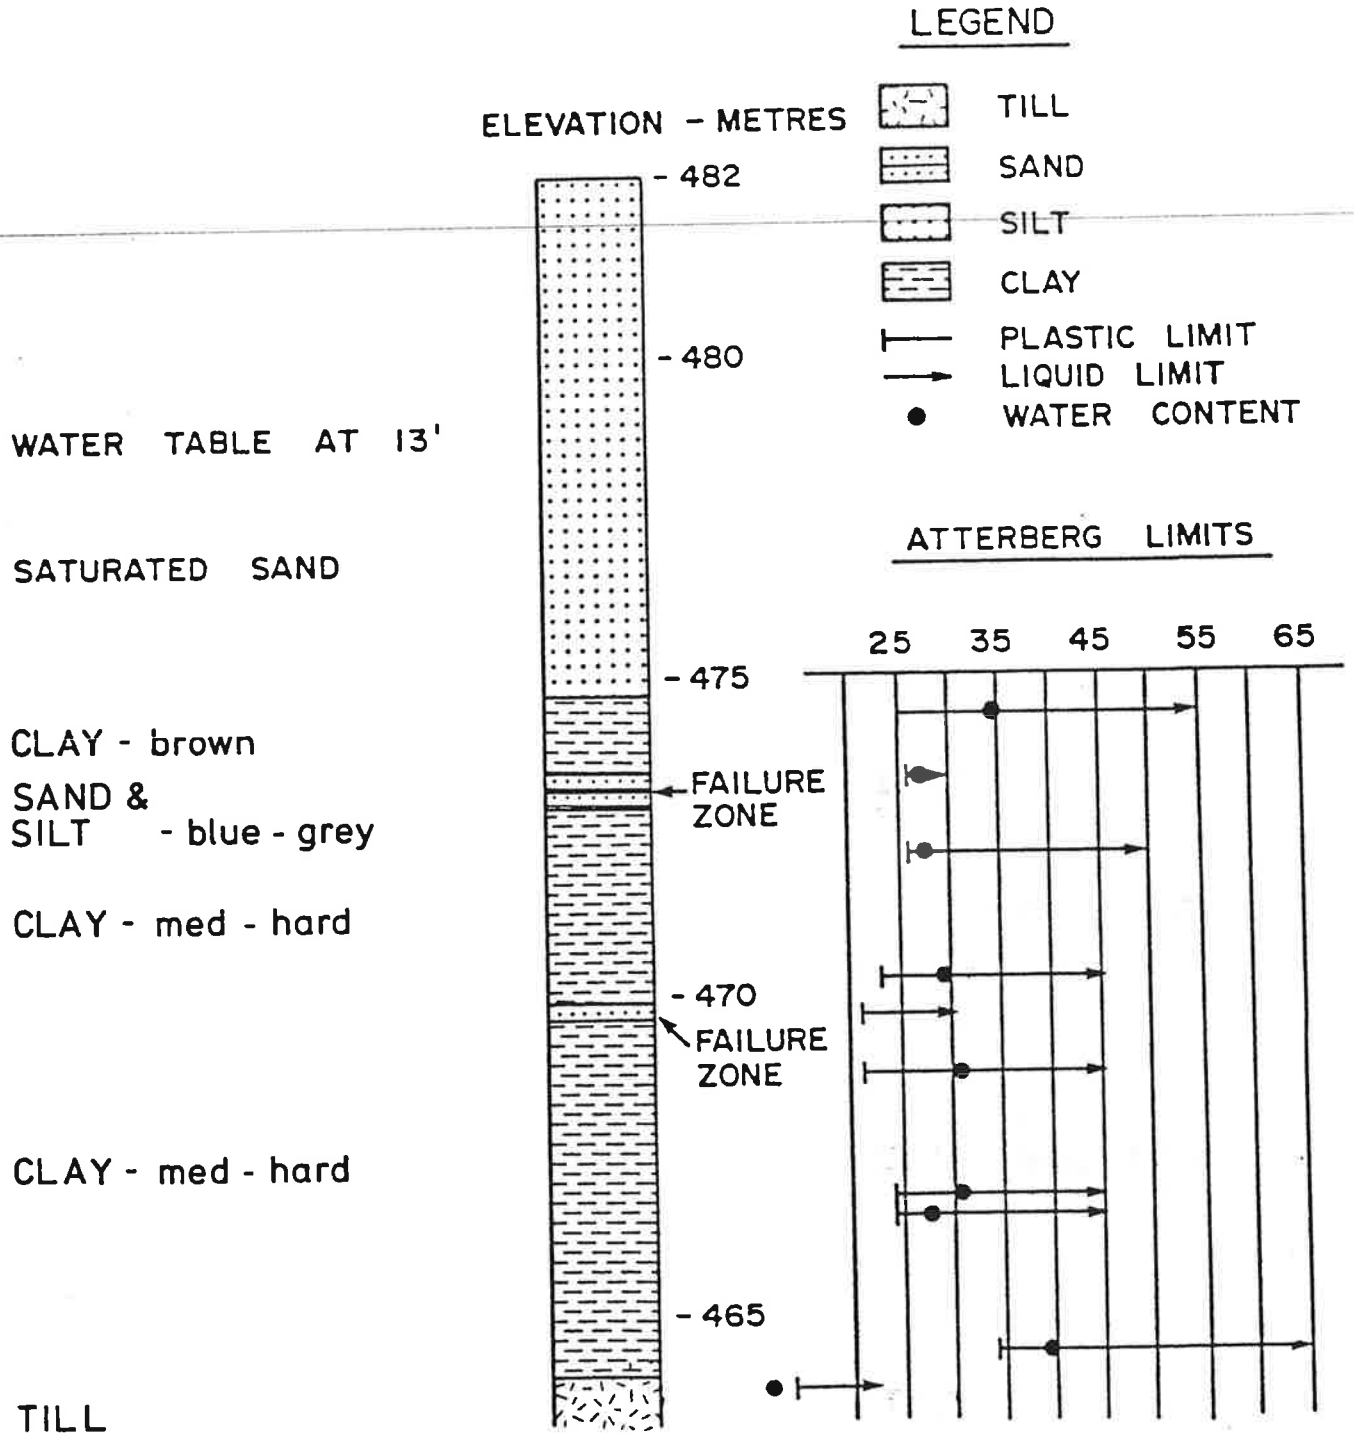
FIGURE 7

Flight auger hole #2 show failure zones

STRATIGRAPHY AND SOIL PROPERTIES AT BEAVER CREEK  
(AFTER YOSHIDA, 1981)

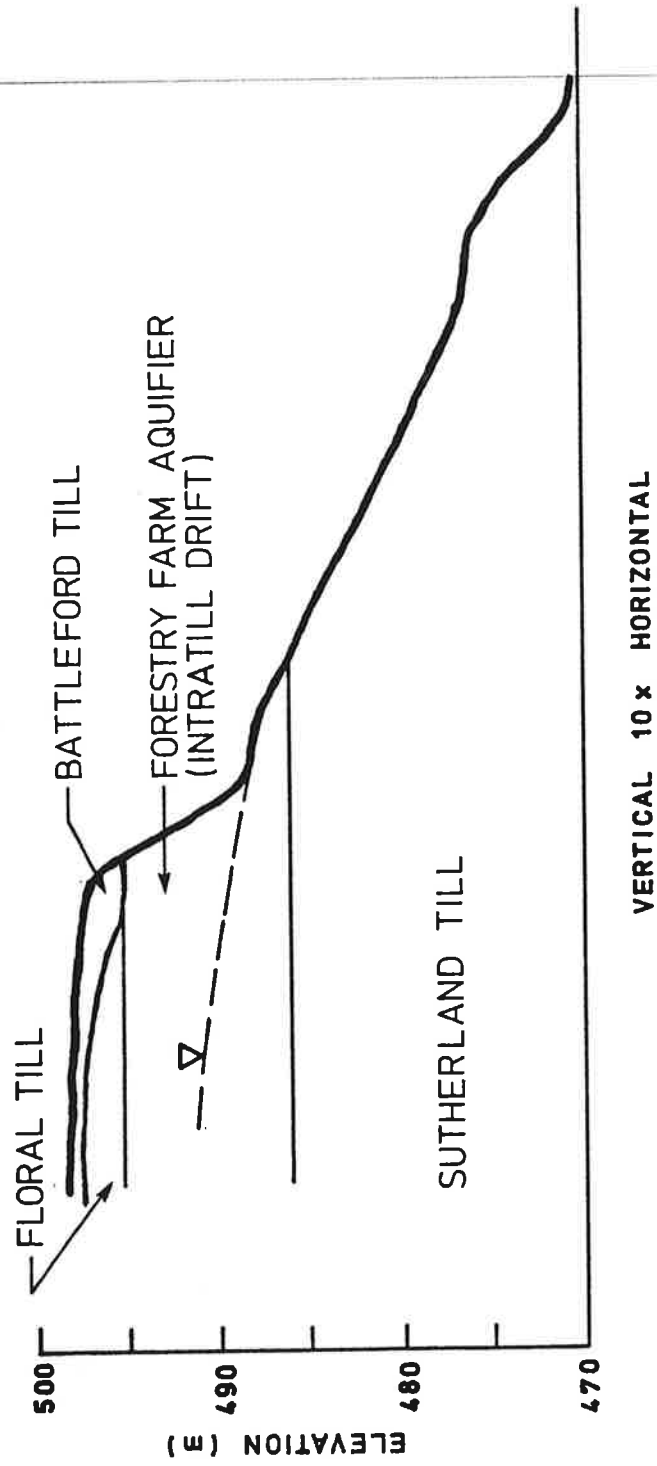
While water levels in the surficial clay govern shear failure, the piezometric level and gradients in silt, sand and gravel strata govern the rate at which piping occurs. When sufficiently high seepage gradients occur, soil particles are carried from the slope by discharging groundwater, leaving the bowl-like features characteristic of piping. The ravines developing north of the President's Residence result from discharge from sand and gravel units within the till. The best documented of these is Petursson's Ravine (Figure 19) which has developed because of seepage discharge from the Forestry Farm aquifer.

PROFILE SHOWING STRATIGRAPHY AT PETURSSON'S RAVINE  
 (AFTER CLIFTON et al 1981)

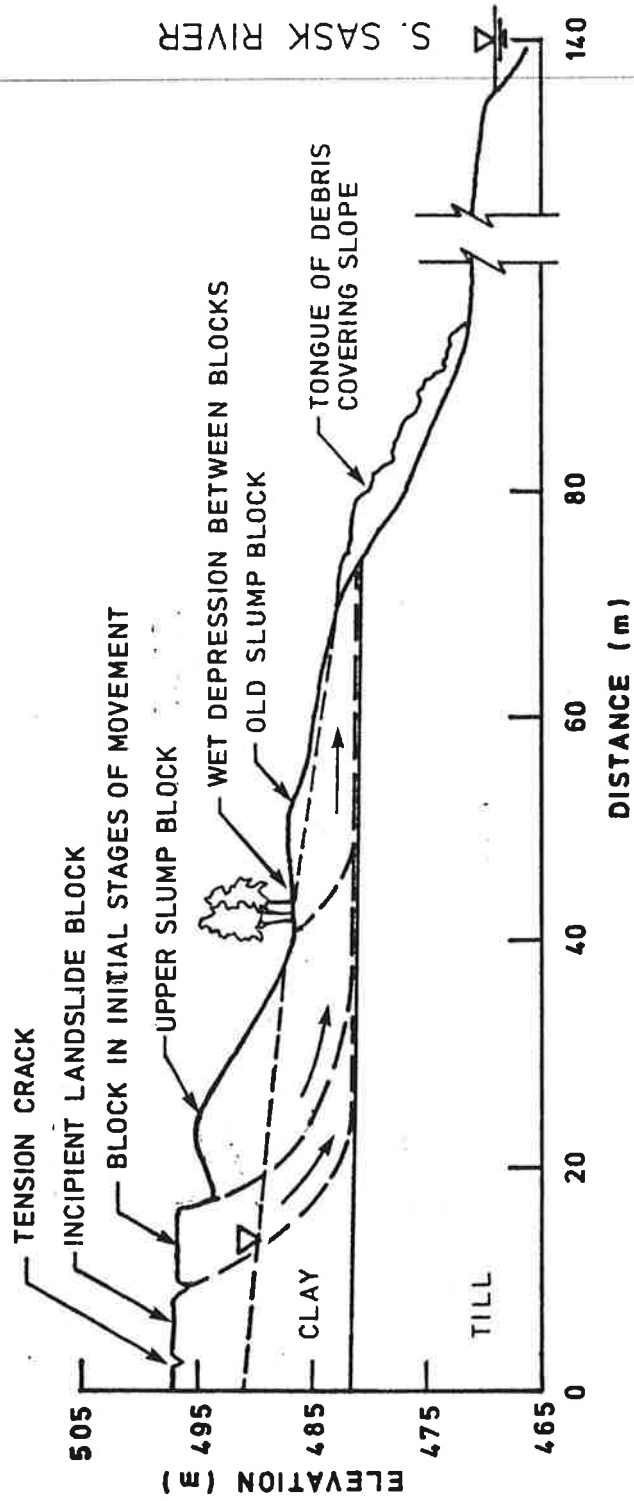
The Diefenbaker Park slide (Figure 34) is located on the east riverbank at the south limit of the city. Recent movement of the ancient slide was relatively rapid, and continues to be active. A large amount of material has dropped and moved laterally, leaving a steep, sharp headscarp and a lobe of debris extending into the river. The slide has removed a portion of a historic cemetery, is interfering with park development and is considered a hazard to park users.

DIAGRAM SHOWING PROBABLE MECHANISM OF PROGRESSIVE DEVELOPMENT OF LANDSLIDES IN THICK LACUSTRINE SEDIMENTS AT DIEFENBAKER PARK AND SASKATCHEWAN CRESCENT AT 18TH STREET

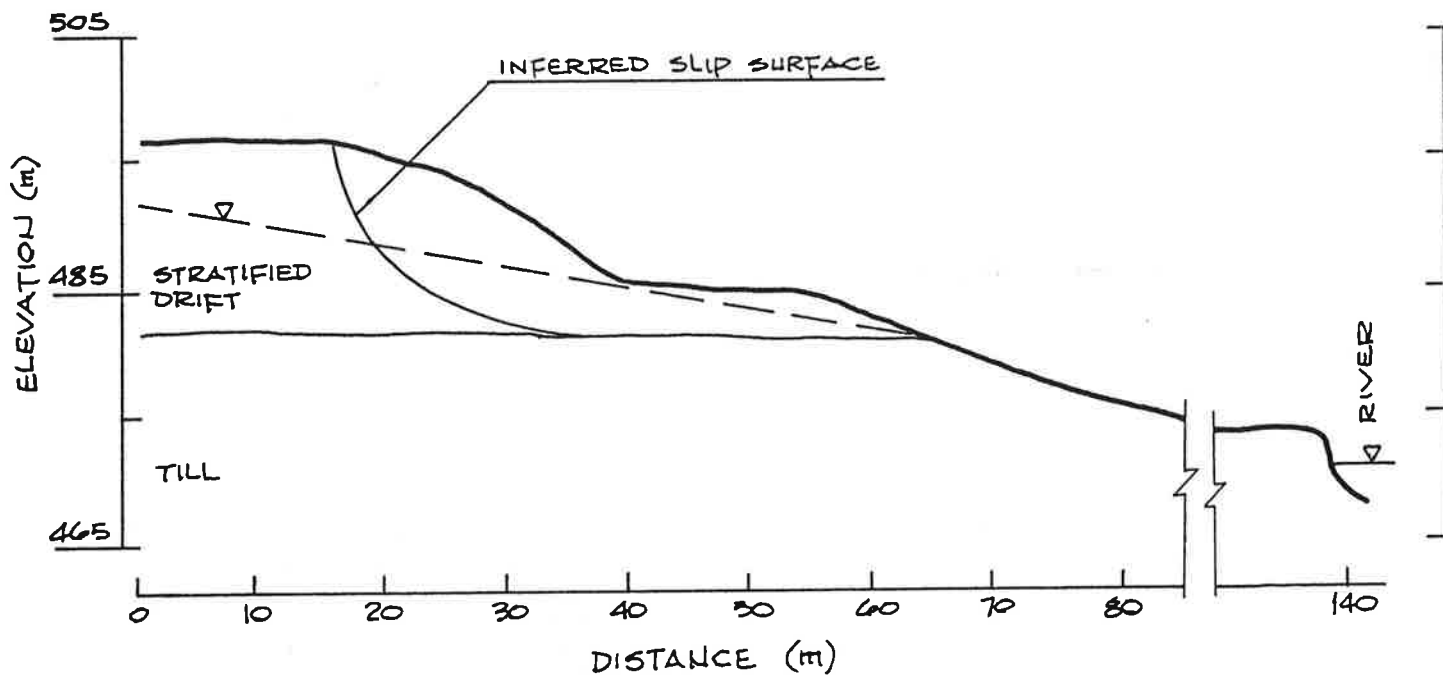
Several landslides have occurred along Saskatchewan Crescent between 13th and 18th Street. The first slide occurred at 16th Street in May, 1929. This slide is sometimes referred to as the McCraney slide (Figure 38). Subsequently, slides occurred near 15th and 17th Street

CROSS SECTION OF EAST RIVER BANK AT THE 18TH STREET LANDSLIDE  
 (COMPILED FROM CITY OF SASKATOON DATA)

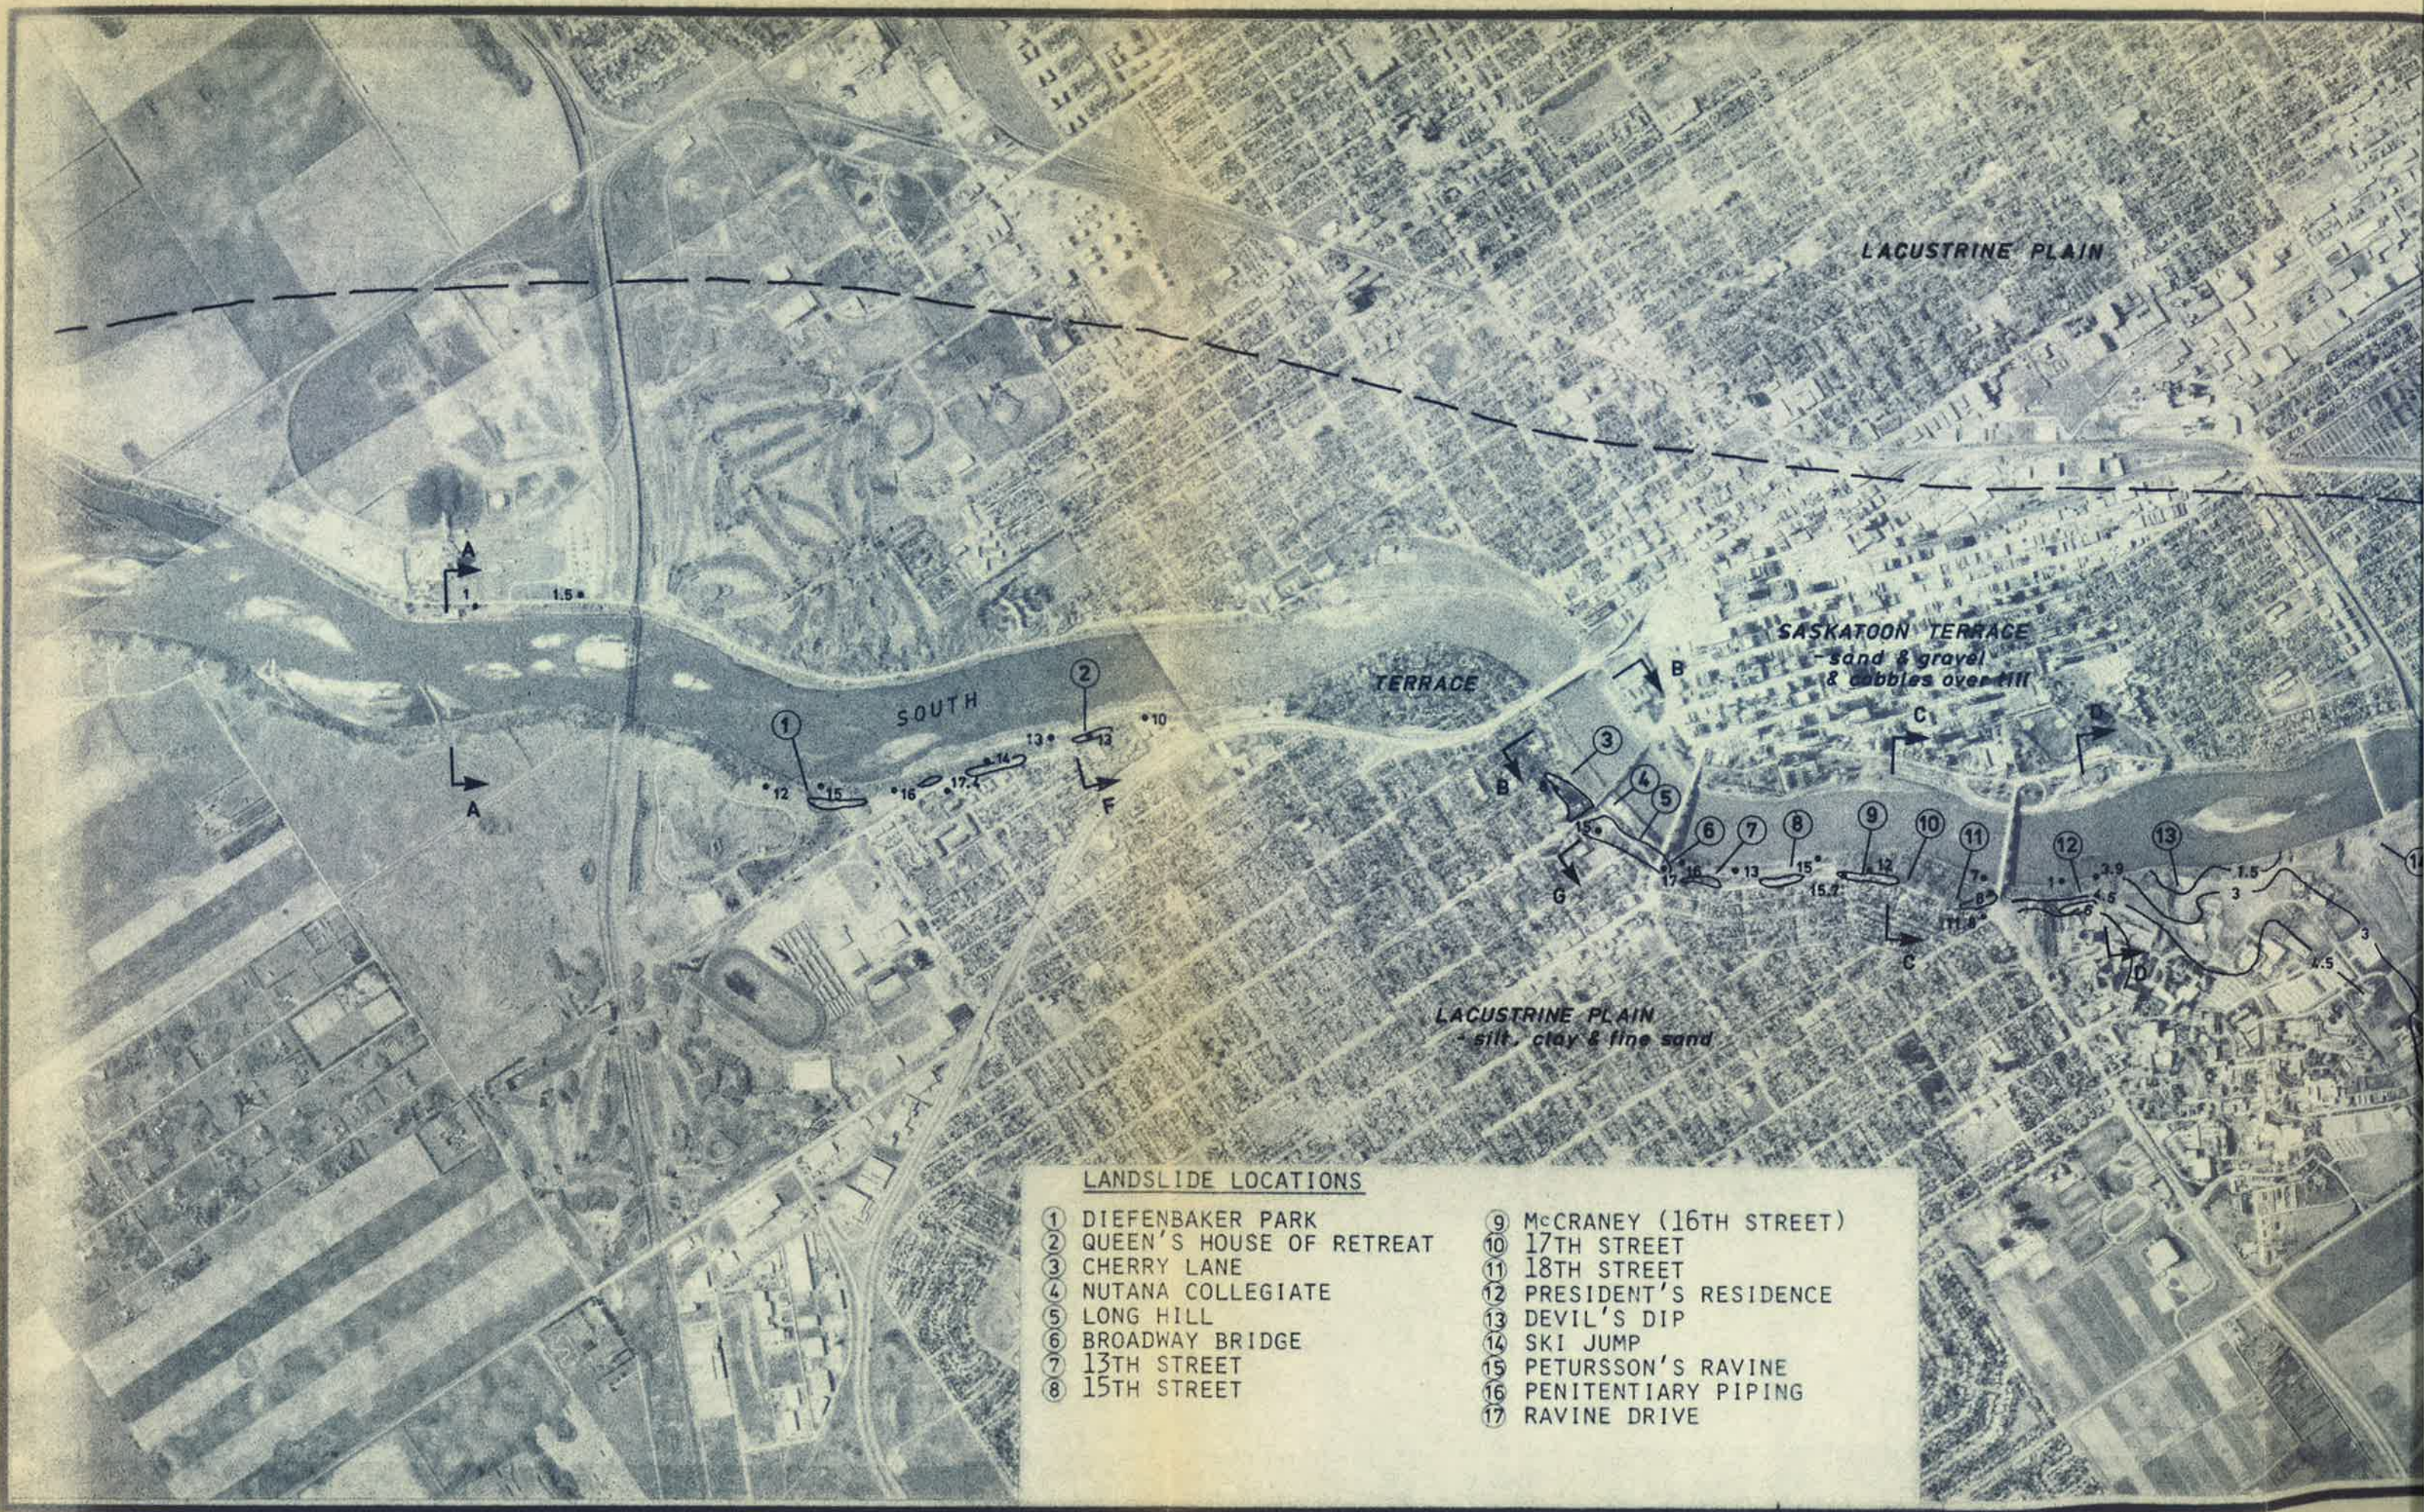
**LANDSLIDE LOCATIONS**

| | ⑰ RAVINE DRIVE |
