CHERRY LANE SLOPE MOVEMENT, SASKATOON, SK

Geotechnical Investigation and Evaluation of Conceptual Remedial Options

Report Number: 11-1362-0057/5100

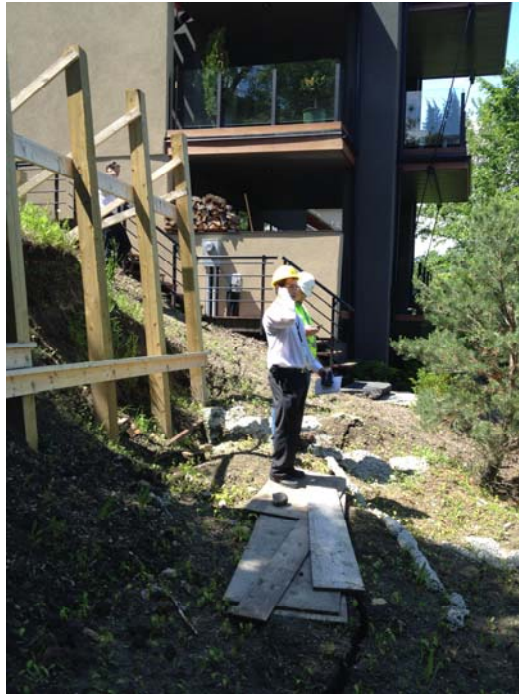
Photo C.10. Looking East at Tension Cracking along Cherry Lane (June 21, 2013)

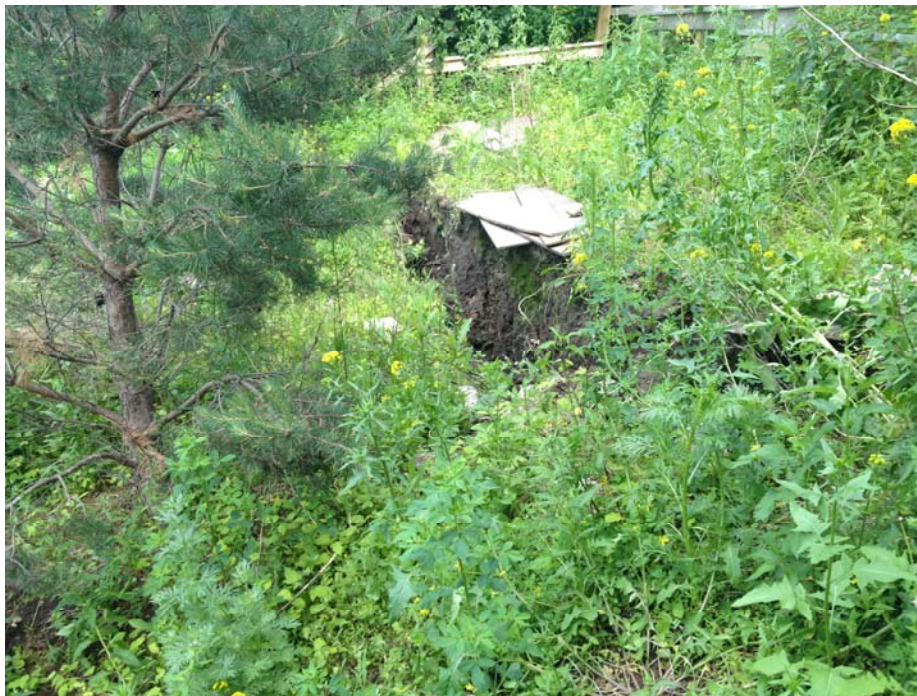
Photo C.11. Cracking along Headscarp of East Failure (June 21, 2012)

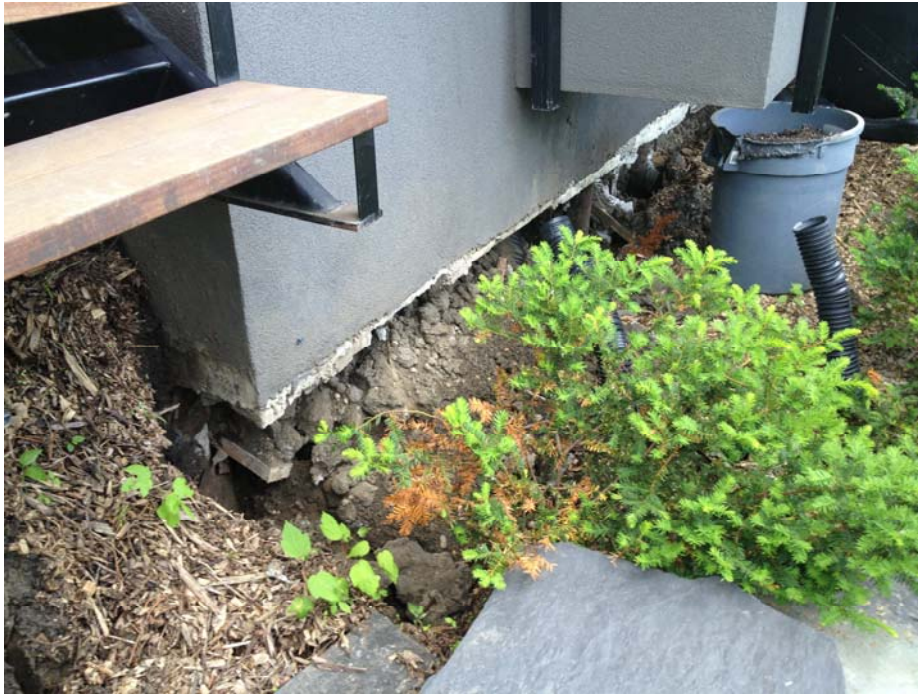
Photo C.12. Looking East at Headscarp of East Failure in Backyard of 305 11th St. E.; Approx. 90 cm Drop (June 24, 2013)

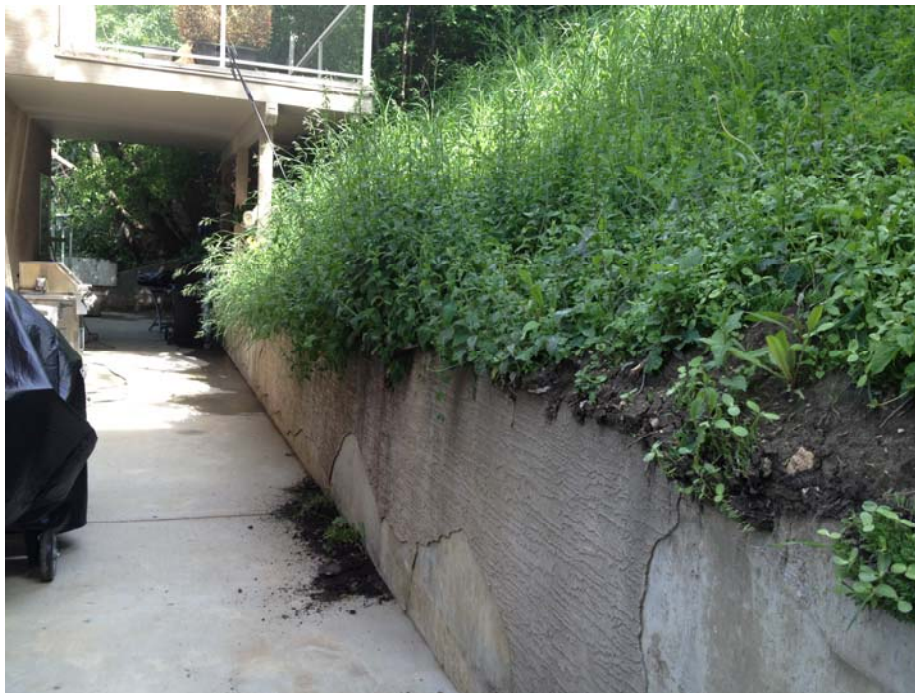
Photo C.13. Headscarp of East Failure in Backyard of 303 11th St. E.; Approx. 60 cm Drop (June 24, 2013)

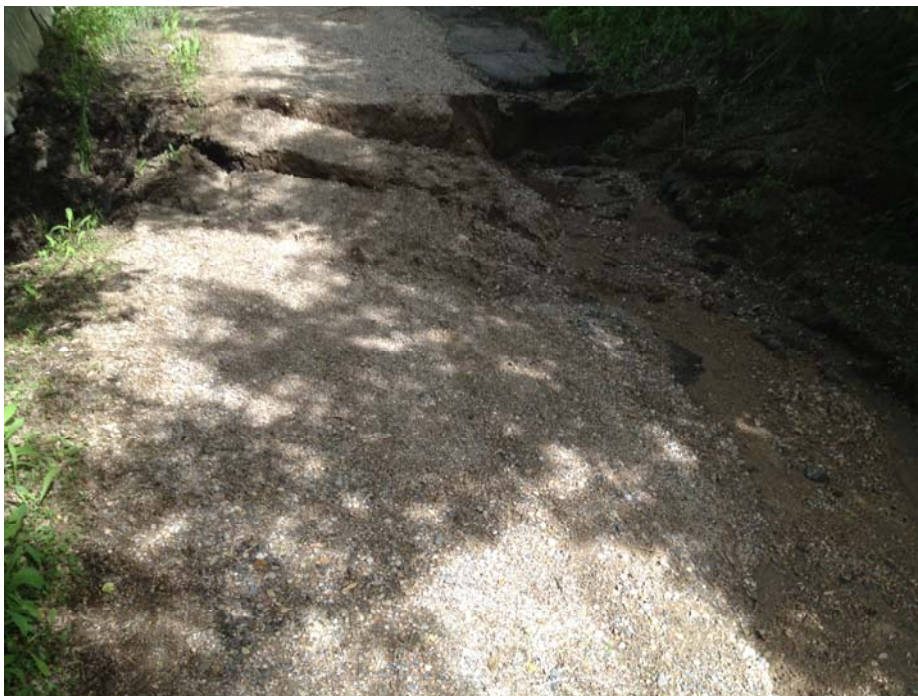
Photo C.14. Looking East at Bulging Toe of Slide above Retaining Wall behind 306 Sask. Cres. E. (June 24, 2013)

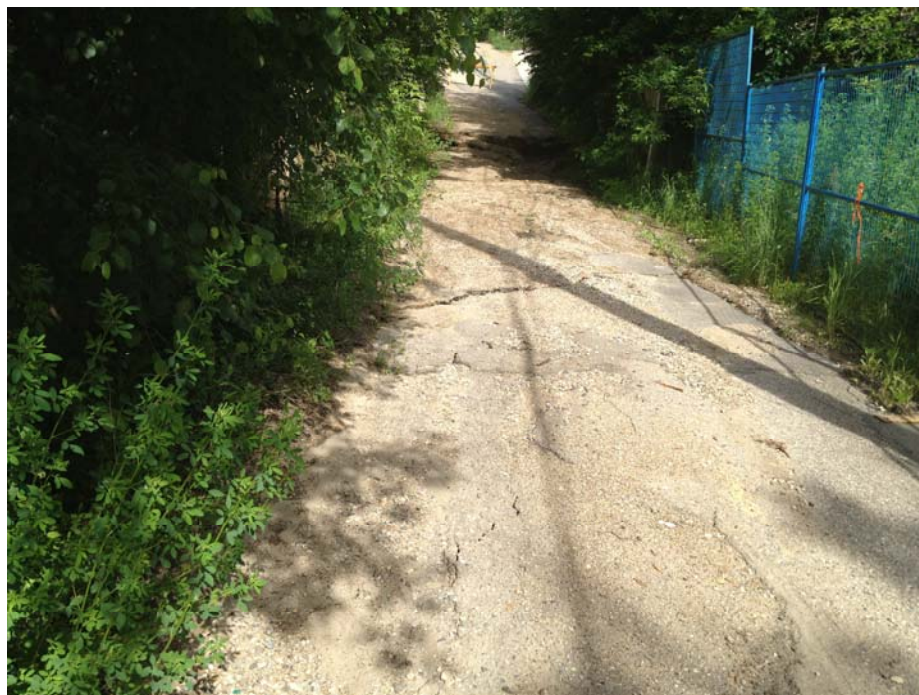
Photo C.15. Looking East at Severe Cracking across Cherry Lane, Pavement; Approx. 50 cm Drop (June 24, 2013)

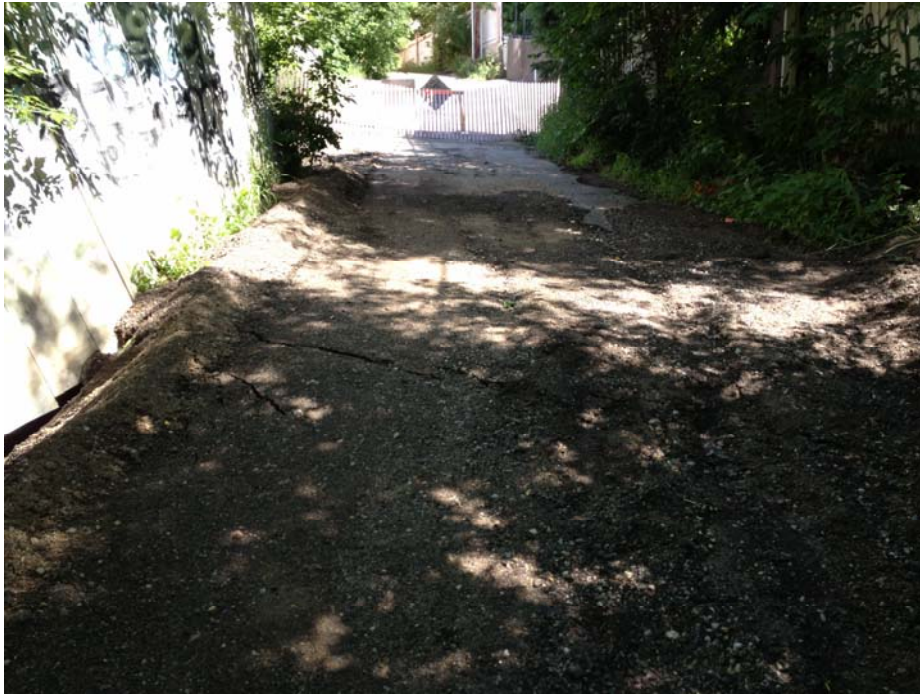
Photo C.26. Looking North at Concrete Retaining Wall between 230 & 306 Sask. Cres. E. (July 7, 2013)

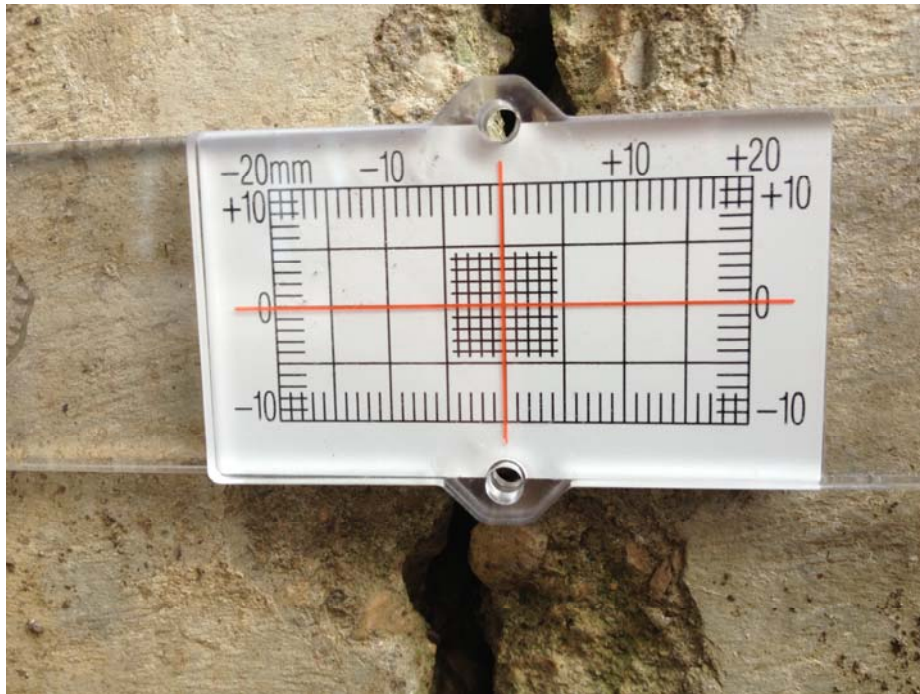
Photo F.1: Crack Meter Located on the Retaining Wall Behind 306 Sask. Cres. E. (CM1) (Aug 12, 2013)

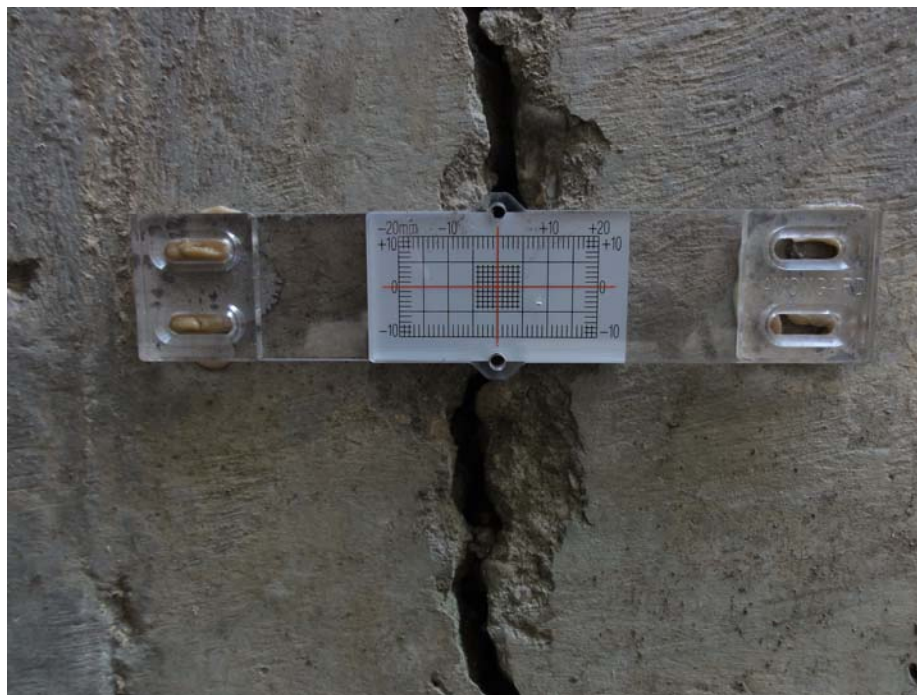
Photo F.2: Crack Meter Located on the Retaining Wall Behind 306 Sask. Cres. E. (CM1) (Sept 18, 2013)

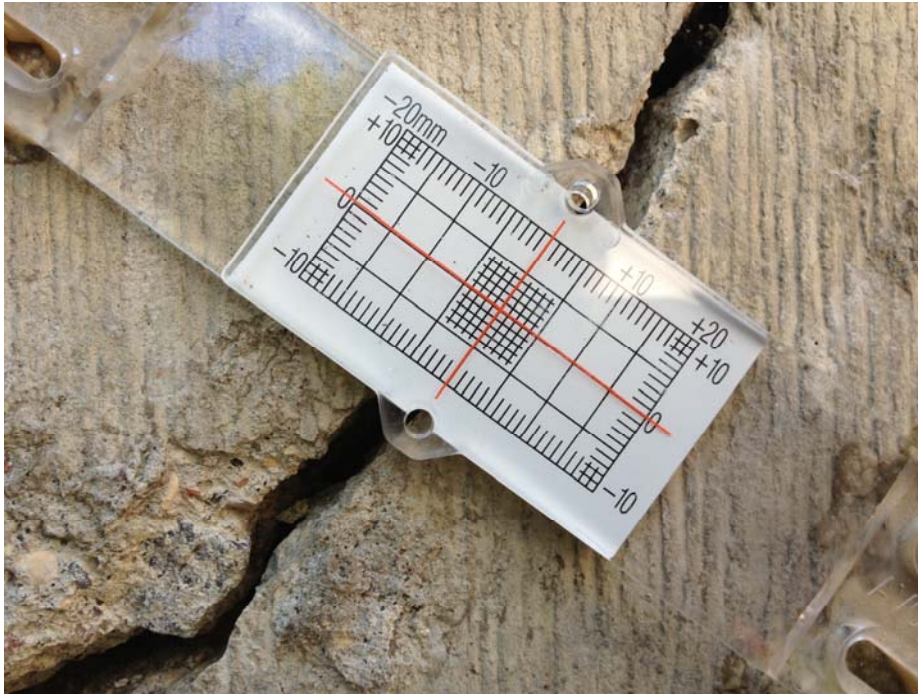
Photo F.3: Crack Meter Located on the East Face of the Retaining Wall Between 230 & 306 Sask. Cres. E. (CM2) (Aug 12, 2013)

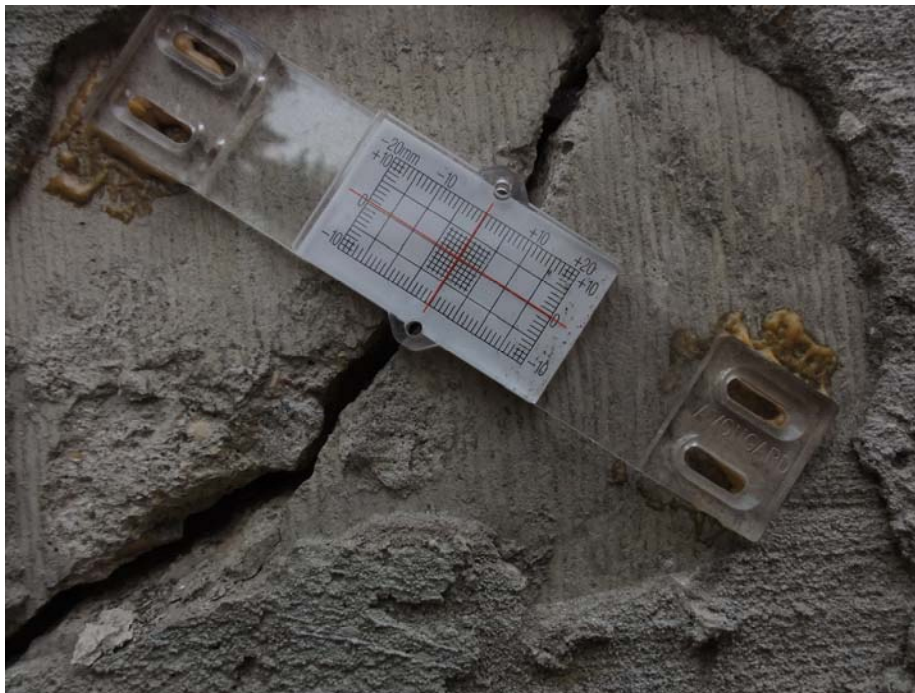
Photo F.4: Crack Meter Located on the East Face of the Retaining Wall Between 230 & 306 Sask. Cres. E. (CM2) (Sept 18, 2013)

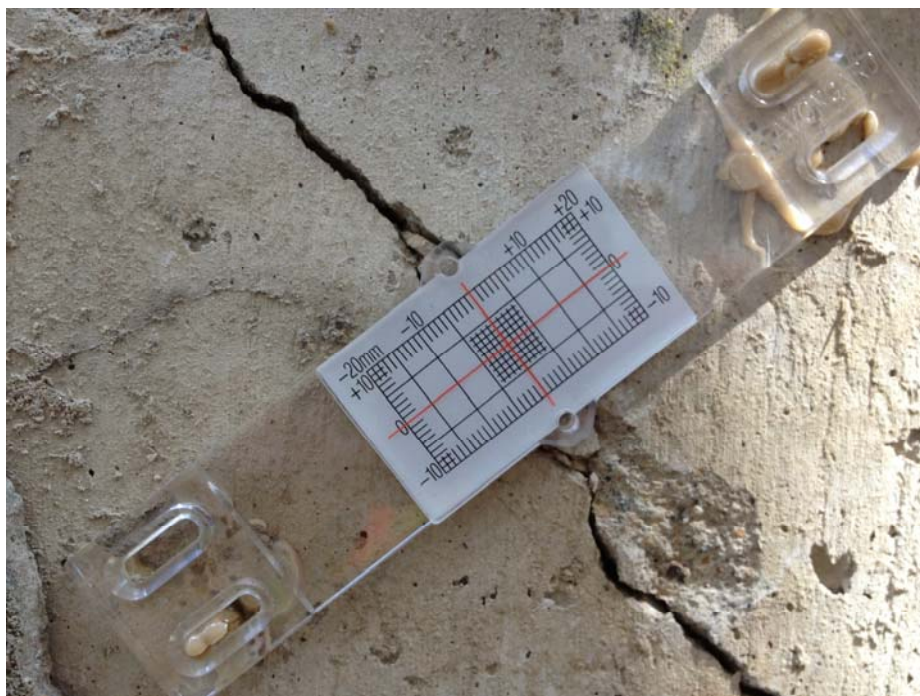
Photo F.5: Crack Meter Located on the West Face of the Retaining Wall Between 230 & 306 Sask. Cres. E. (CM3) (Aug 12, 2013)

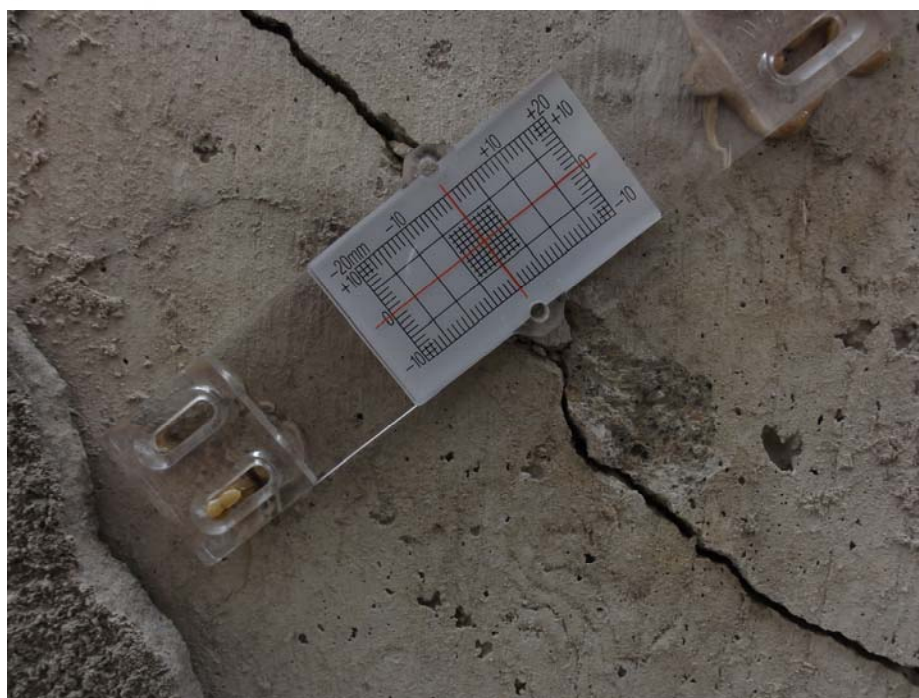
Photo F.6: Crack Meter Located on the West Face of the Retaining Wall Between 230 & 306 Sask. Cres. E. (CM3) (Sept 18, 2013)
