CITY OF SASKATOON

Asbestos-Containing Building Materials Assessment Report - Assessors Building

Report Number: 1667963

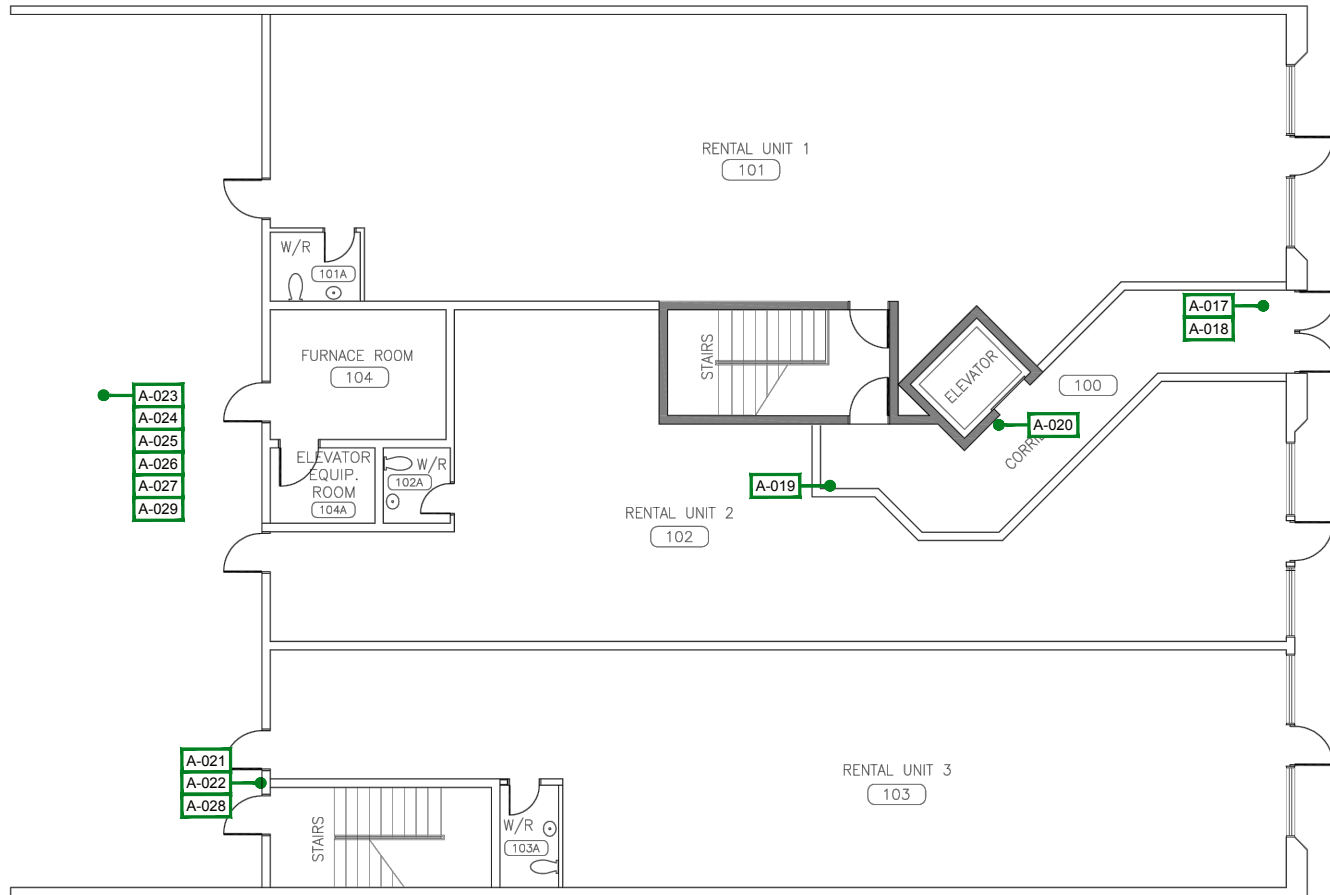
PROJECT NO. 1667963 CONTROL 1000-HM-0001 REV. 0 FIGURE 1

NOTE(S)
 1. ASBESTOS IS A CARCINOGEN. DO NOT BREATHE ASBESTOS DUST.
 2. ASBESTOS-CONTAINING BLACK FIRESTOP IS LOCATED ON THE EXTERIOR OF THE BUILDING.
