SLOPE INSTABILITY STUDY  
SOUTH SASKATCHEWAN RIVER BANKS  
SASKATOON, SASKATCHEWAN

MEEWASIN VALLEY AUTHORITY

FINAL REPORT

23 DECEMBER 1985

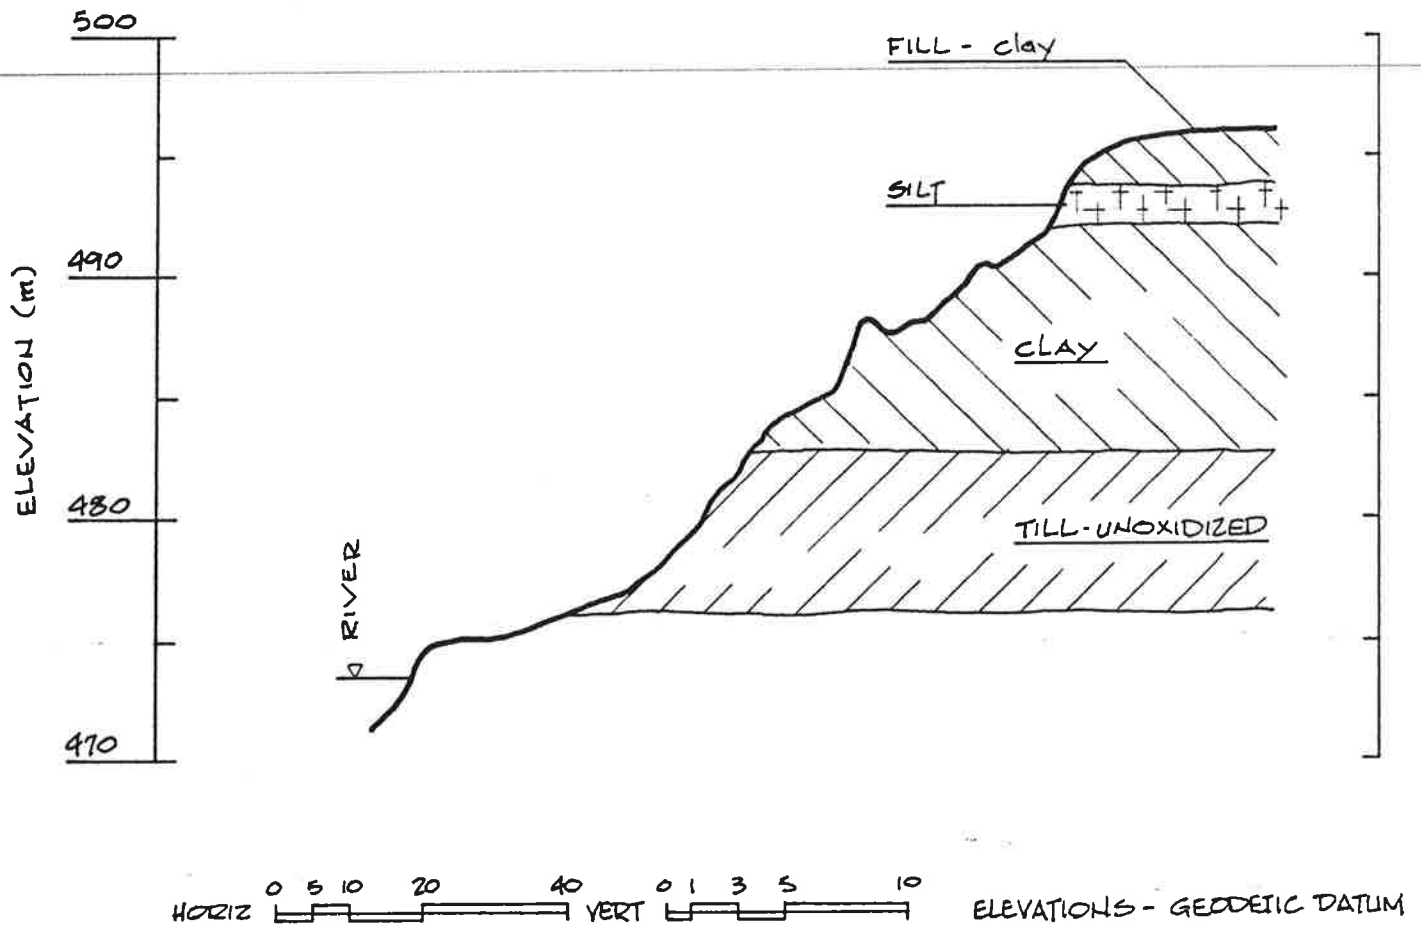
FIGURE 35

The Queen's House of Retreat slide (Figure 35) is similar to the Diefenbaker Park slide although recent movement may have been initiated by irrigation on the grounds. This slide is also active. The headscarp extends onto private land. In an attempt to stabilize the slope, fill material has been placed at the toe of the slide. However, the base of sliding is above this landfill and the stability has not been improved by filling.

STRATIGRAPHIC SECTION ON EAST BANK AT  
 QUEEN'S HOUSE OF RETREAT (FROM CAL, 1984d)

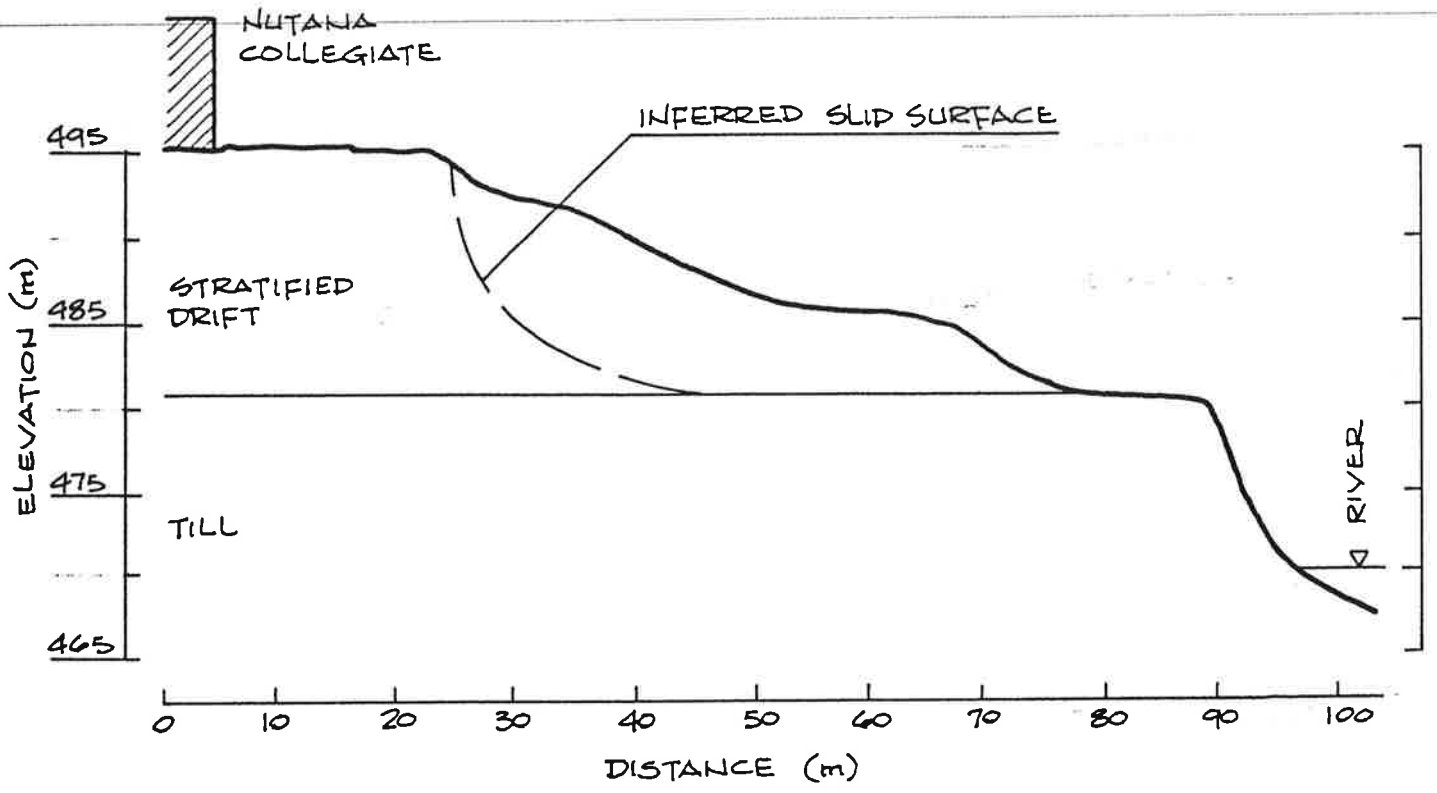
FIGURE 36

In the summer of 1960 a slide occurred just below the Nutana Collegiate. This slide (Figure 36) encroached upon the tennis courts on the uplands. The failure plane intercepted the slope near the elevation of Saskatchewan Drive. Slope geometry modification was undertaken which included excavation at the crest and rock fill along the toe. Surface drainage improvements were also made. This slide has recently been active again. Minor movement occurred in July, 1983, causing dislocation of curbs.

CROSS SECTION AT NUTANA COLLEGIATE  
 (COMPILED FROM P.F.R.A. DATA)

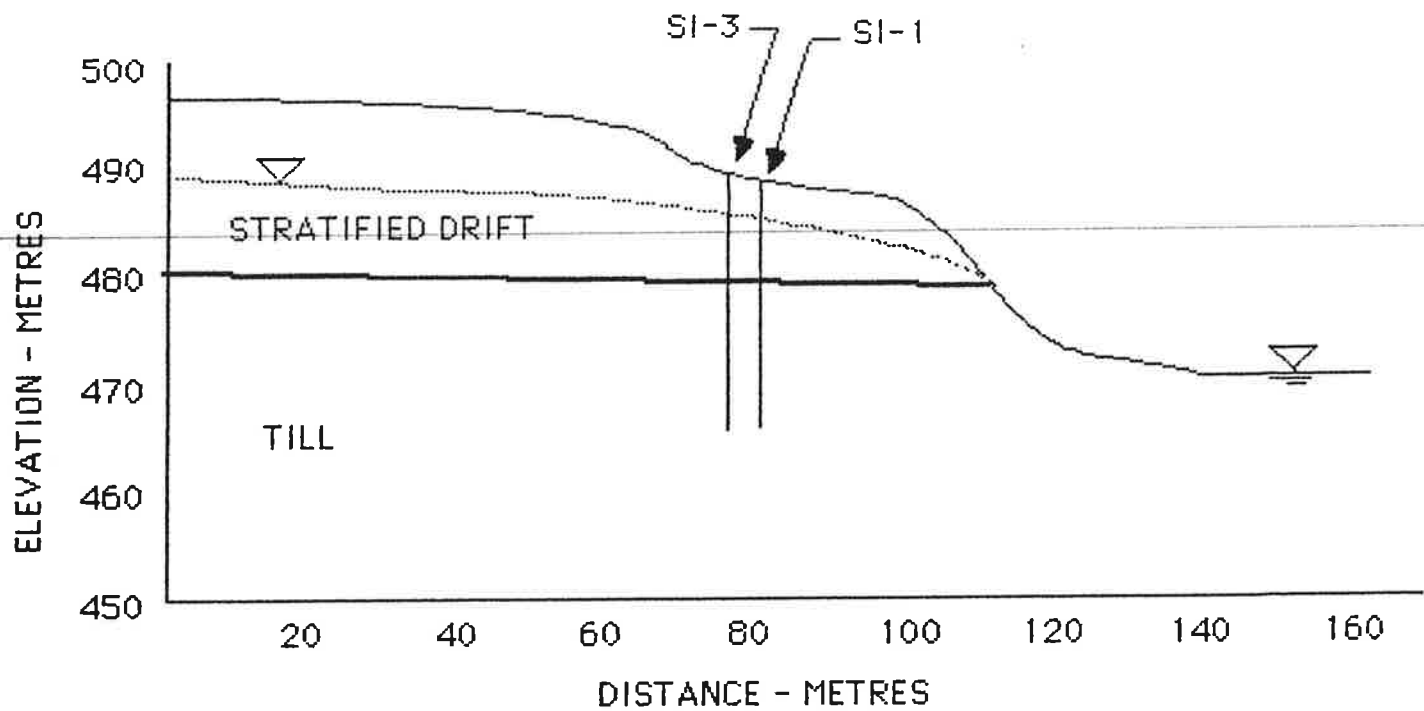
Figure 35a: The 13th Street Cross Section Just North Of The Broadway Bridge

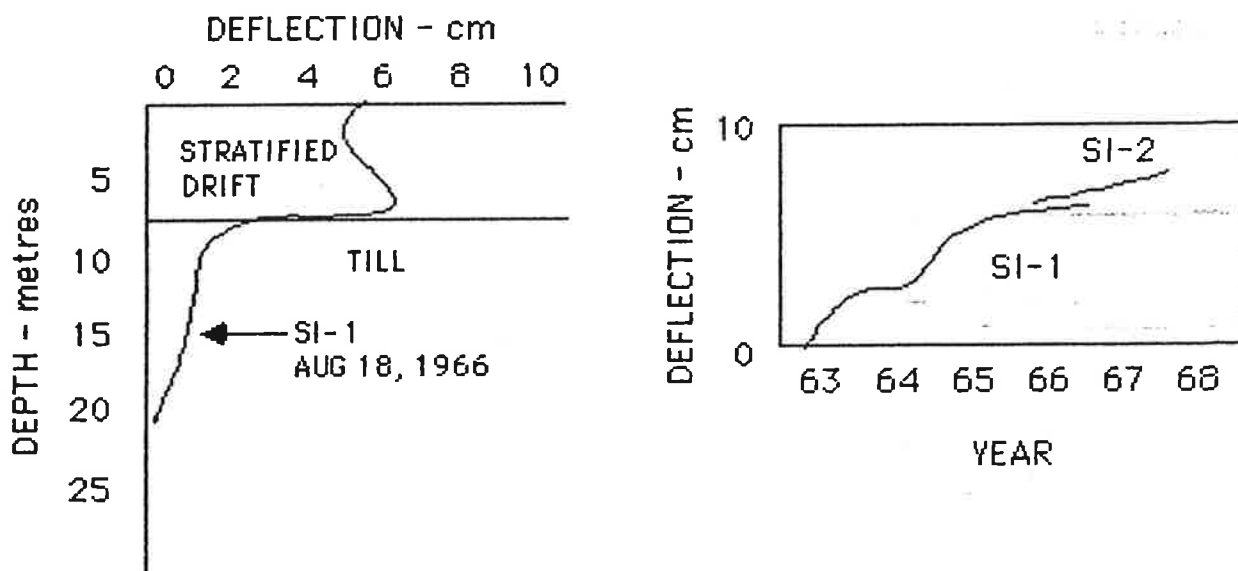
FIGURE 37

Slopes at the south abutment (Figure 37) of the Broadway Bridge have experienced movement. A geotechnical investigation in August, 1962, indicated a potential for sliding. A short time later, a slide occurred in the 600 block of Saskatchewan Crescent just north of the Broadway Bridge. Structural distress was subsequently noted at the southeast abutment of the bridge in the latter part of the year.

SLOPE INDICATOR MOVEMENTS NORTH SIDE OF EAST ABUTMENT OF THE BROADWAY BRIDGE (COMPILED FROM P.F.R.A. DATA)

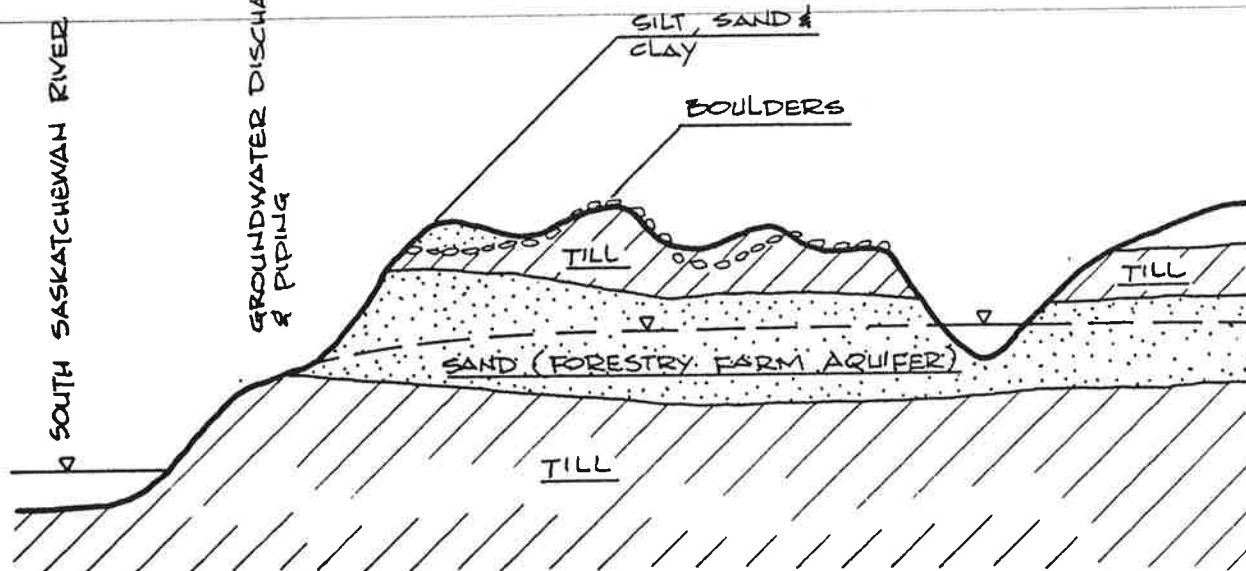
FIGURE 39

Slope failures have occurred on the east river bank north of the University, at the Penitentiary and Petursson's Ravine (Figure 39). These failures are piping failures and are not landslides. The discharge of groundwater at these locations is undermining the slope.

SCHEMATIC CROSS SECTION AT PETURSSON'S RAVINE

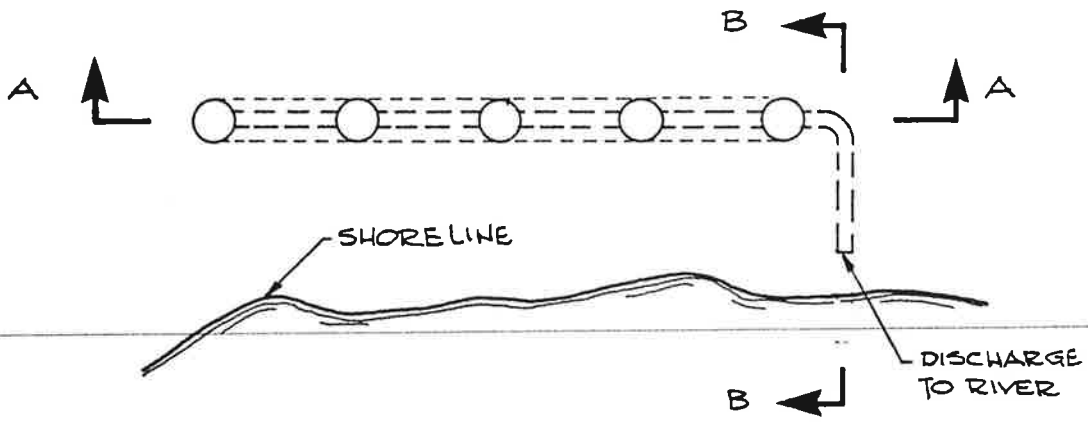
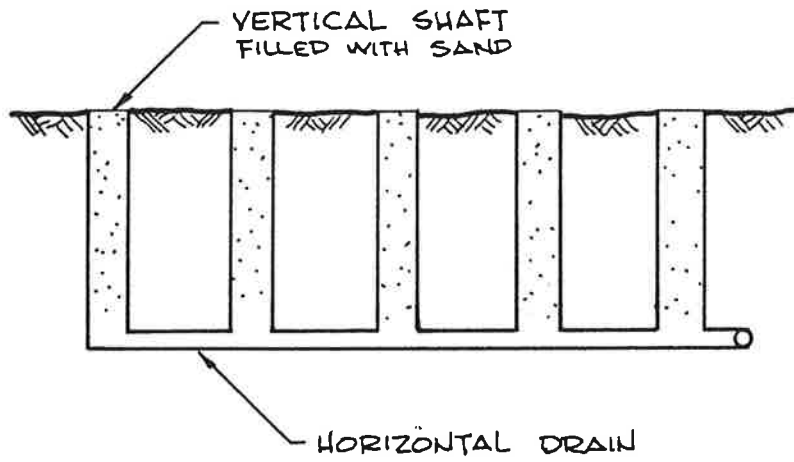
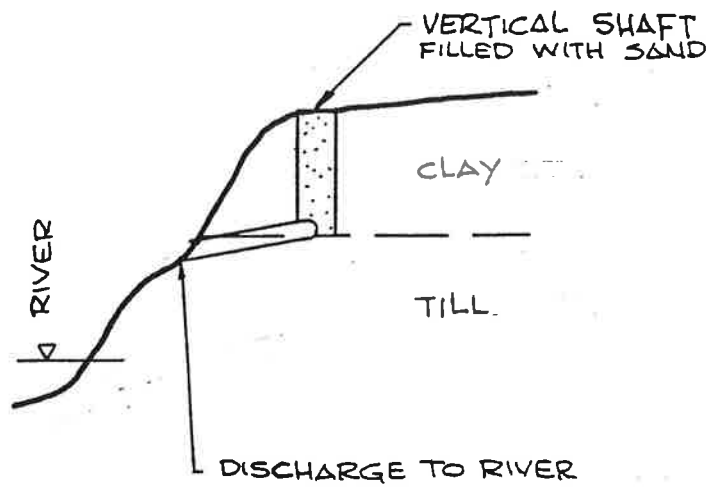
FIGURE 48

SKETCH OF SLOPE DRAIN ALONG SASKATCHEWAN CRESCENT  
NORTH OF BROADWAY BRIDGE

An elaborate subdrainage system was installed in the 1960's to stabilize landslides on Saskatchewan Crescent between University Bridge and Broadway Bridge. The extent of subdrainage installation cannot be confirmed, nor was it possible to locate details of the construction. However, it is understood that the construction consisted of large diameter shafts drilled at close spacings into the dense till. The intervening soil between the base of the shafts was excavated and a drainage pipe installed to form a continuous drain that discharges to the river. The shafts were backfilled with sand to form a vertical drainage curtain. An illustration of this concept is given in Figure 48.
