SLOPE INSTABILITY STUDY  
SOUTH SASKATCHEWAN RIVER BANKS  
SASKATOON, SASKATCHEWAN

MEEWASIN VALLEY AUTHORITY

FINAL REPORT

23 DECEMBER 1985

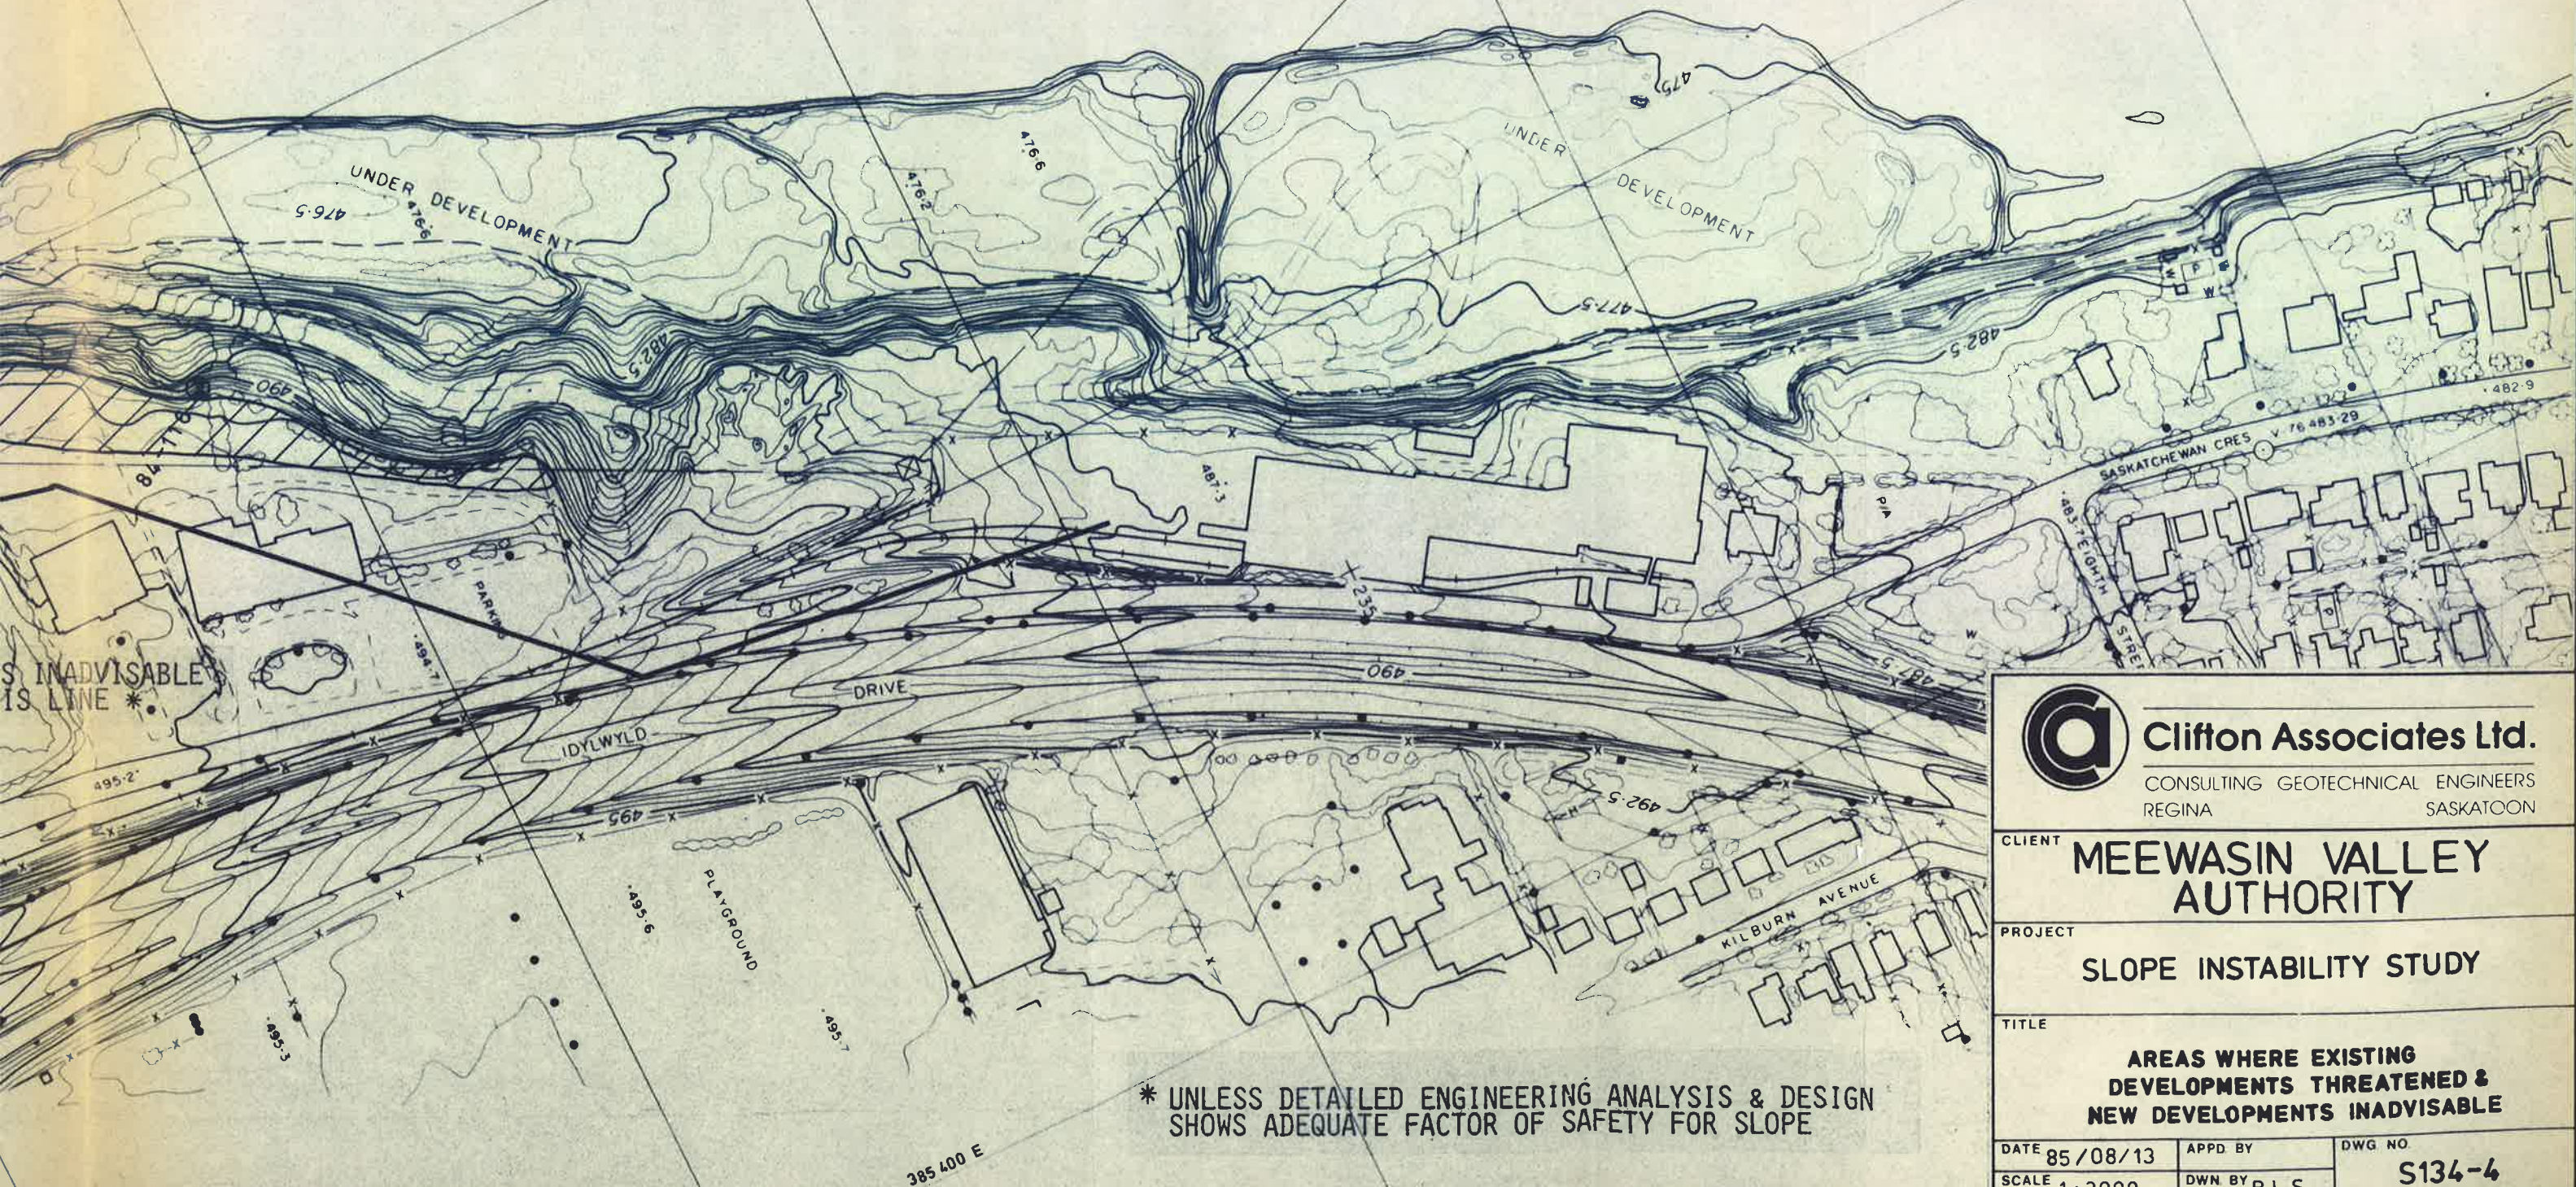
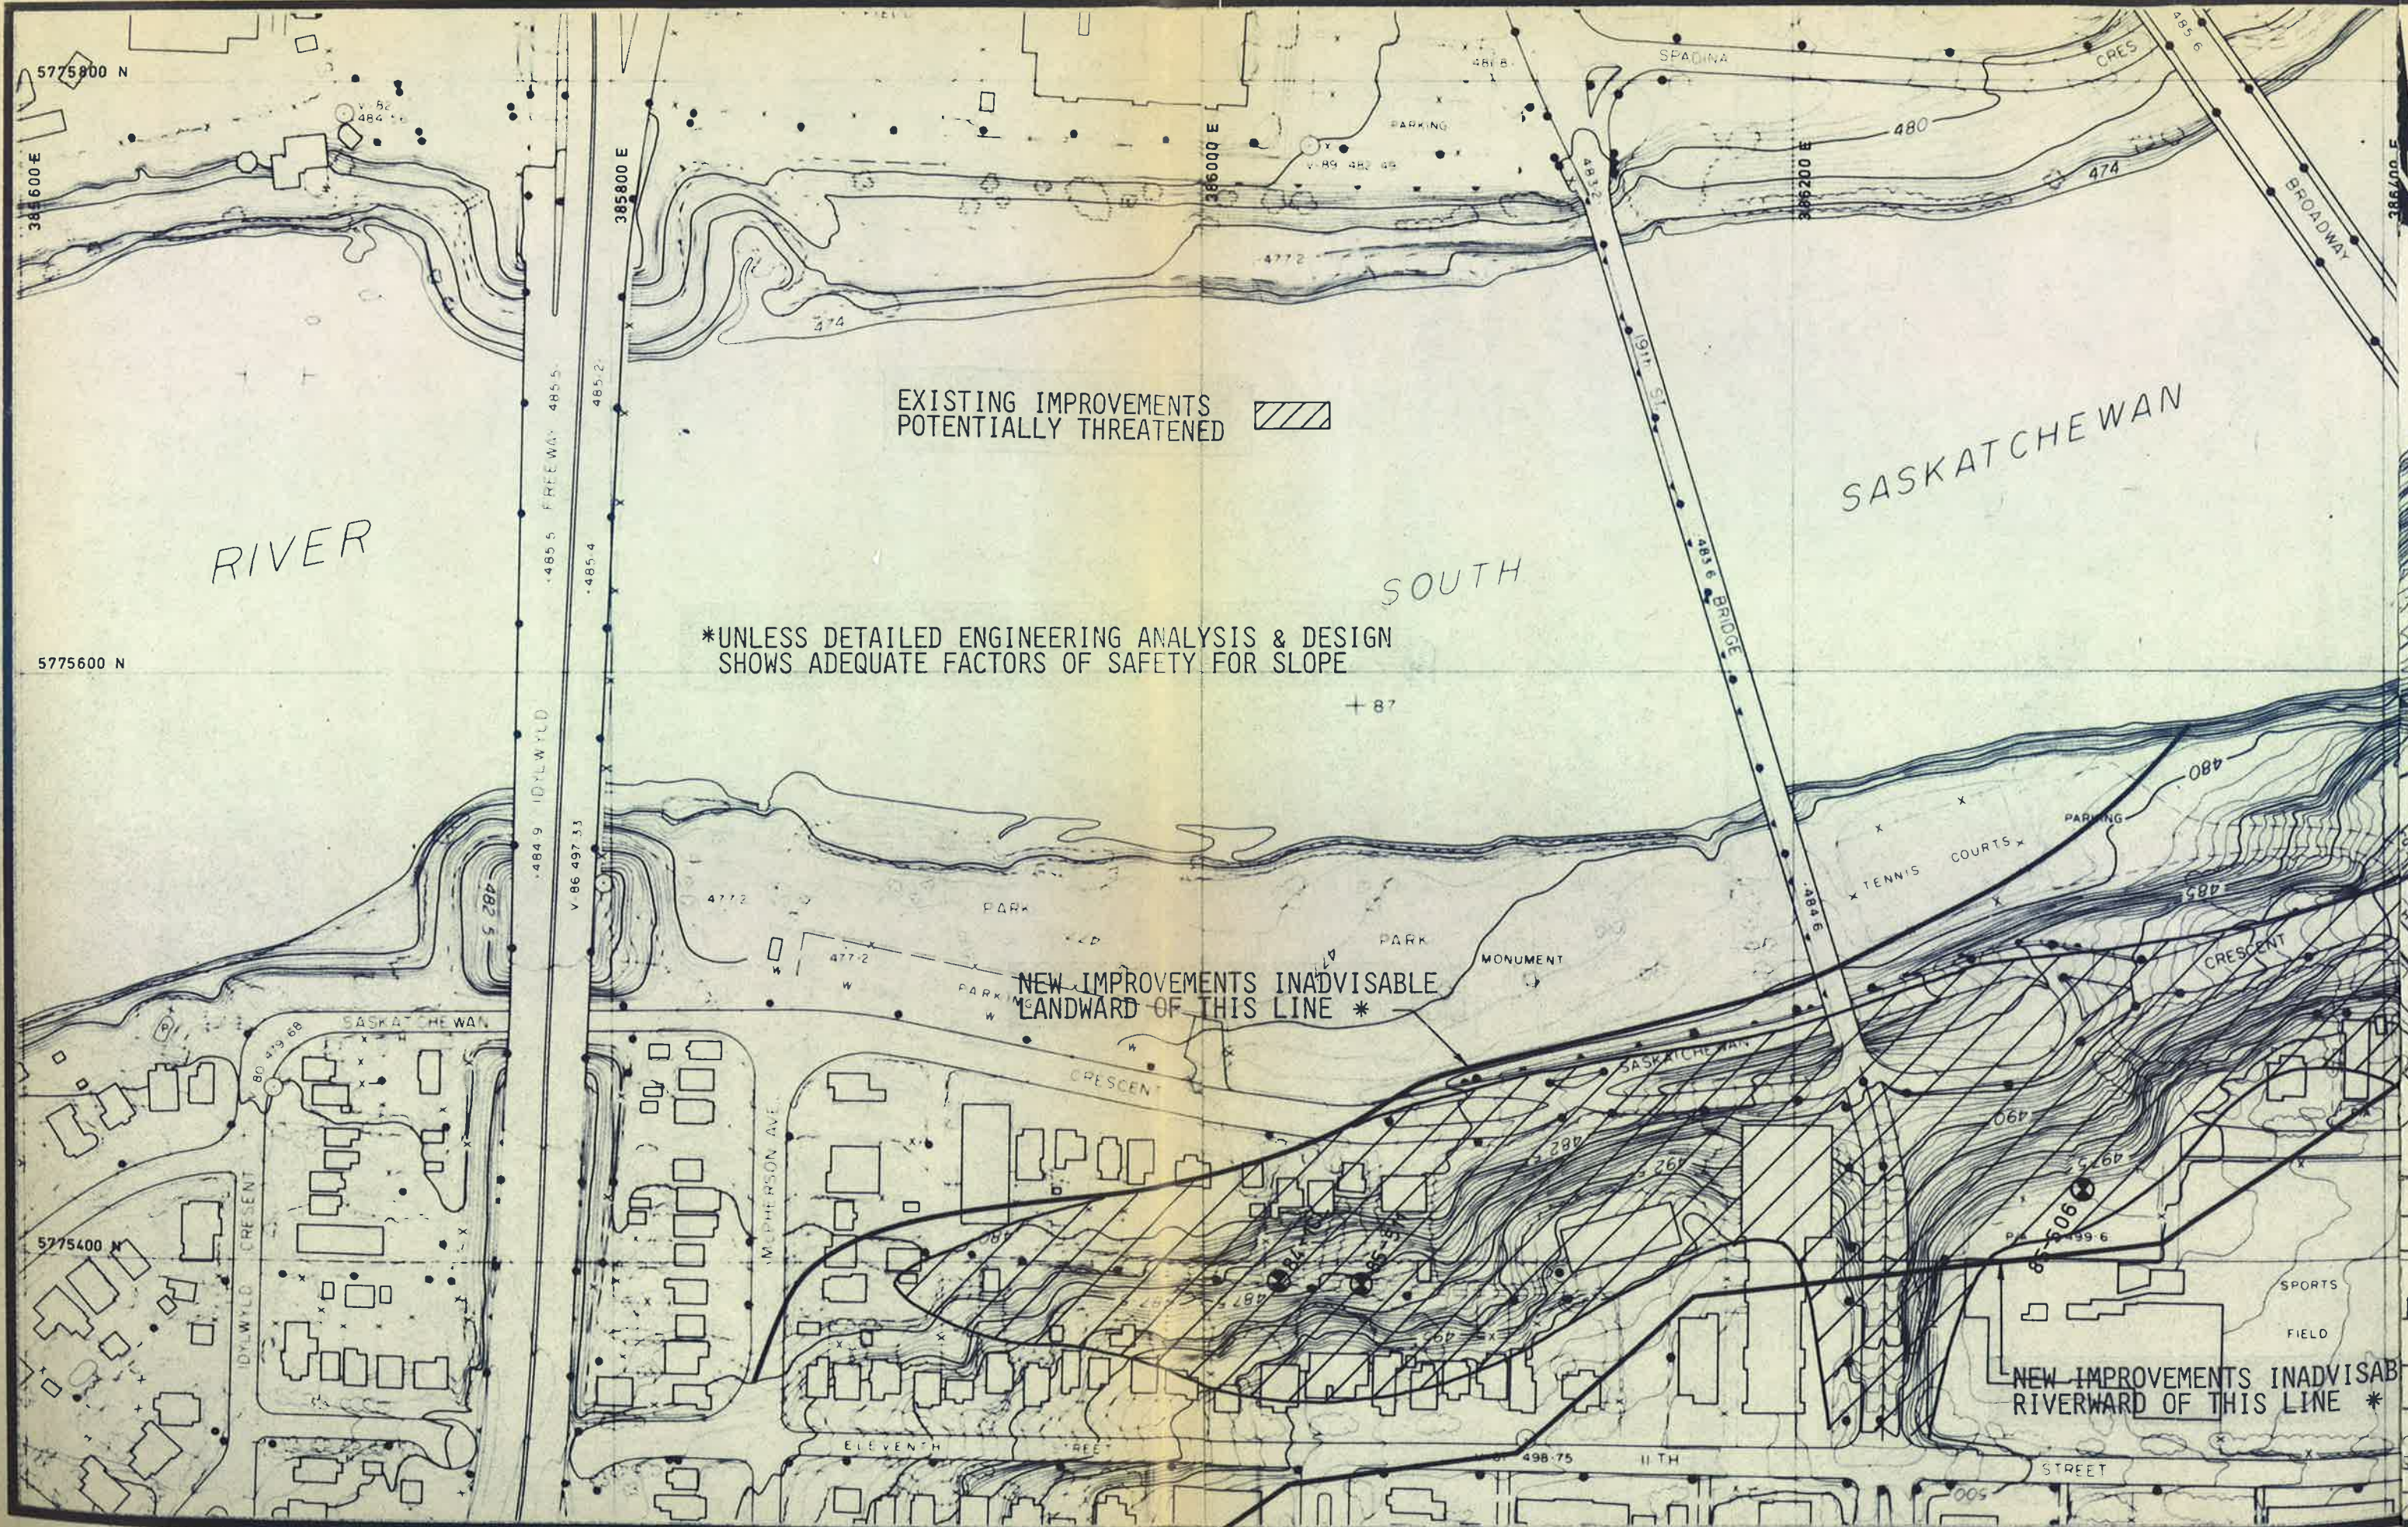
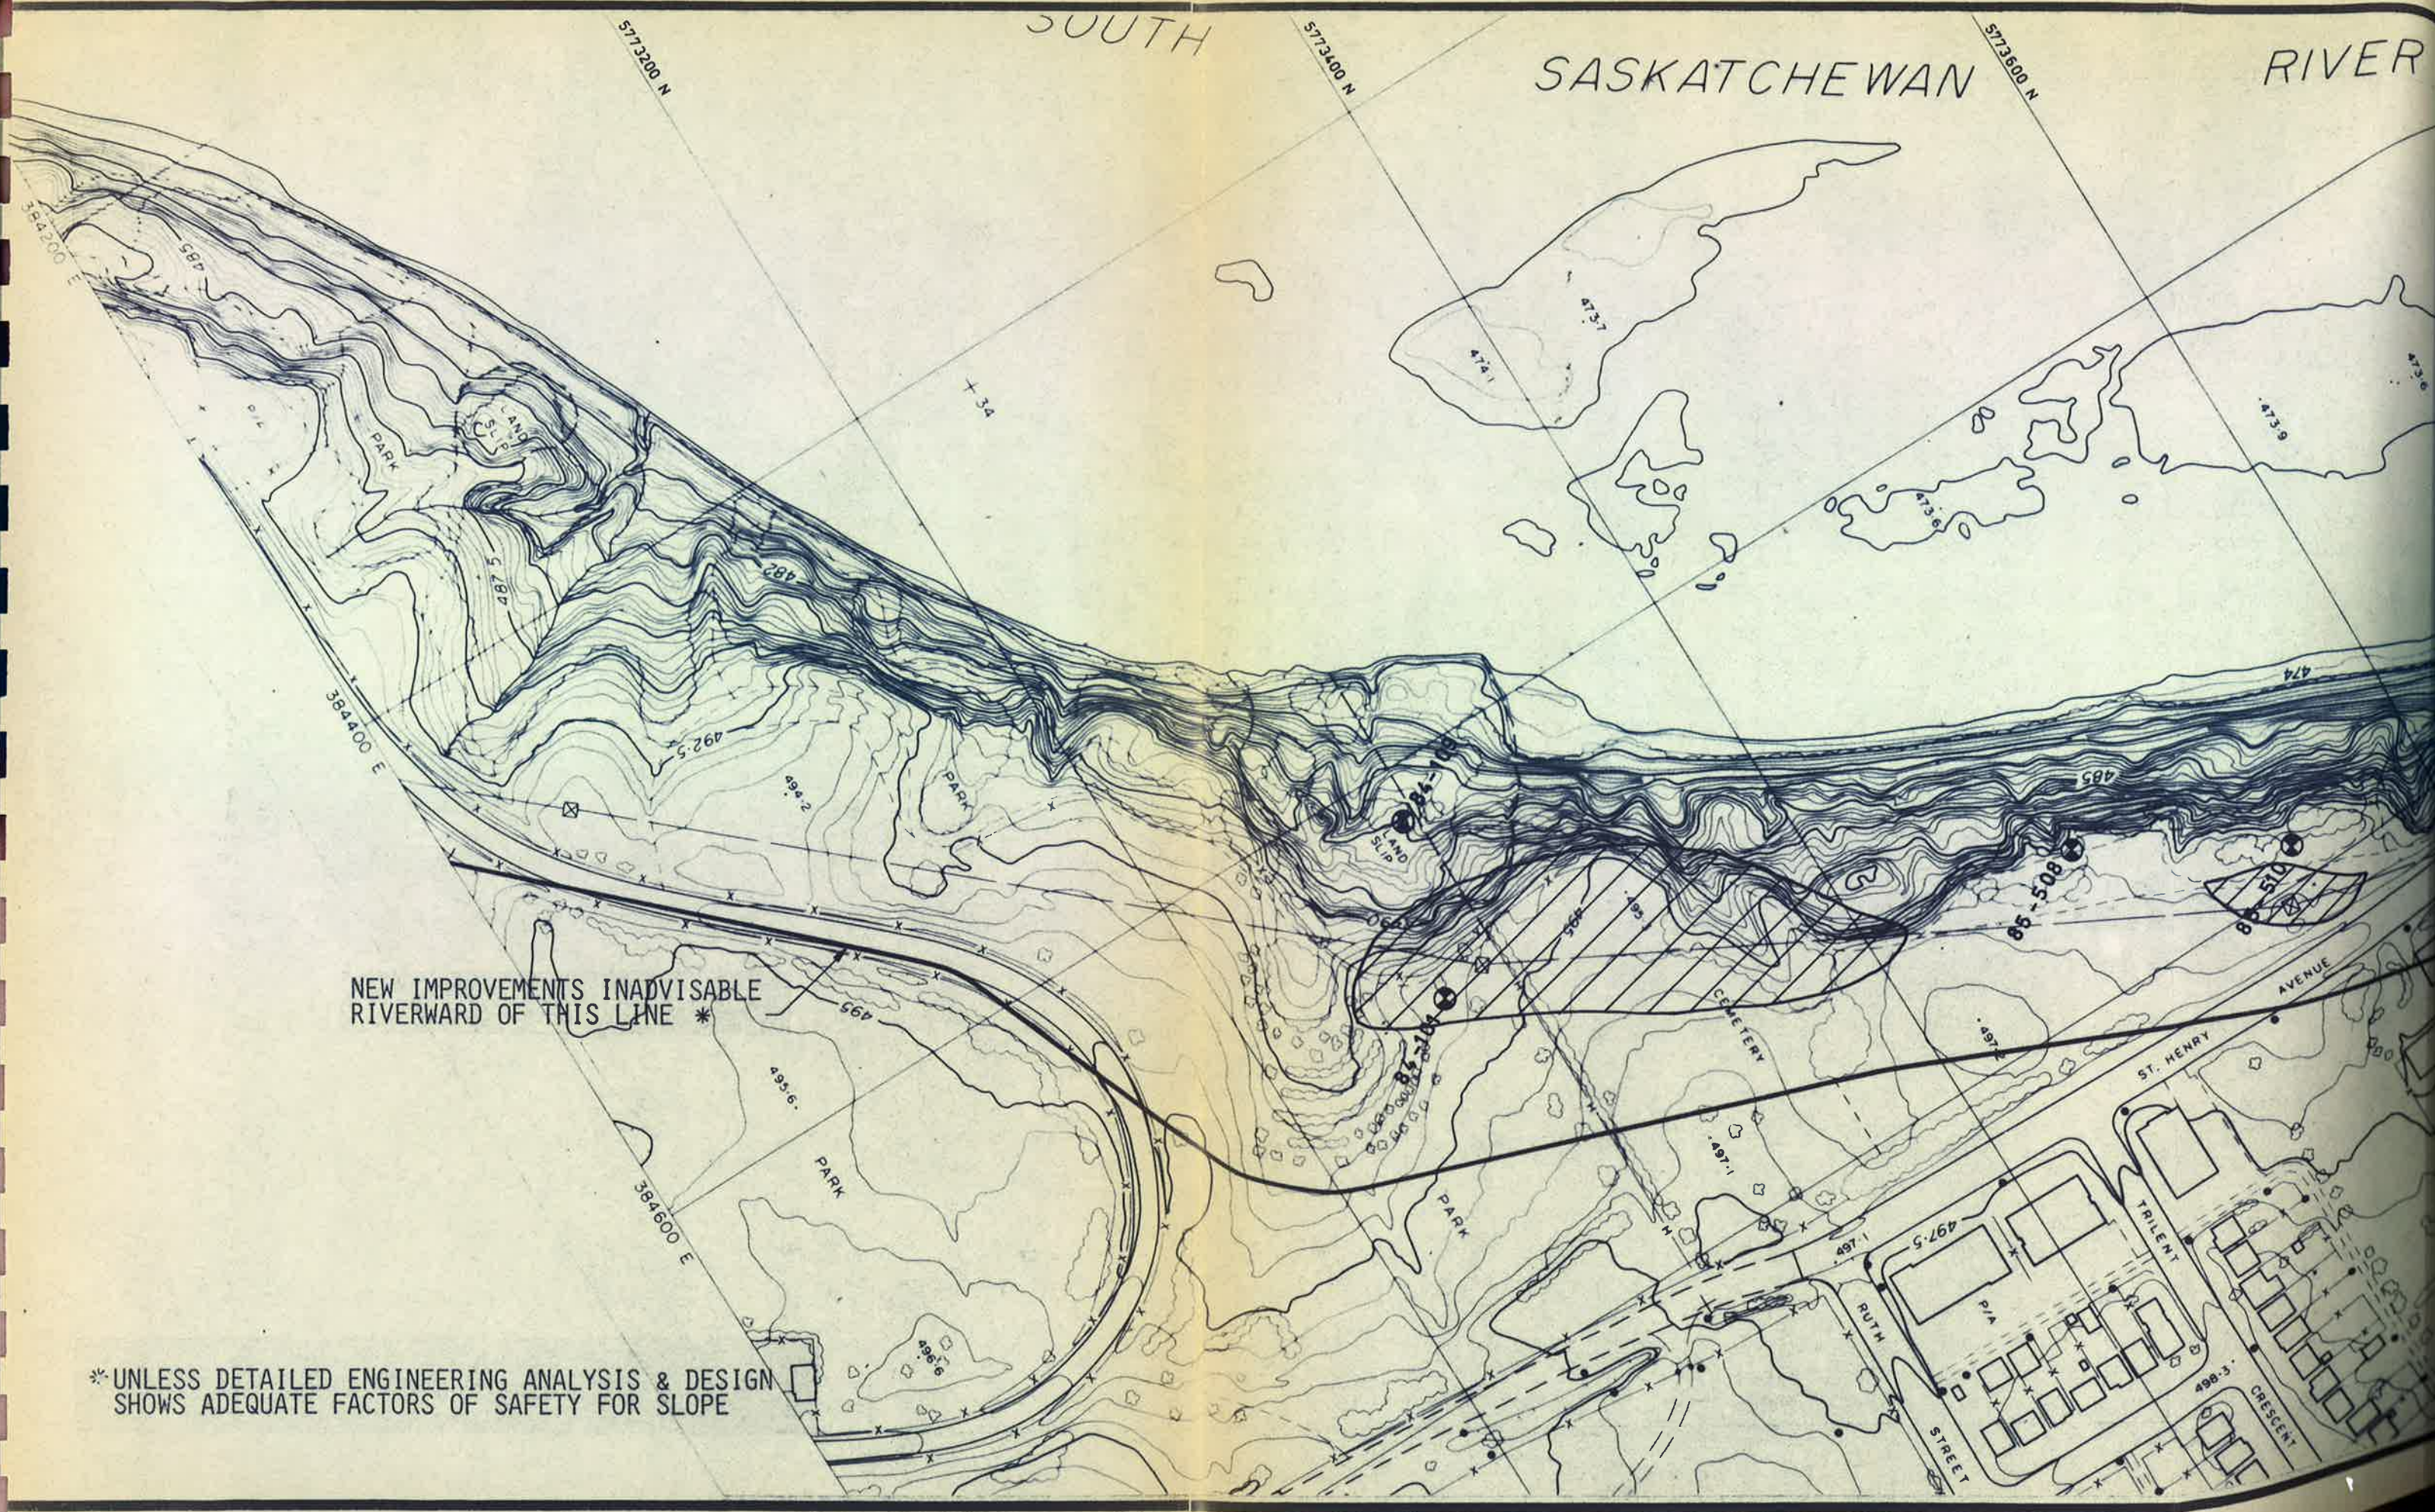
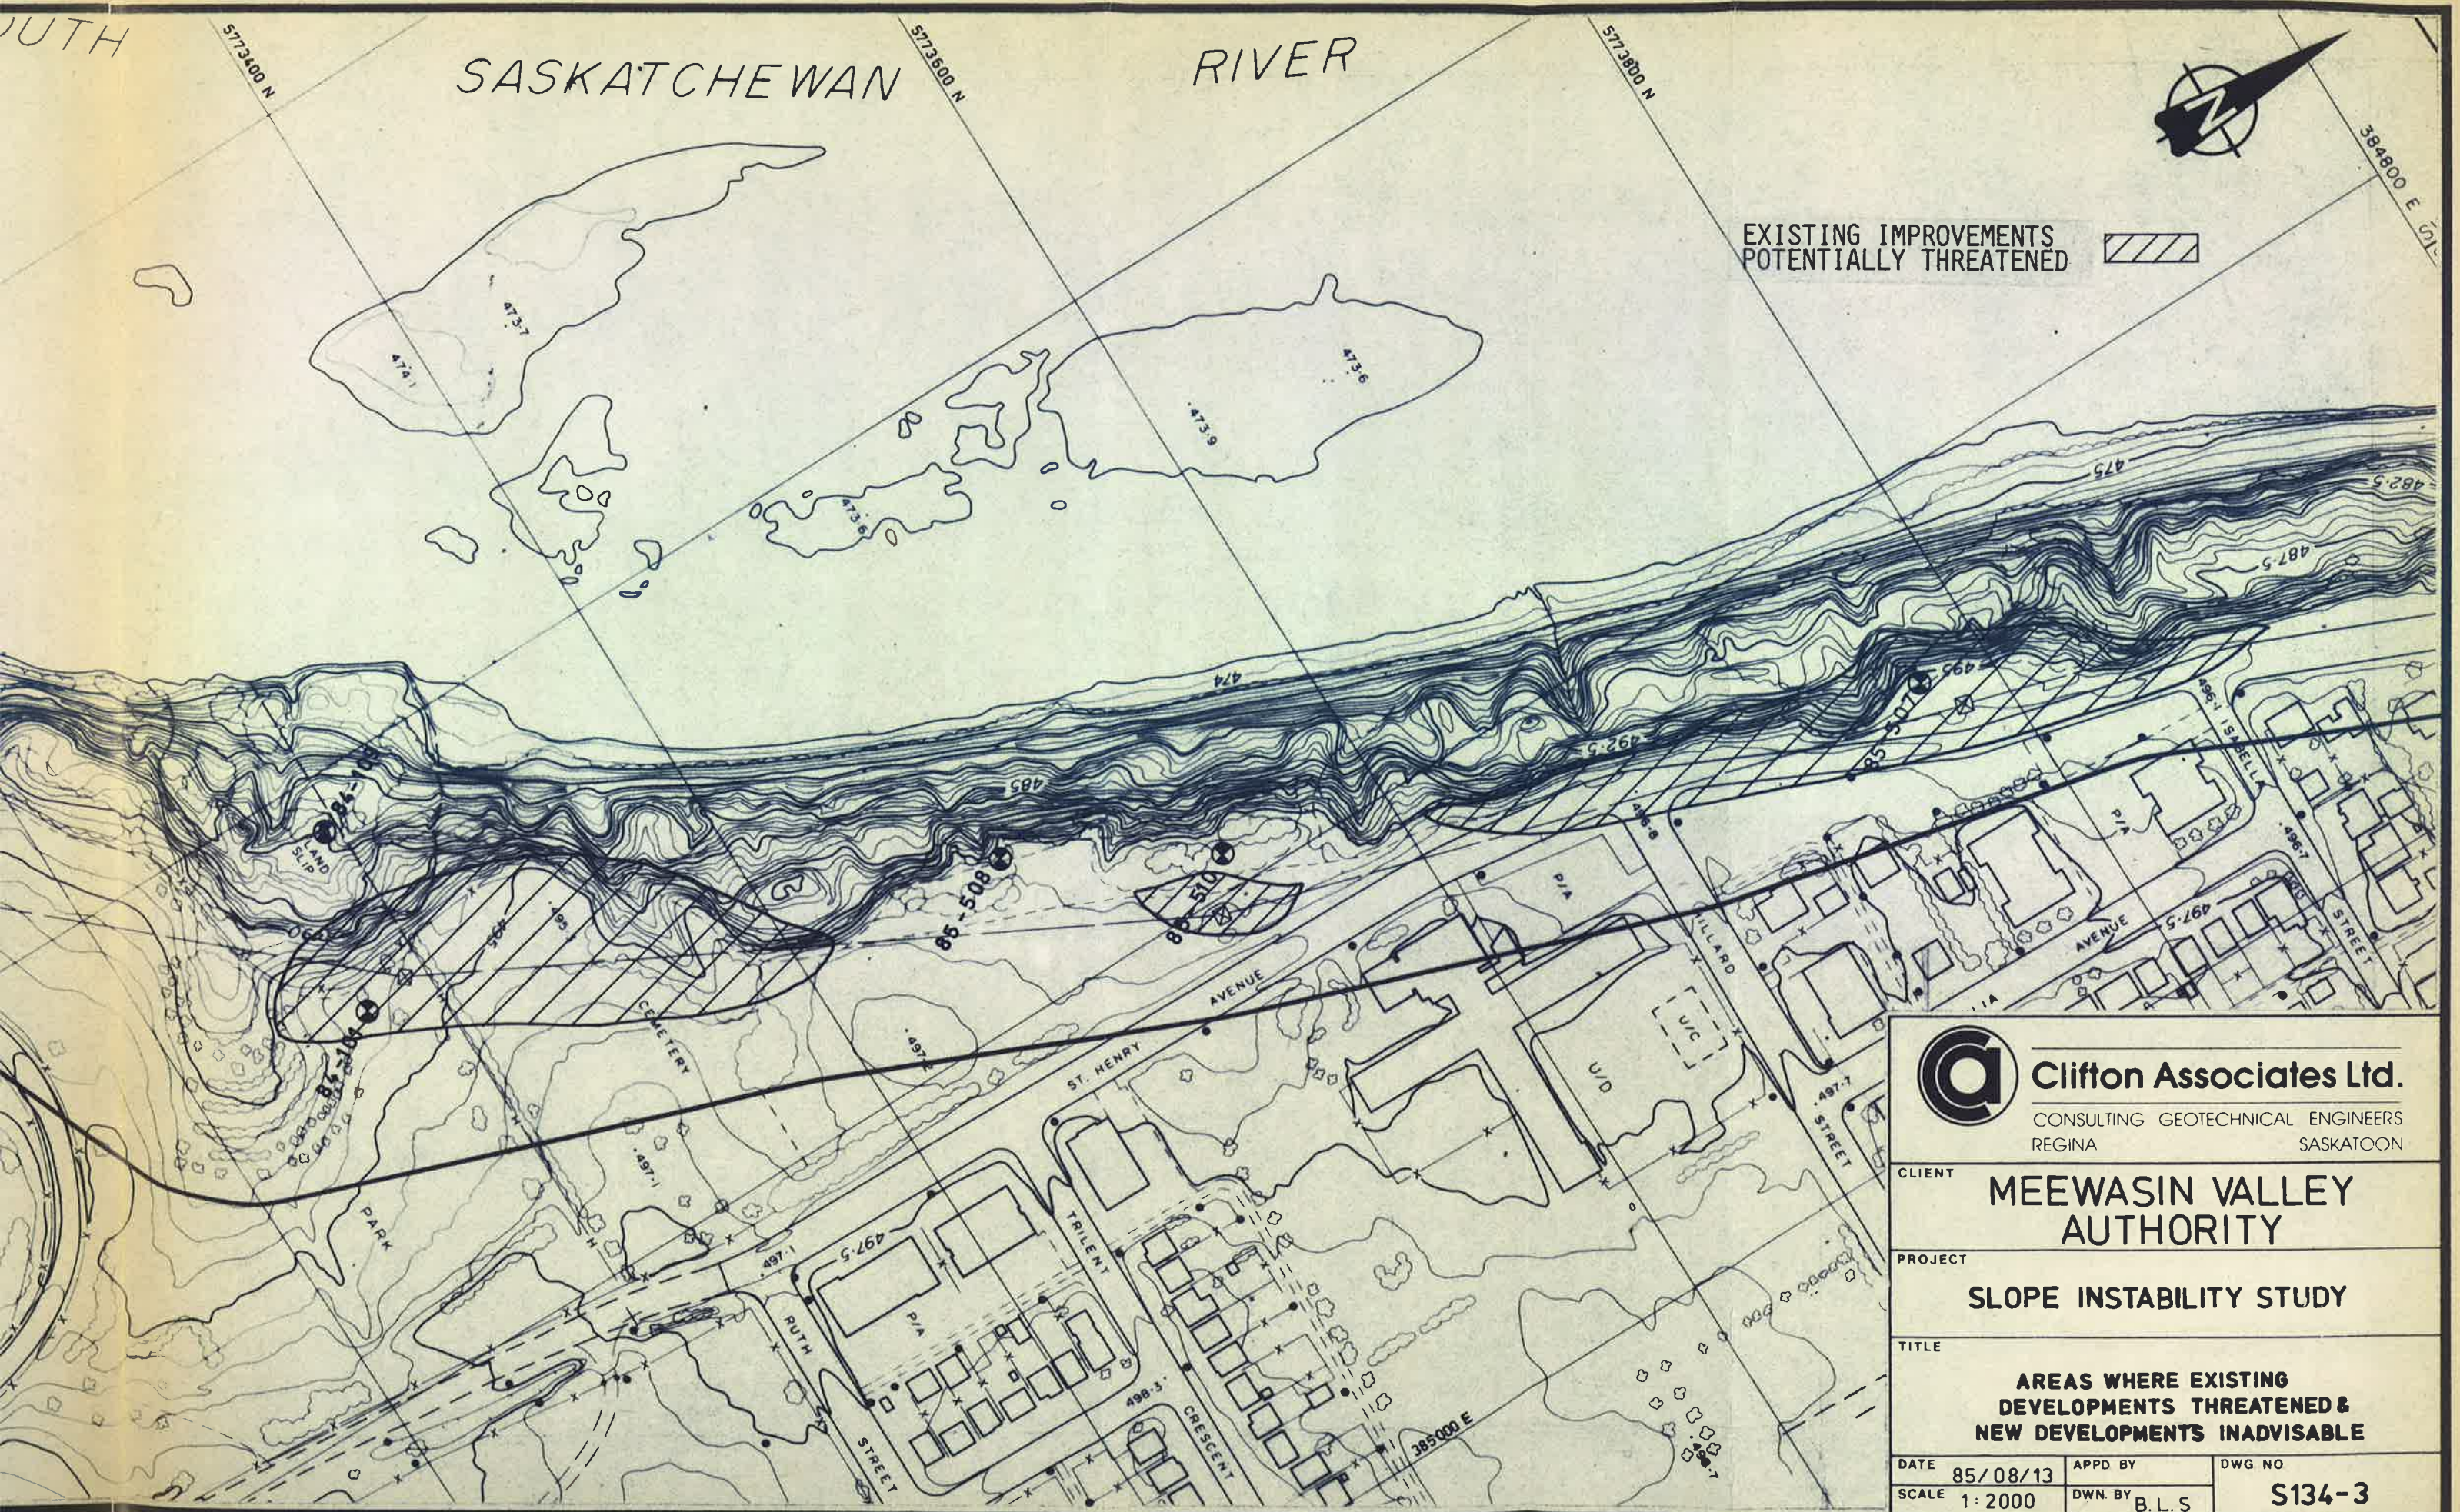
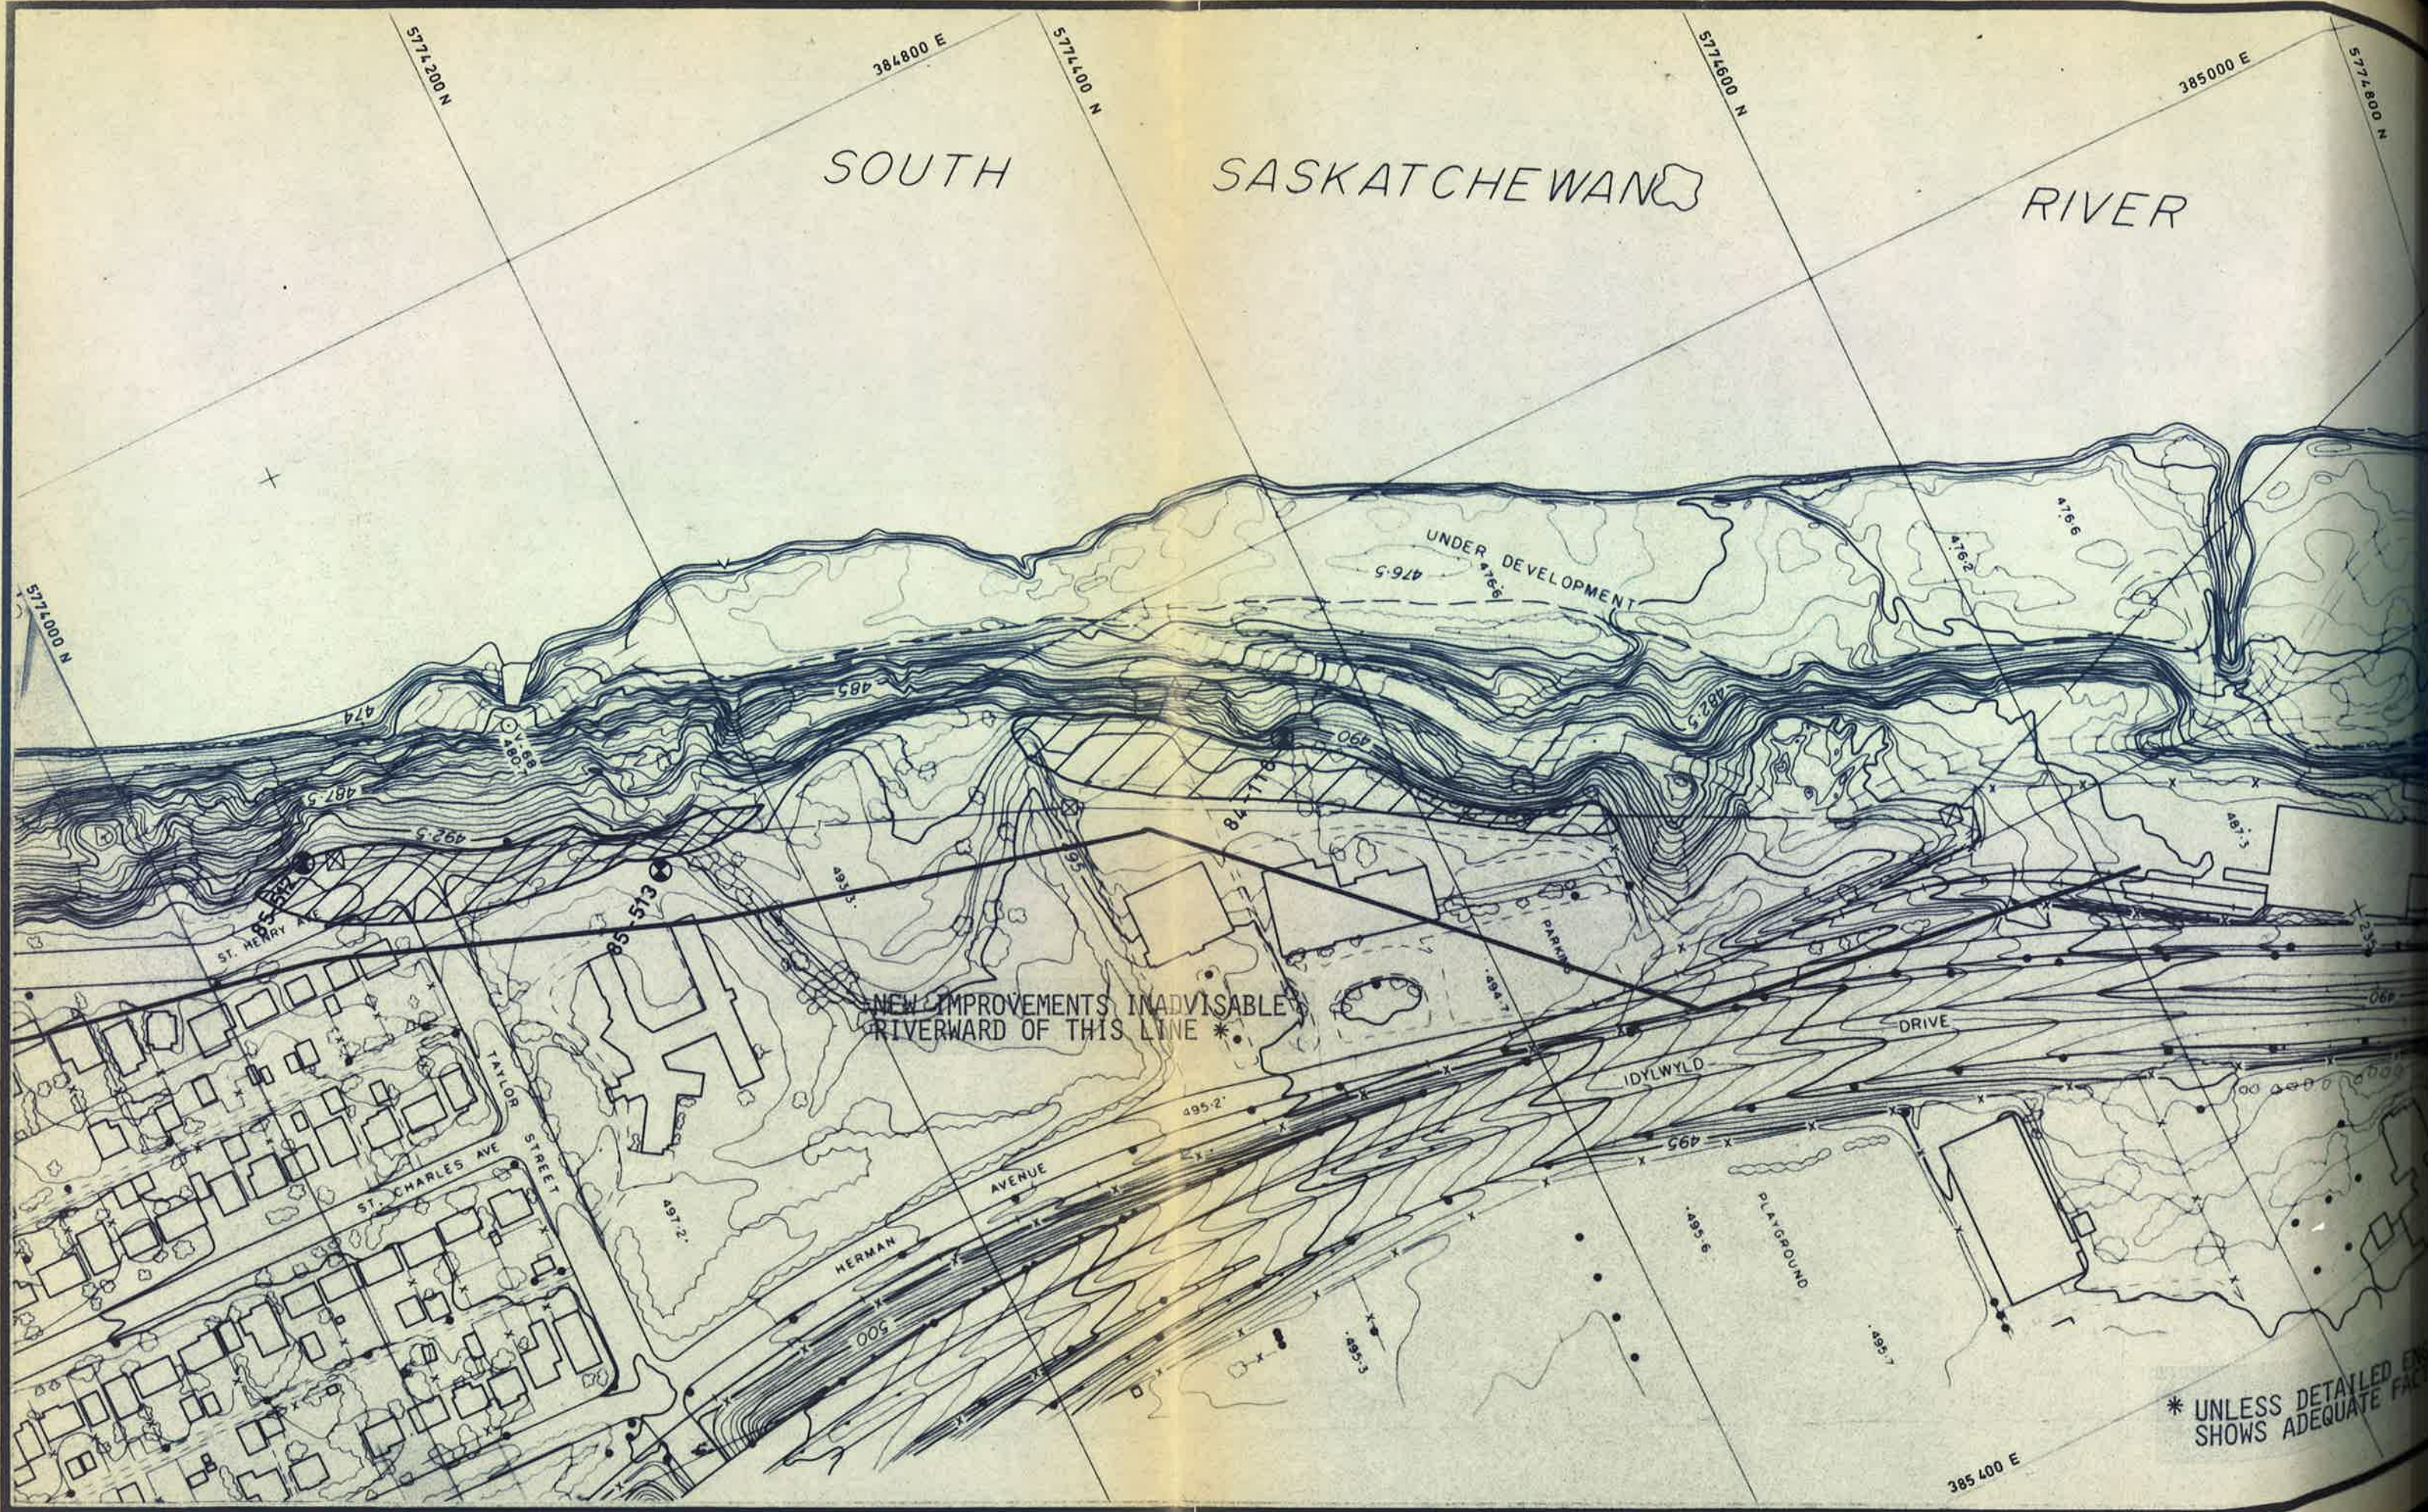
DATE 85/08/13	APPD BY	DWG NO.
SCALE 1:2000	DWN BY B.L.S	<b>S134-4</b>

TITLE **AREAS WHERE EXISTING  
DEVELOPMENTS THREATENED &  
NEW DEVELOPMENTS INADVISABLE**
