SLOPE INSTABILITY STUDY  
SOUTH SASKATCHEWAN RIVER BANKS  
SASKATOON, SASKATCHEWAN

MEEWASIN VALLEY AUTHORITY

FINAL REPORT

23 DECEMBER 1985

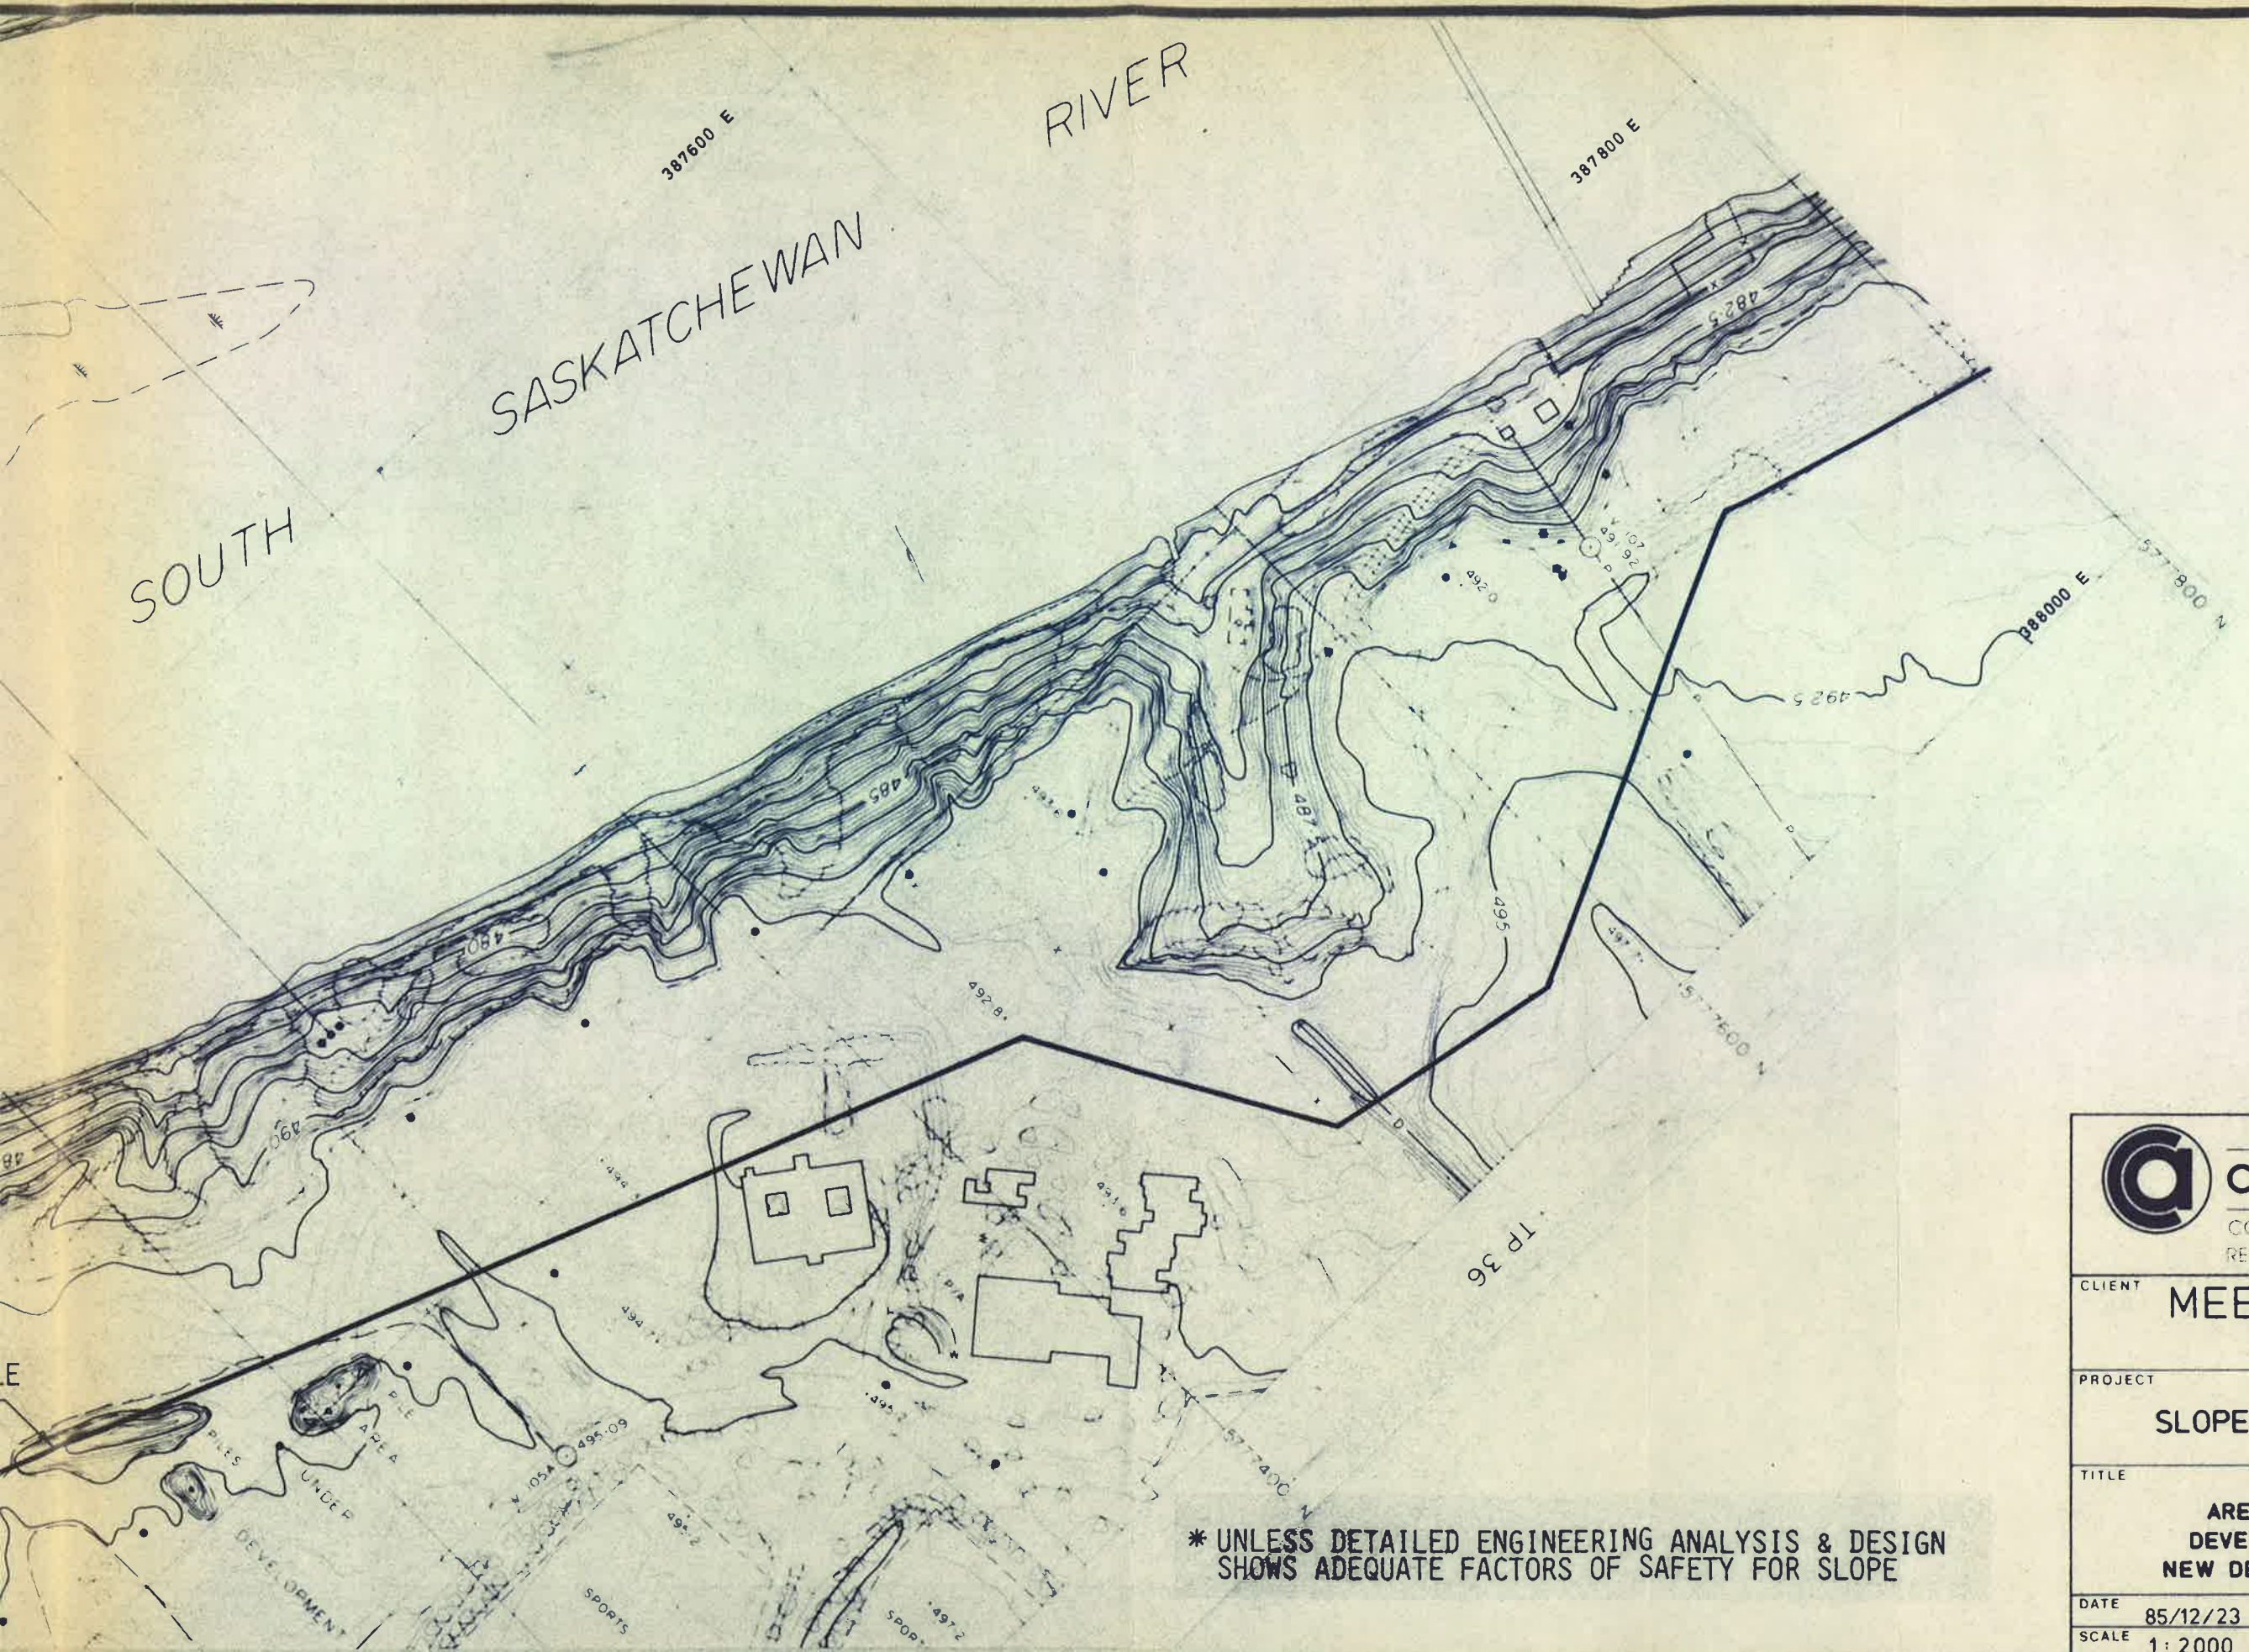
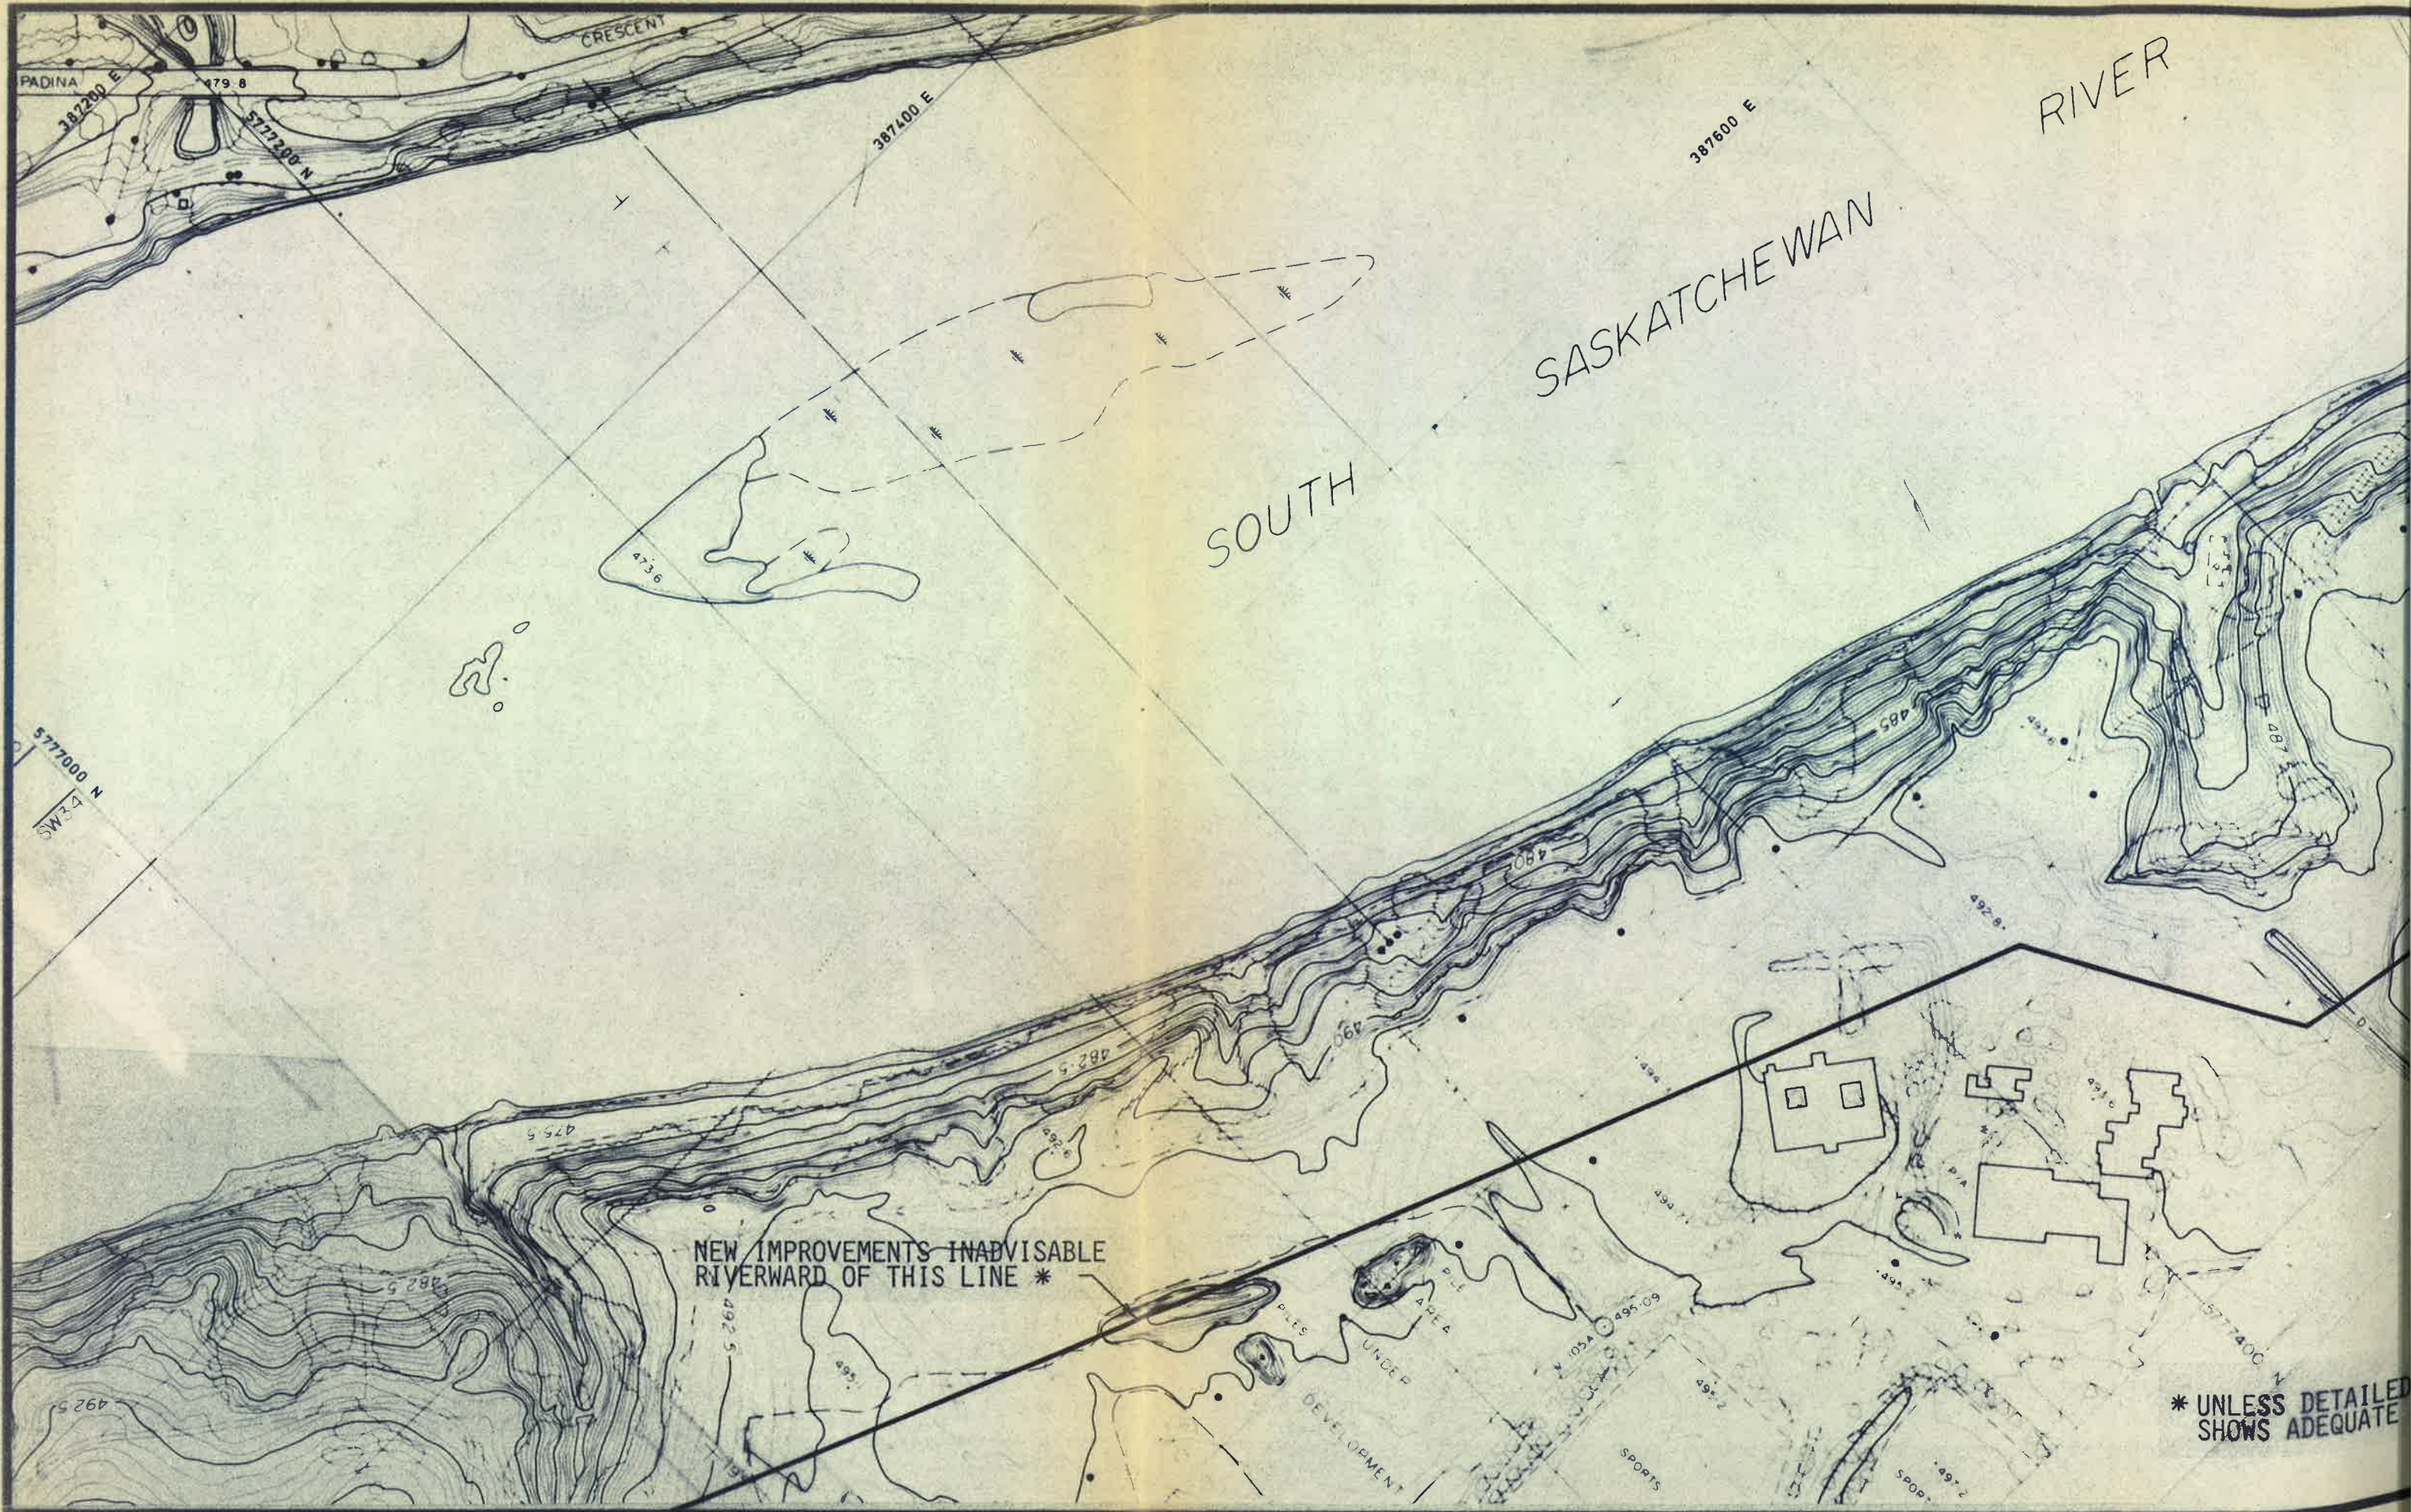
<b>Clifton Associates Ltd.</b> CONSULTING GEOTECHNICAL ENGINEERS REGINA SASKATOON		
CLIENT	MEEWASIN VALLEY AUTHORITY	
PROJECT	SLOPE INSTABILITY STUDY	
TITLE	AREAS WHERE EXISTING DEVELOPMENTS THREATENED & NEW DEVELOPMENTS INADVISABLE	
DATE	85/12/23	APPD BY
SCALE	1:2000	DWN BY
		DWG. NO. S134-7

\* UNLESS DETAILED ENGINEERING ANALYSIS & DESIGN SHOWS ADEQUATE FACTORS OF SAFETY FOR SLOPE

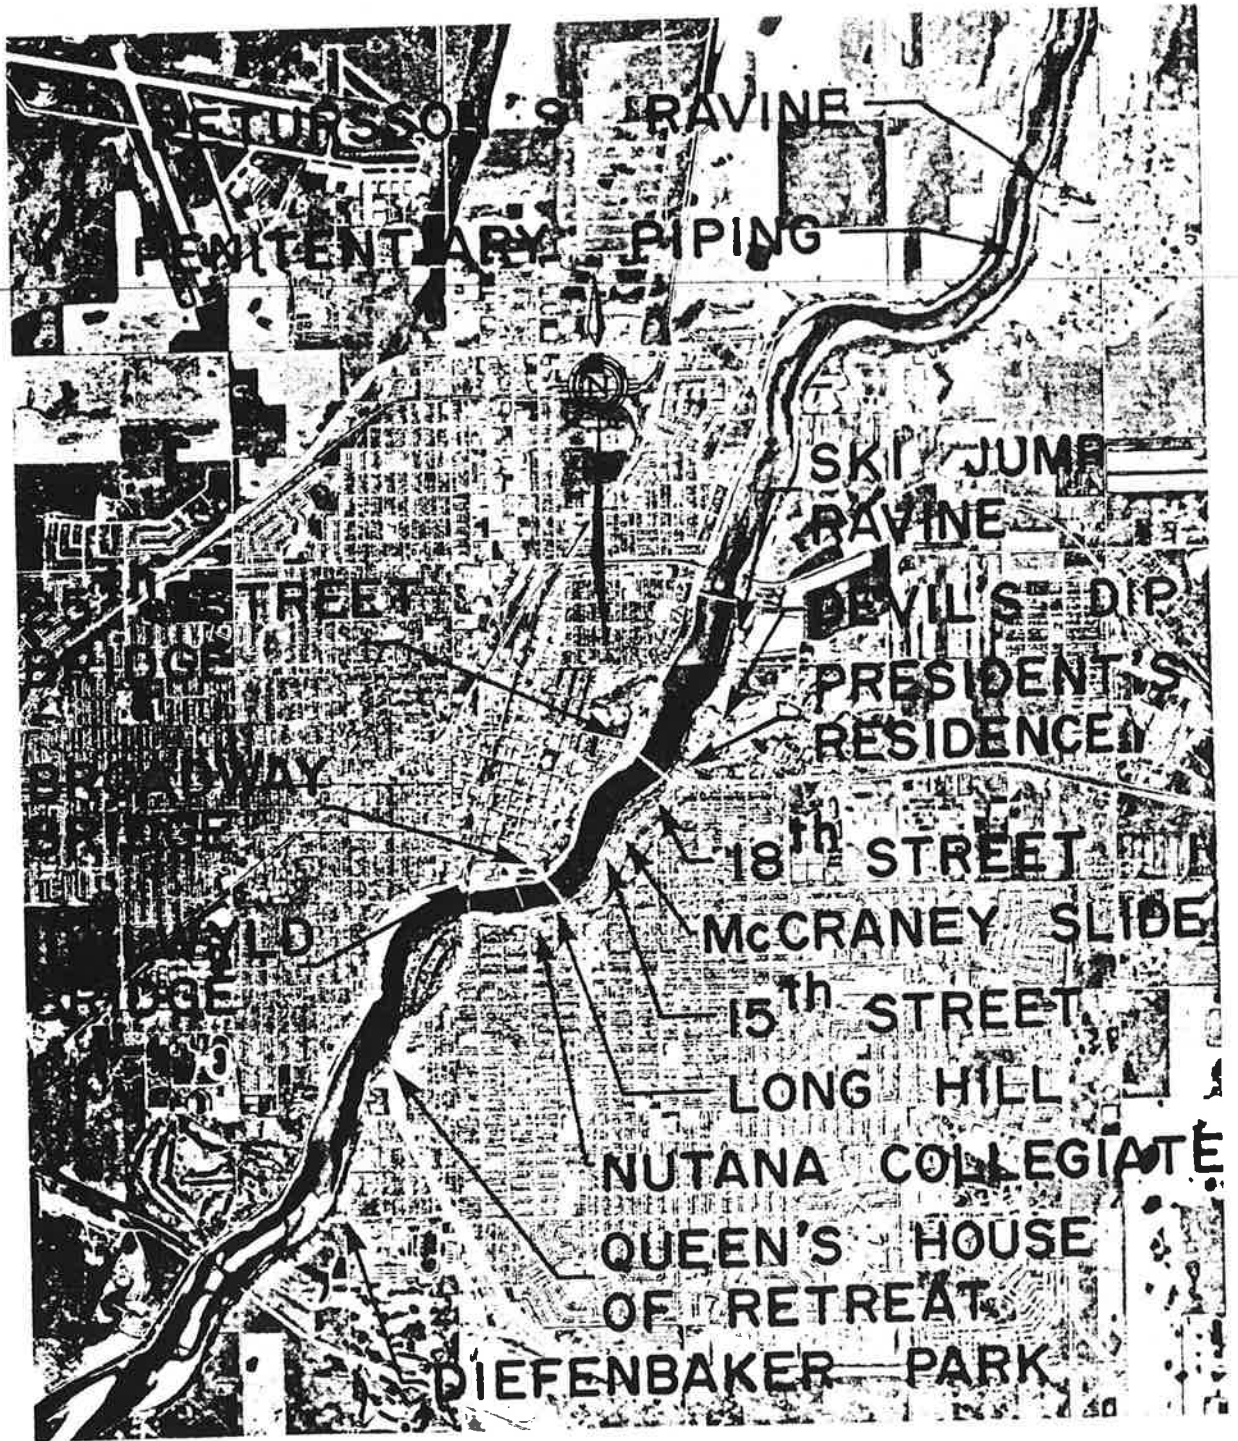
FIGURE C1

1970 - 1972      Slope movements threatened a portion of  
the President's Residence  
Remedial work included reduction of  
watering and underpinning the structure

**RAVINE DRIVE**      Shallow slope movements following  
construction of a road cut

SLOPE INSTABILITY LOCATIONS IN SASKATOON
