CHERRY LANE SLOPE MOVEMENT, SASKATOON, SK

Geotechnical Investigation and Evaluation of Conceptual Remedial Options

Report Number: 11-1362-0057/5100

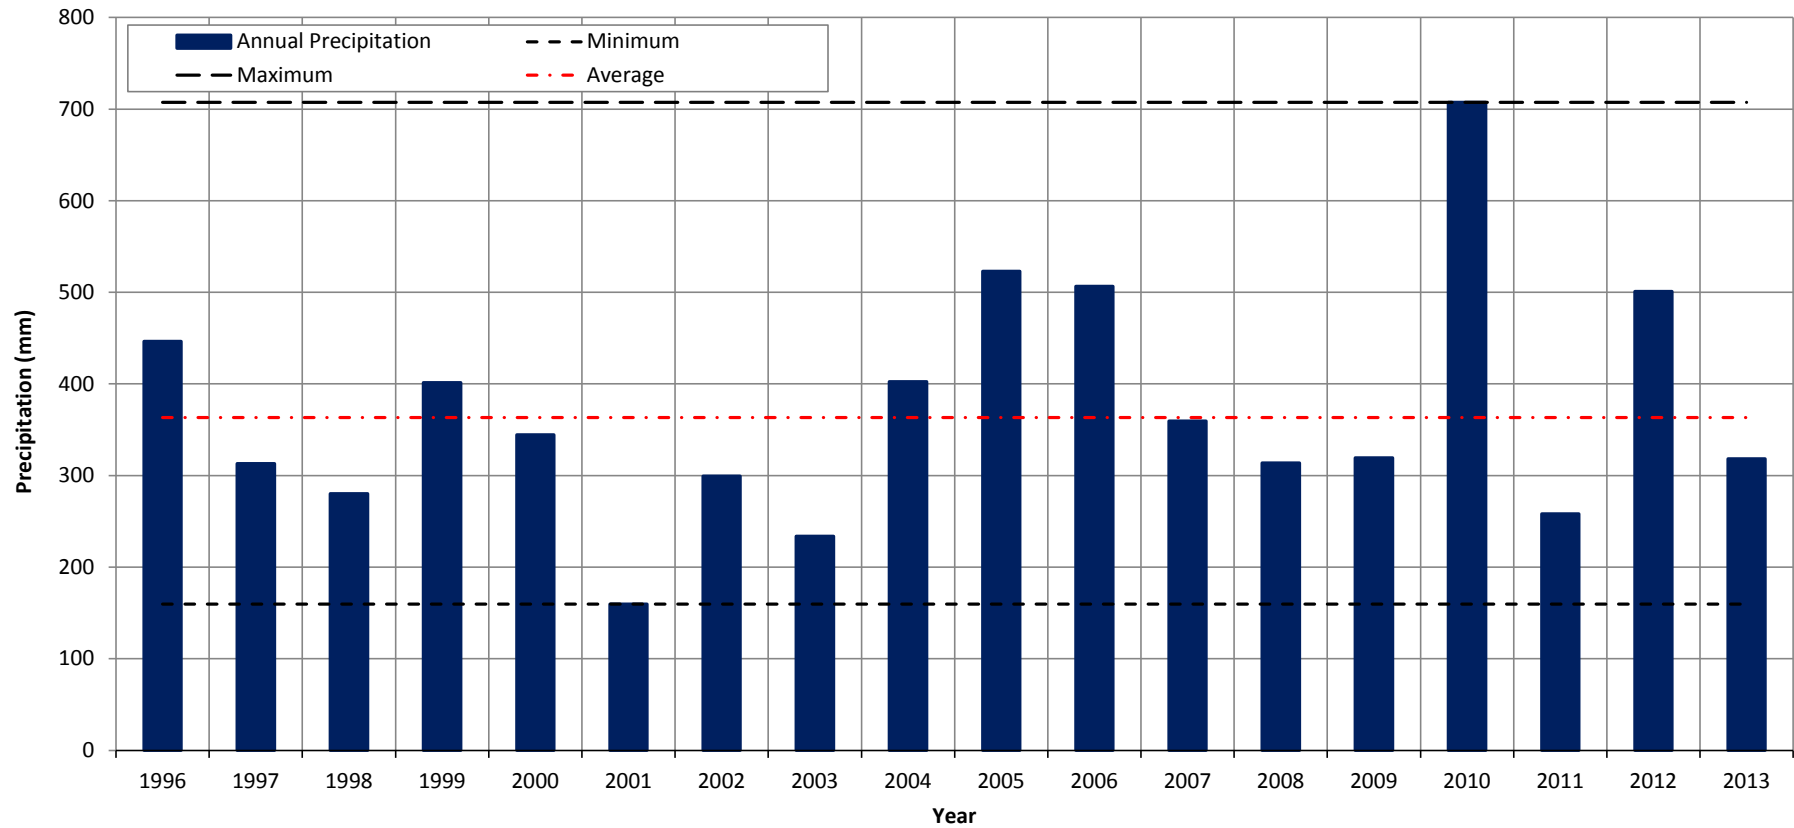
PROJECT 11-1362-0057 DESIGN LNM 08/05/14 CADD CHECK PGB 08/05/14 REVIEW HQV 08/05/14	FILE No. SCALE N/A REV.
			FIGURE: 3

Saskatoon has experienced a wet cycle over the past ten years. Following a severe drought from 1997-2003, precipitation was above average between 2004 and 2006 (Figure 3) with 2005 and 2006 being the fourth and fifth wettest years on record, respectively. Although precipitation was below average between 2007 and 2009, the wettest year on record occurred in 2010 when 708 mm fell, almost double the historic average. High precipitation in 2010 created the antecedent conditions that led to flooding throughout the Prairie Provinces during 2011.

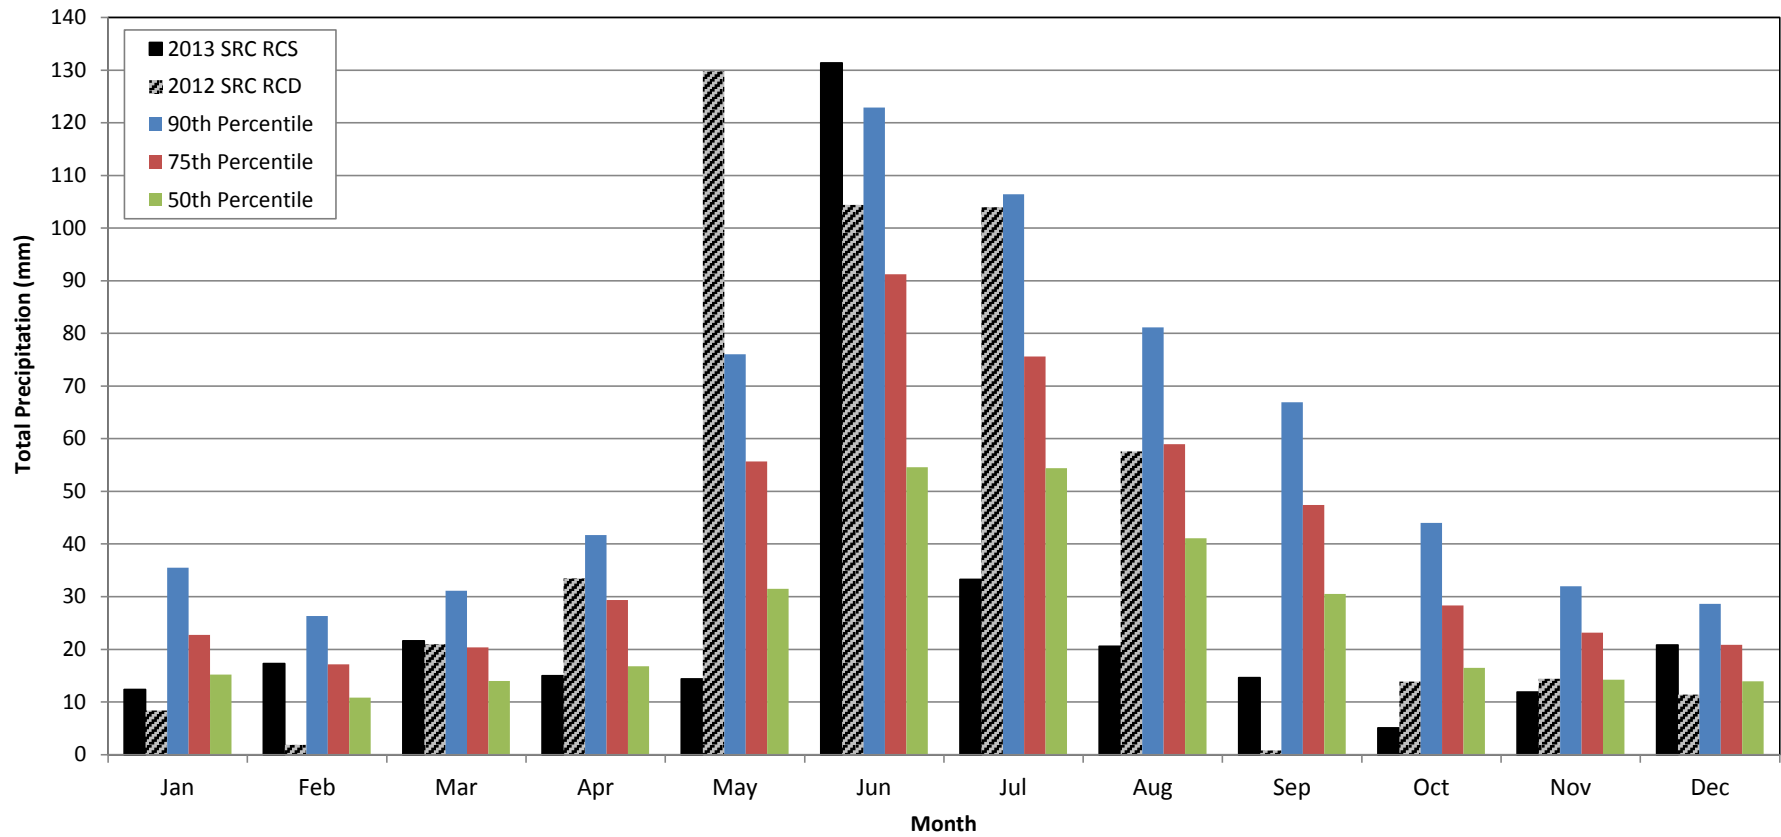
CHERRY LANE SLOPE INSTABILITY	
TITLE SASKATOON AREA TOTAL PRECIPITATION (1908 - 2013)			
		PROJECT 11-1362-0057 DESIGN LNM 08/05/14 CADD CHECK PGB 08/05/14 REVIEW HQV 08/05/14	FILE No. SCALE N/A REV.
FIGURE: 4

Although low through the winter of 2011-2012, precipitation was above normal during the spring and summer of 2012, particularly May and June (Figure 4). Several rain events between 10 and 25 mm led to a total precipitation of 129.8 mm in May 2012, making it the third wettest year observed between 1908 and 2012 and more than three times the median value of 31.5 mm: 69.6 mm of rain fell in the first week of May with 61.2 mm concentrated on May 5 and 6, 2012. On May 22 and 23, 2012, 33.6 mm of rain fell.

Rainfall in June 2012 was 104.4 mm, making it almost twice the median June precipitation of 54.6 mm (Figure 4). Sustained daily rainfall between June 9 and June 19, 2012 amounted to 81mm with 47.6 mm concentrated on June 9 and 10, 2012 (Figure 5). An additional 18.6 mm fell between June 24 and June 27, 2012.

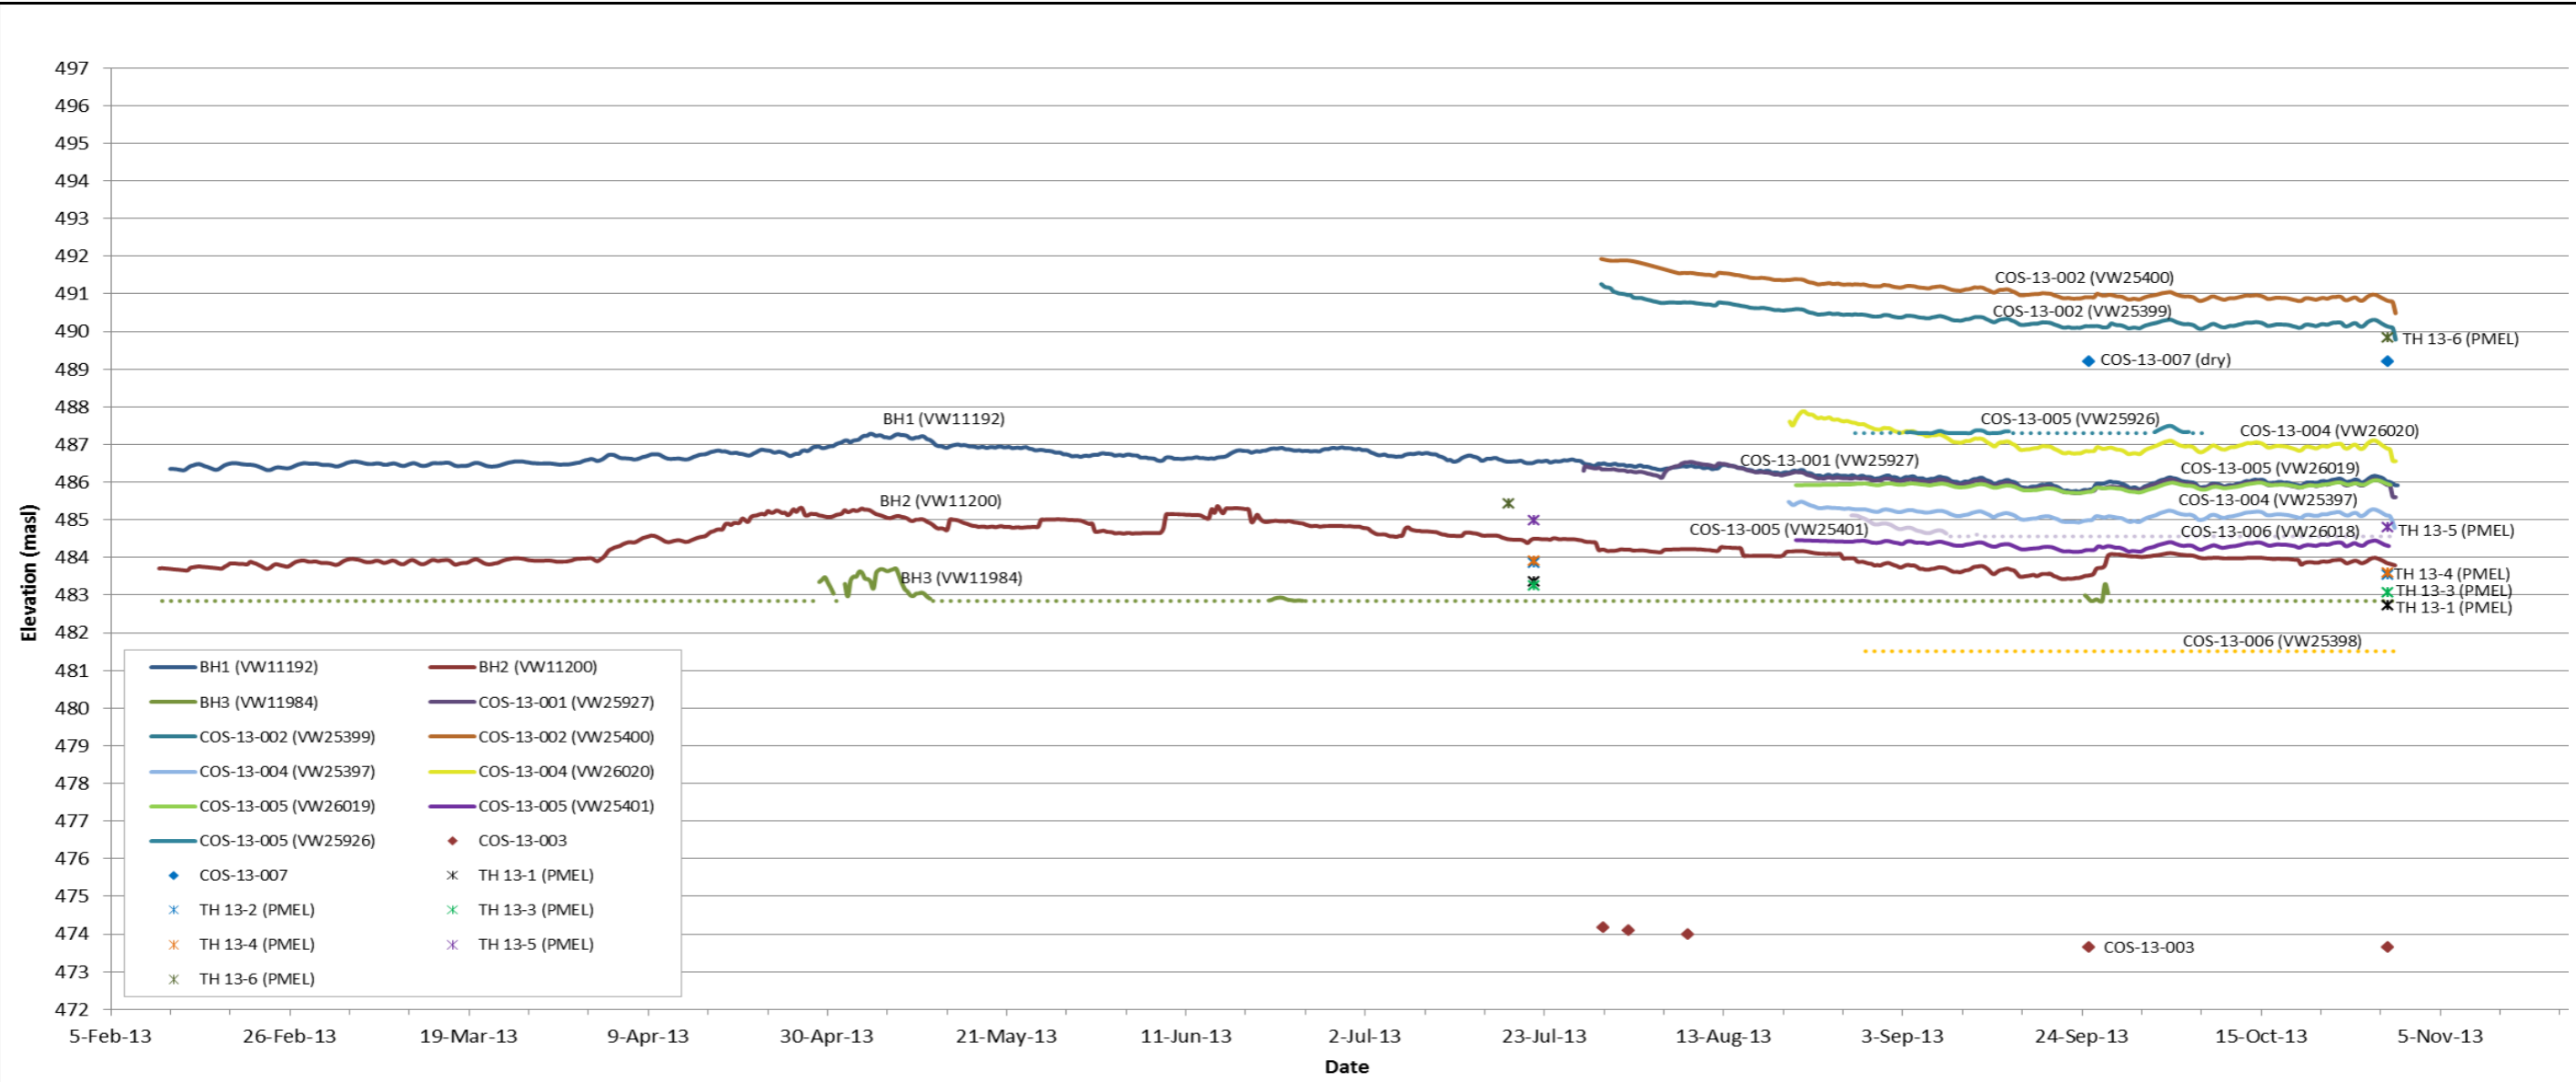
CHERRY LANE SLOPE INSTABILITY	
MONITORED PIEZOMETRIC LEVELS (2012-2013)			
	PROJECT	11-1362-0057	FILE No.
	DESIGN	LNK 08/05/14	SCALE N/A
	CADD		REV.
	CHECK	PGB 08/05/14	FIGURE: 17
REVIEW	HQV 08/05/14

- High groundwater levels recorded at borehole 11-1362-0057 BH2 were 485.3 masl (about 0.6 mbgs) and 485.4 masl (about 0.5 mbgs), recorded on April 27 and June 14, 2013, respectively.

- The highest groundwater level recorded in borehole 11-1362-0057 BH3 was 483.7 masl (about 0.4 mbgs) on May 8, 2013.
- Groundwater levels recorded at 11-0057 BH1 and BH2 started to decrease early in July 2013.

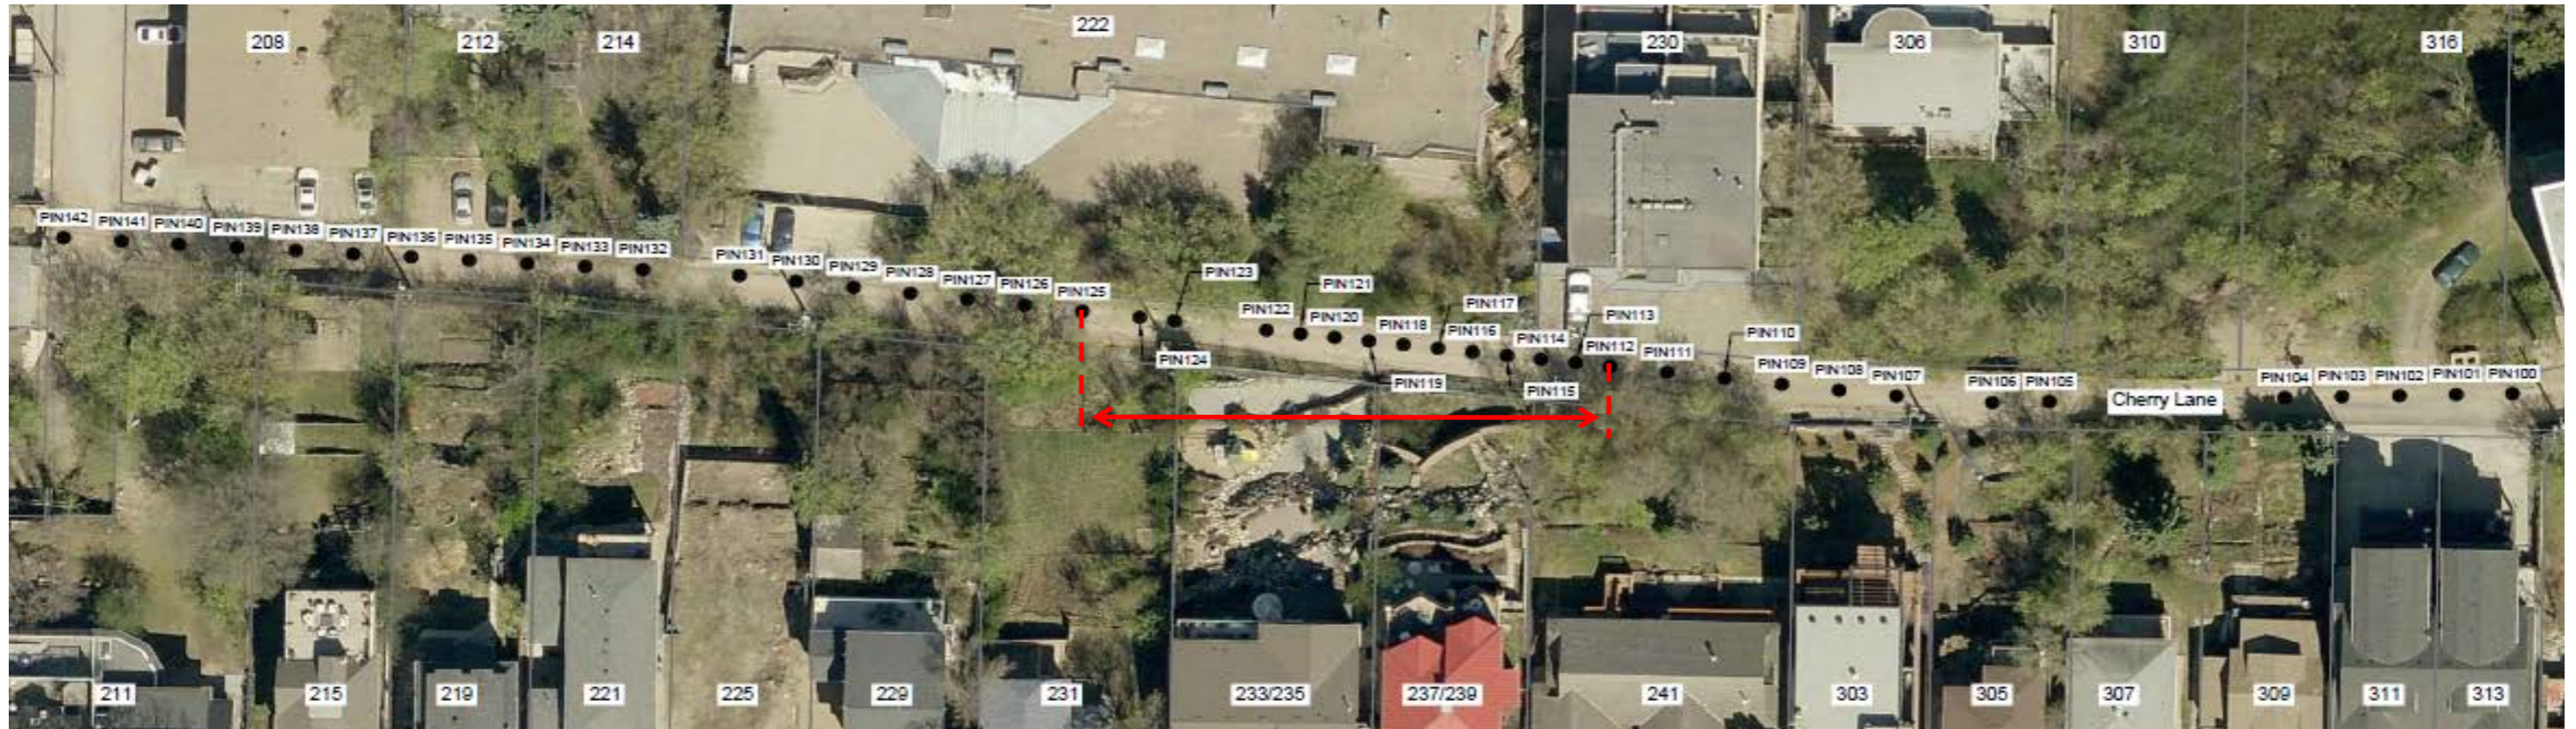
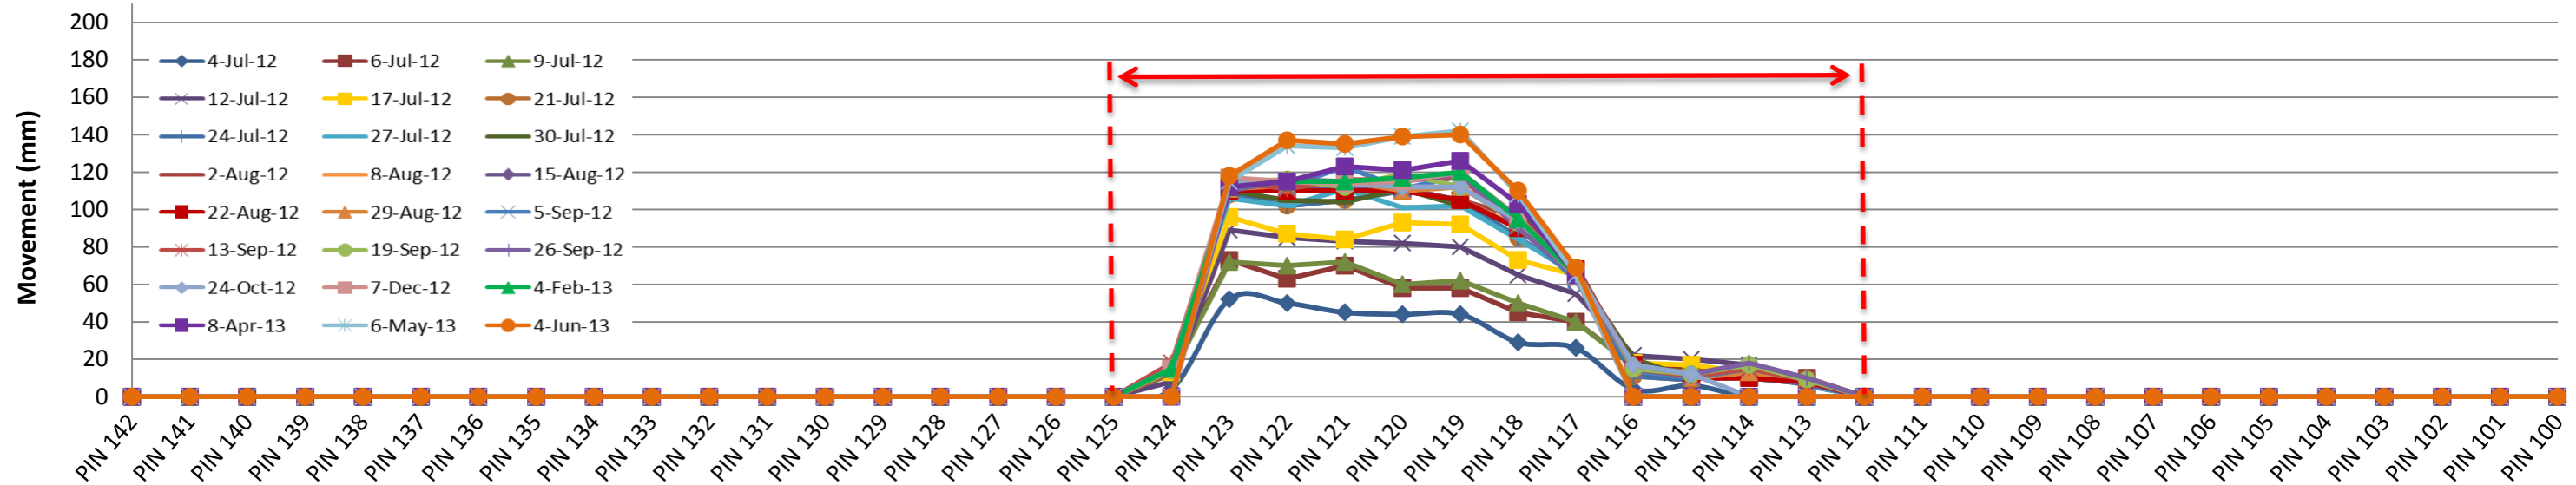
CHERRY LANE SLOPE INSTABILITY	
HORIZONTAL SLOPE MOVEMENT, 100 SERIES PINS (June 28, 2012 to June 4, 2013)			
	PROJECT	11-1362-0057	FILE No.
	DESIGN	LNK 08/05/14	SCALE N/A
	CADD		REV.
	CHECK	HQV 08/05/14	
	REVIEW	PGB 08/05/14	
			FIGURE: 20

Survey Pins 100 to 142 (Figure 9) were installed on June 28, 2012, along Cherry Lane at approximately 5 m intervals, to monitor the slope movement along the lane using a survey line. This series of pins was surveyed from July 4, 2012 to June 4, 2013. Horizontal movement of this series of survey pins was monitored every third day from June 28 to August 2, 2012; the rate of movement then reduced, and the frequency of monitoring was reduced to weekly. Cumulative horizontal movements and rates of movement between June 28, 2012 and June 4, 2013 are shown in Figure 20 and Figure 21, respectively.

Figure 22 presents the results of GPS survey of the 100 series pins between June 28, 2012 and June 27, 2013 for the Cherry Lane at the East Failure. The results show 765 mm of horizontal movement for Pin 106, 555 mm for Pin 107, and 366 mm for Pin 108. Most of these movements occurred in June 2013 because less than 5 mm of movement was measured by line survey for this location up to June 4, 2013 (Figure 20).

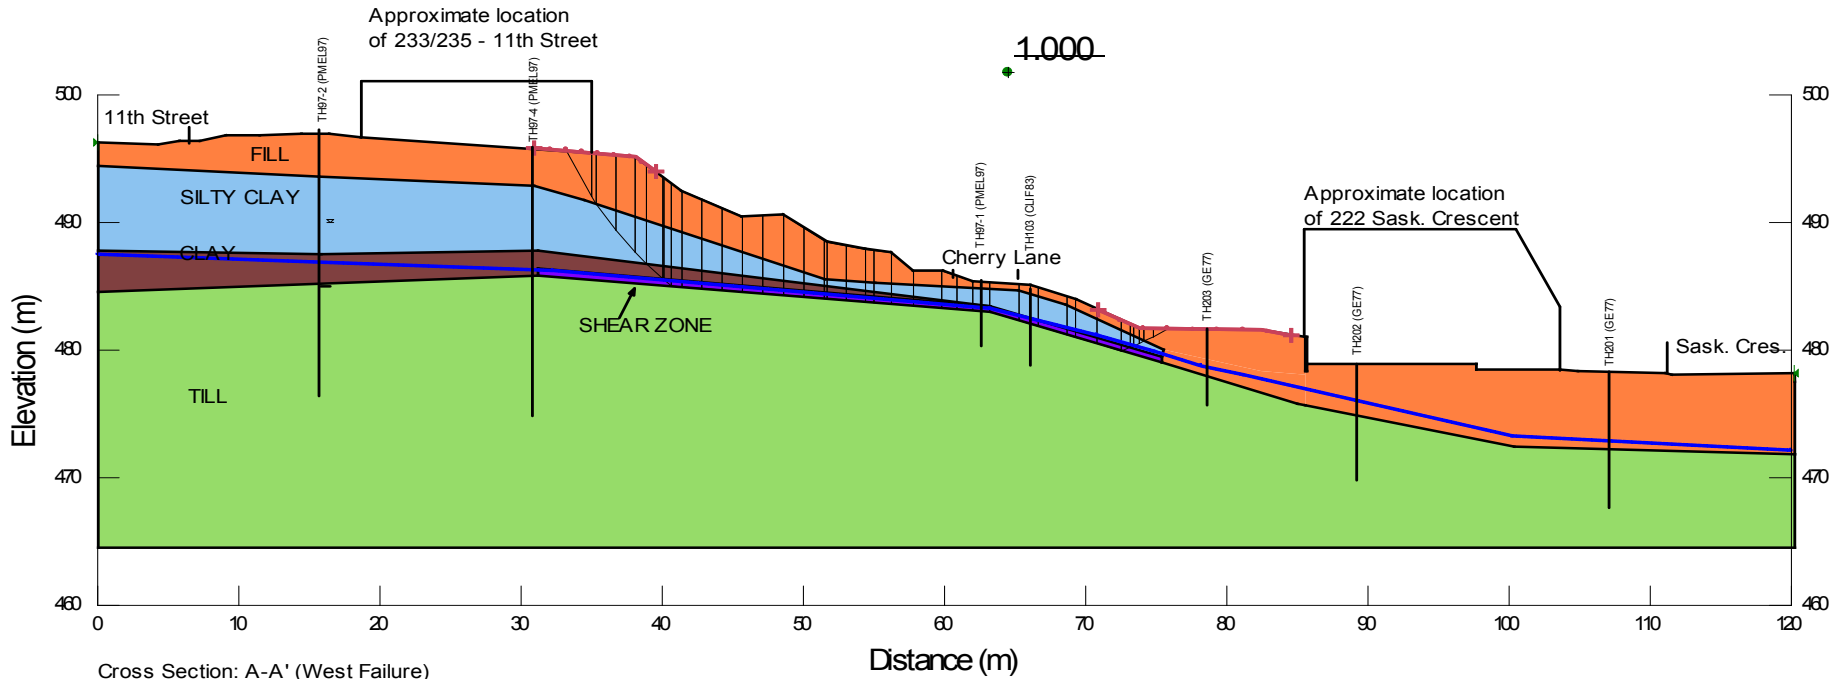
CHERRY LANE SLOPE INSTABILITY	
BACK ANALYSIS - CROSS SECTION A-A' WEST FAILURE			
	PROJECT	11-1362-0057	FILE No.
	DESIGN	LNLM 08/05/14	SCALE N/A REV.
	CADD	HQV 08/05/14	FIGURE: 26
	REVIEW	PGB 08/05/14

As the slope has already failed, a stability back-analysis can be conducted. The back-analysis method models the geometry, soil, and groundwater conditions at failure, indicated by a factor of safety (FS) of 1.0. Back-analysis is shown in Figure 26 for the West Failure and Figure 27 for the East Failure.

Cross-sections A-A and B-B were selected as the primary section for analysis for the West Failure and East Failure, respectively. The location of the cross-sections is shown on Figure 2. Figure 12 and Figure 13 show the inferred stratigraphic soil profiles along each cross-section. Both the West Failure and East Failure were back-analysed to determine the residual (or large strain) shear strength parameters corresponding to failure or a FS of 1.0.

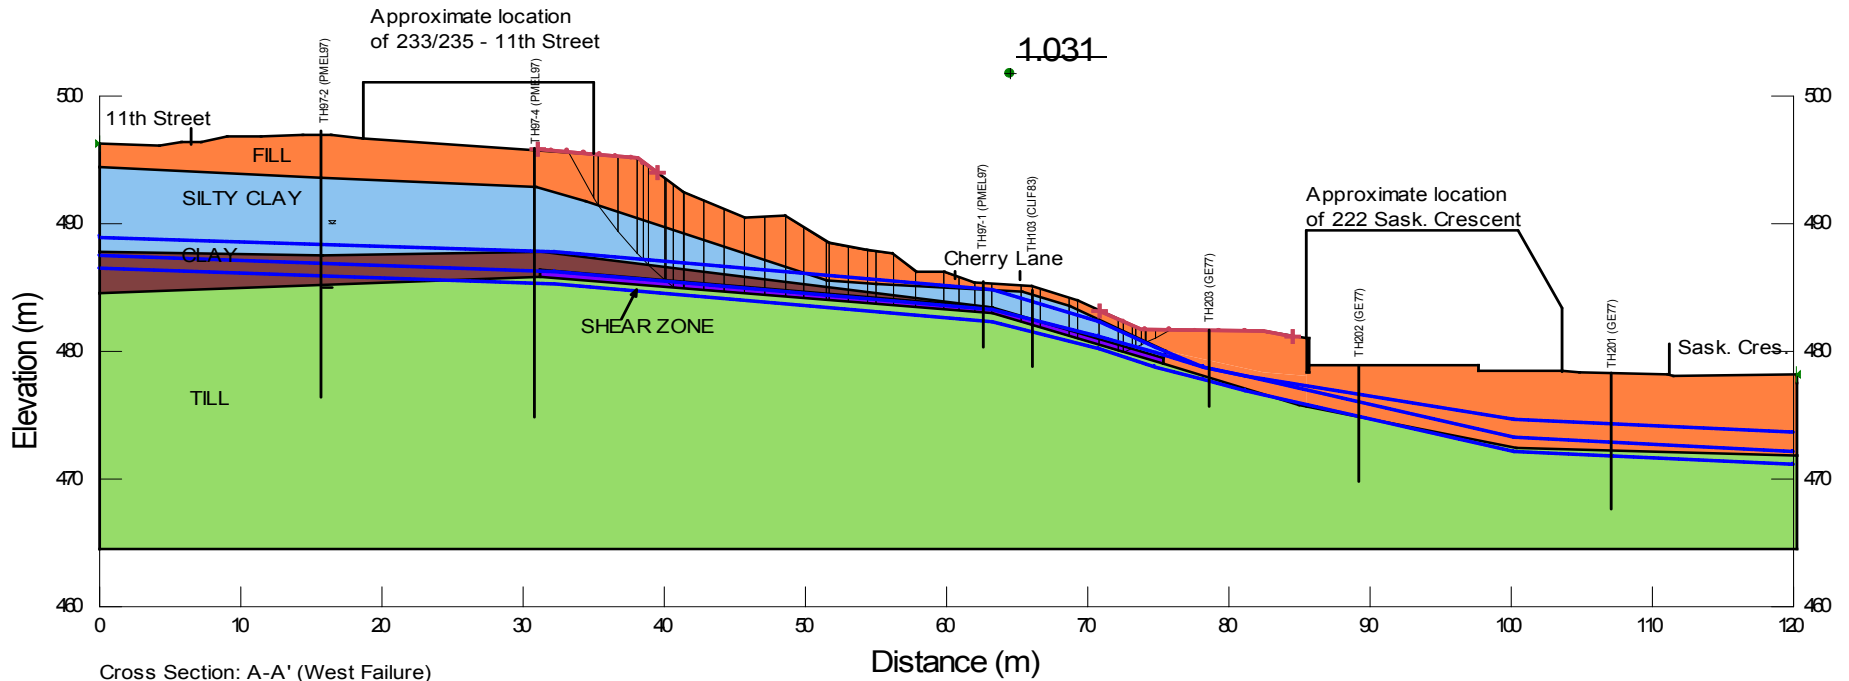
CHERRY LANE SLOPE INSTABILITY	
SLOPE STABILITY ANALYSIS CROSS SECTION A-A' DO NOTHING OPTION WITH LOW WATER TABLE			
	PROJECT	11-1362-0057	FILE No.
	DESIGN	LNLM 08/05/14	SCALE N/A REV.
	CADD	HQV 08/05/14	FIGURE: 28
	CHECK	PGB 08/05/14

The first remedial option considered was leaving the slope in its existing condition. Based on the slope stability analysis conducted, it is likely that the slope at the East and West Failure locations will continue to move, likely on a seasonal basis with higher rates of movement in the spring when groundwater levels in the area are high. Rates of movement are expected to be low in the winter months and in dry years where the groundwater table is at or near the contact surface between the glacial till and surficial stratified deposits. As noted in Sections 3.6 and 7.0, groundwater level fluctuations of up to 2 m during a year and up to 6 m in the long term are measured.

Figure 28 and Figure 29 show the stability analyses for the do nothing option, with the piezometric levels approximately 1 m lower than those used on the back-analysis to represent slope instability conditions. The calculated factors of safety are 1.03 and 1.09 for cross-sections A-A' and B-B', respectively, for the case where nothing is done other than lowering the groundwater table.

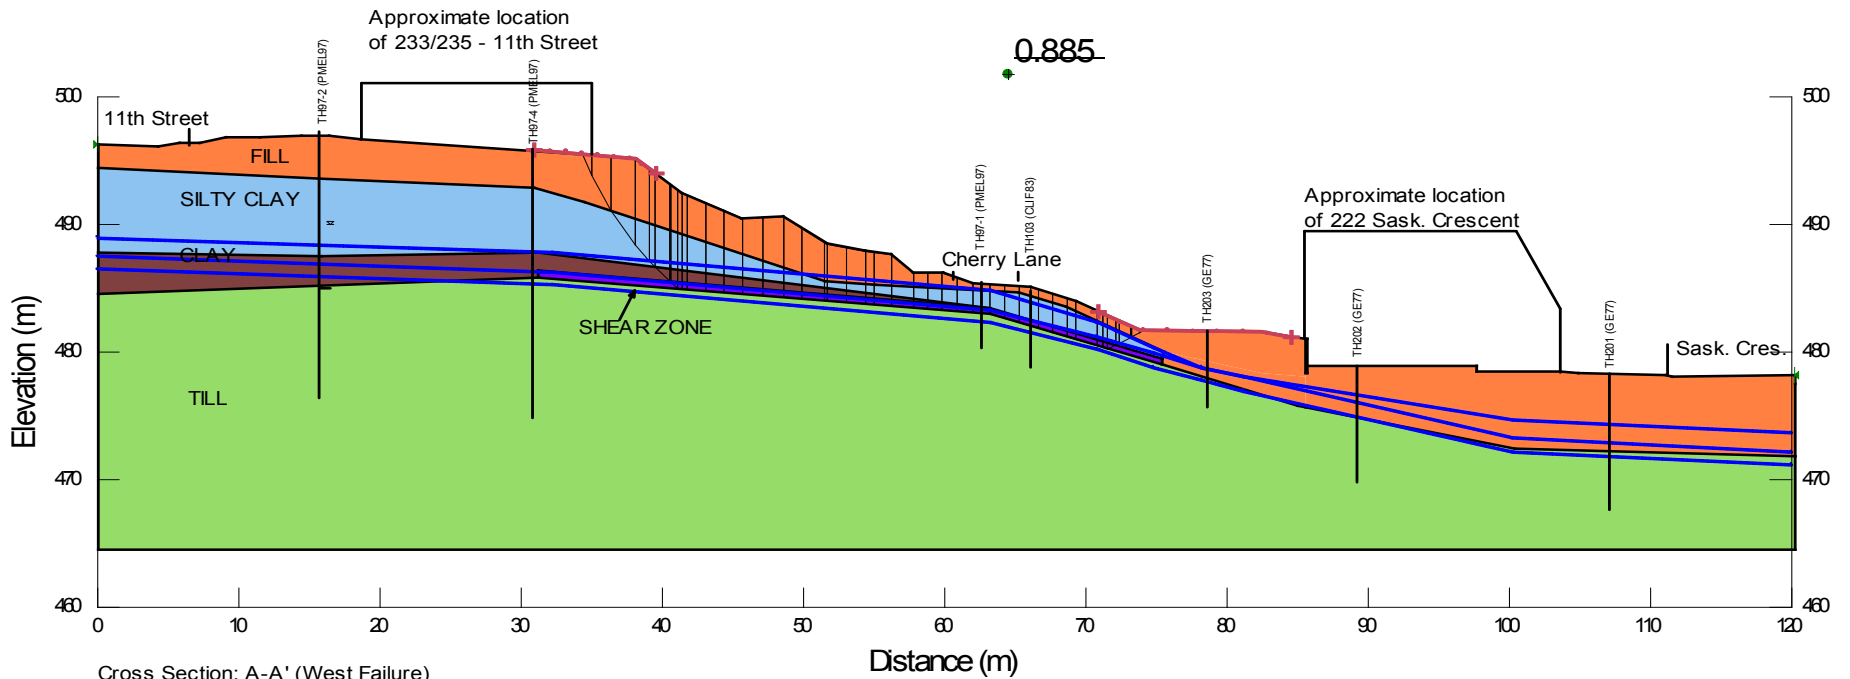
CHERRY LANE SLOPE INSTABILITY		
SLOPE STABILITY ANALYSIS CROSS SECTION A-A' DO NOTHING OPTION WITH HIGH WATER TABLE				
	PROJECT	11-1362-0057	FILE No.	
	DESIGN	LNМ	08/05/14	SCALE N/A REV.
	CADD	HQV	08/05/14	FIGURE: 30
	CHECK	PGB	08/05/14

Figure 30 and Figure 31 show the stability analyses for the do nothing option, with the piezometric level elevated approximately 1.5 m above those used in the back-analysis to represent slope instability. The calculated factor of safety is 0.89 for cross-section A-A' and 0.87 for cross-section B-B' when the raised groundwater level is used in the analysis. There is also a significant potential for additional sloughing of the material at the scarps of the failure areas, where there is up to 2 m of vertical drop. There is also a buildup of material at the toe and the slope has reached a flatter angle. Advancement of the failure toward 11th Street East will result in undermining of existing building foundations. Additionally, properties located below 11th Street East may experience damage from debris or additional soil loading as material collects at the toe of the sliding zone. It is expected that there will continue to be slope movement along Cherry Lane as the slope failure progresses, disrupting traffic access and power service along the lane.

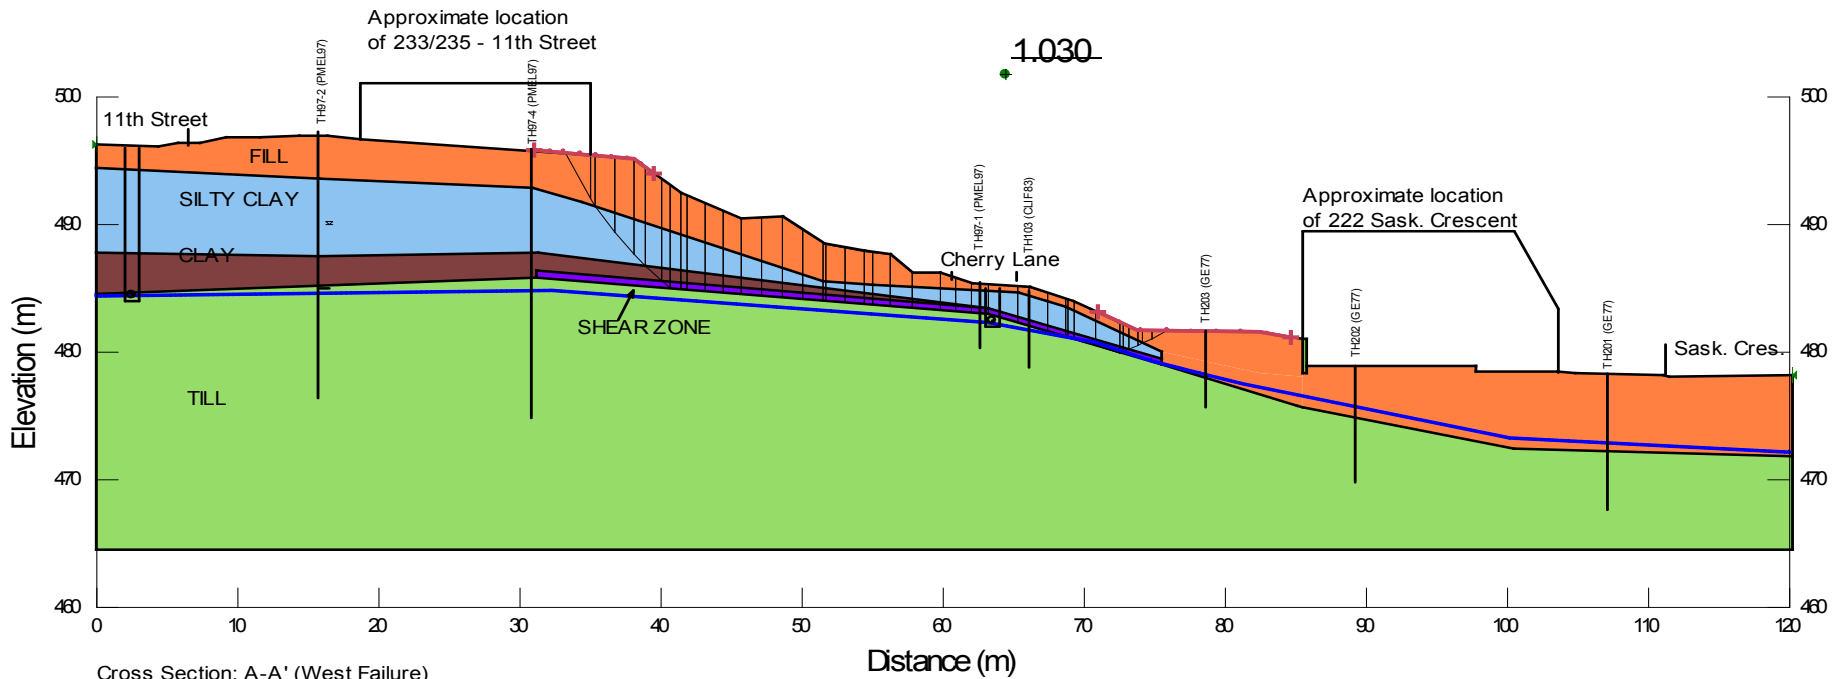
CHERRY LANE SLOPE INSTABILITY	
SLOPE STABILITY ANALYSIS CROSS SECTION A-A' DRAINAGE OPTION			
	PROJECT	11-1362-0057	FILE No.
	DESIGN	LNLM	08/05/14
	CADD	HQV	08/05/14
	CHECK	PGB	08/05/14
		SCALE	N/A
		REV.	
			FIGURE: 32

For the slope stability analysis, groundwater conditions where drainage systems were installed along 11th Street East approximately 10 mbgs and along Cherry Lane between 3 mbgs and 8 mbgs were considered. Installation of drainage systems in both locations for the existing slope will be more effective than a single drainage system. For the West Failure (cross-section A-A'), the post-failure pore-water conditions along 11th Street East were already near the clay and till interface, resulting in marginal increase to FS when the level was lowered, however lowering the pore-water pressures along the East Failure (cross-section B-B') resulted in an approximate 20% increase in FS. It should be noted that this increase in slope FOS will not be achieved immediately after the sub-drainage system construction because pore-water pressure in clay slope may take several years to dissipate.

Figure 32 and Figure 33 show the stability analyses for this conceptual remedial option for the West Failure and East Failure, respectively. Installation of a drainage system in 11th Street East will require a minimum length of 135 m and a depth ranging between 8.6 m and 12.5 m. Installation of a drainage system in Cherry Lane will require a length of 135 m at a depth between 3.6 m and 8 m. Detailed design will refine the overall dimensions of this option.

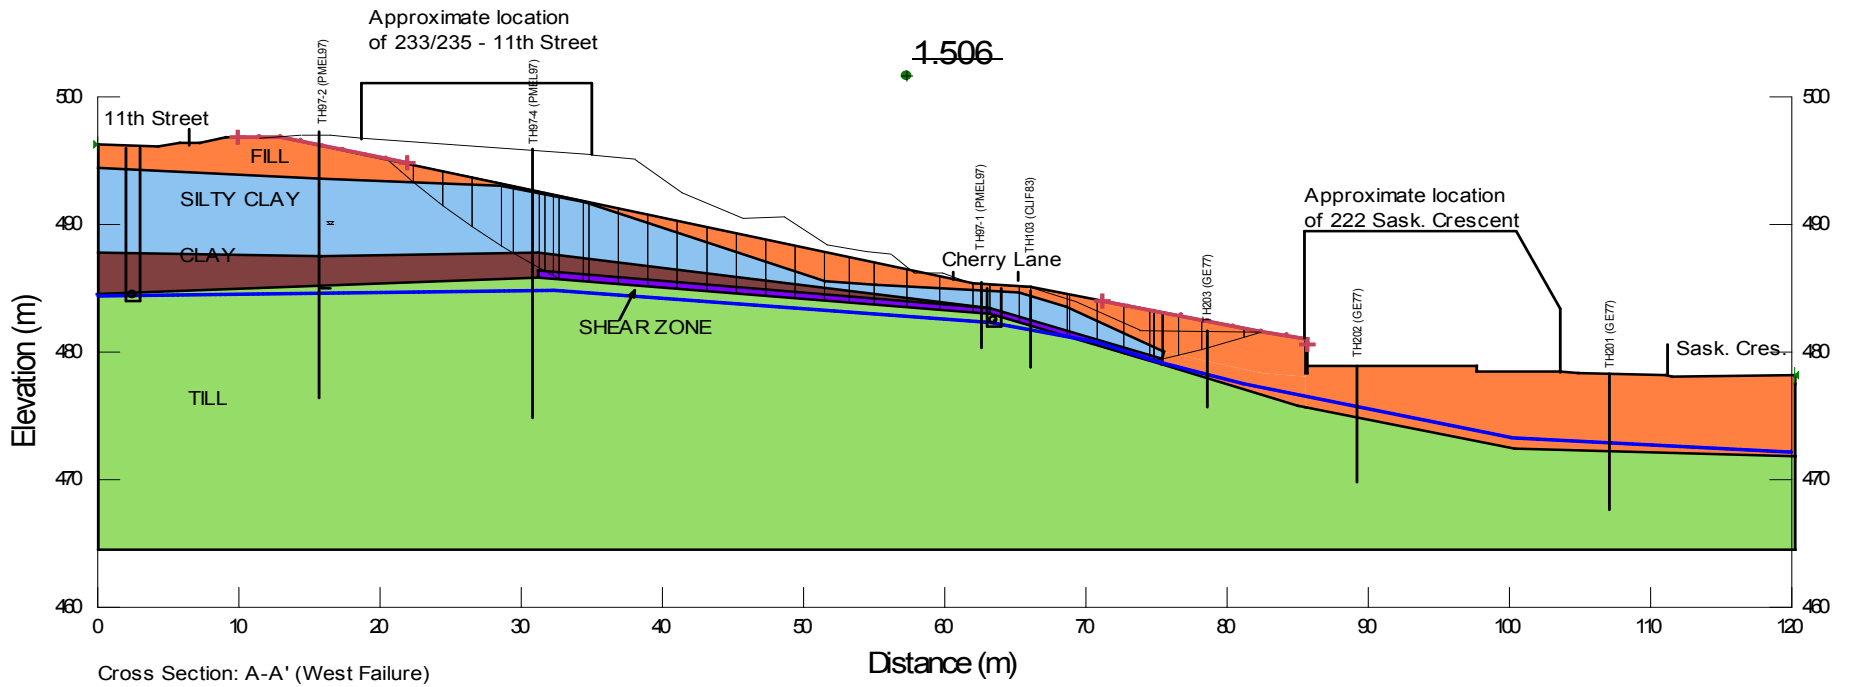
CHERRY LANE SLOPE INSTABILITY	
SLOPE STABILITY ANALYSIS CROSS SECTION A-A' SITE REGRADING OPTION			
	PROJECT	11-1362-0057	FILE No.
	DESIGN	LNLM 08/05/14	SCALE N/A REV.
	CADD	HQV 08/05/14	FIGURE: 34
	CHECK	PGB 08/05/14

Review of the upper slope topography shows that the current slope has an average slope of 2.5H:1V along cross-section A-A' (West Failure), and 1.9H:1V along cross-section B-B' (East Failure).

Figure 34 and Figure 35 show the stability analyses for this conceptual remedial slope flattening option. Figure 36 shows the plan view of the estimated extents of slope re-grading required to re-establish the slope to a minimum FS = 1.5. The approximate dimension of the conceptual slope re-grading is an area approximately 135 m long by 17 m to 67 m wide. Detailed design will refine the overall dimensions of this option.

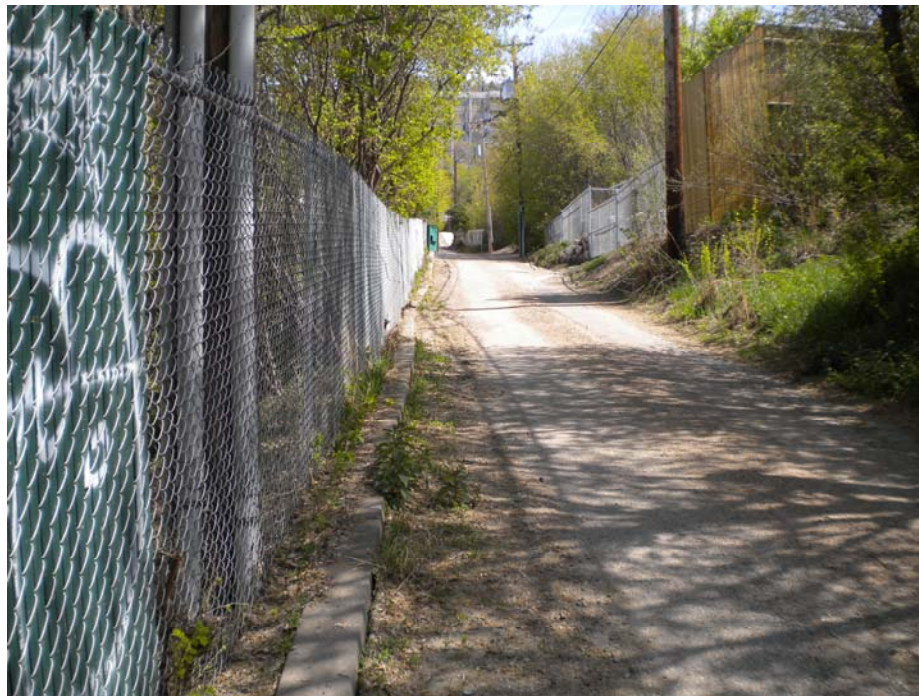
Photo C.2. Looking East at Deflection of Curb and Fence Line along Cherry Lane (May 27, 2010)

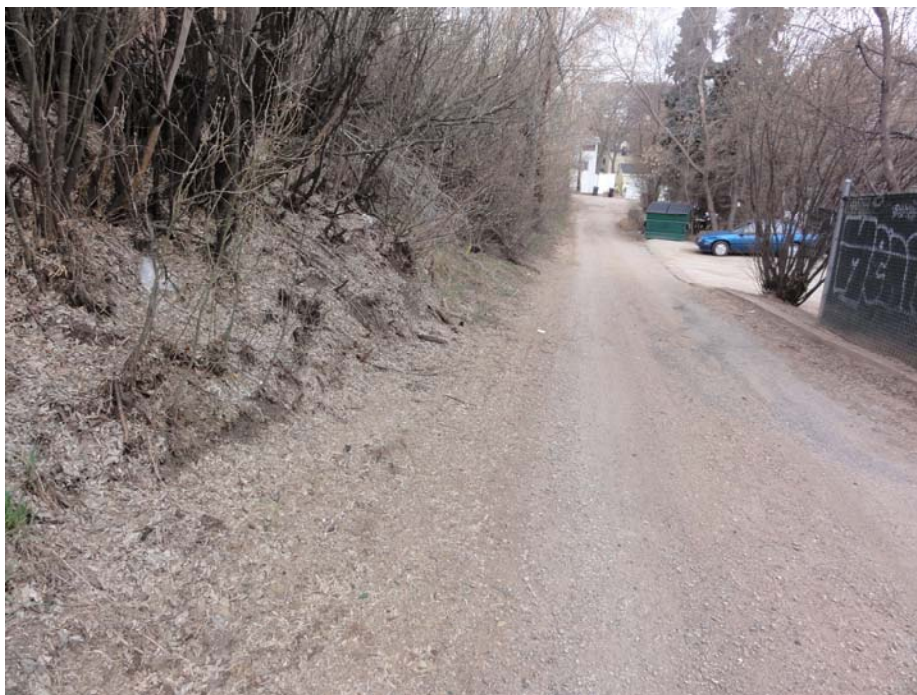
Photo C.4. Looking West at Toe of Upper Slope (April 26, 2012)

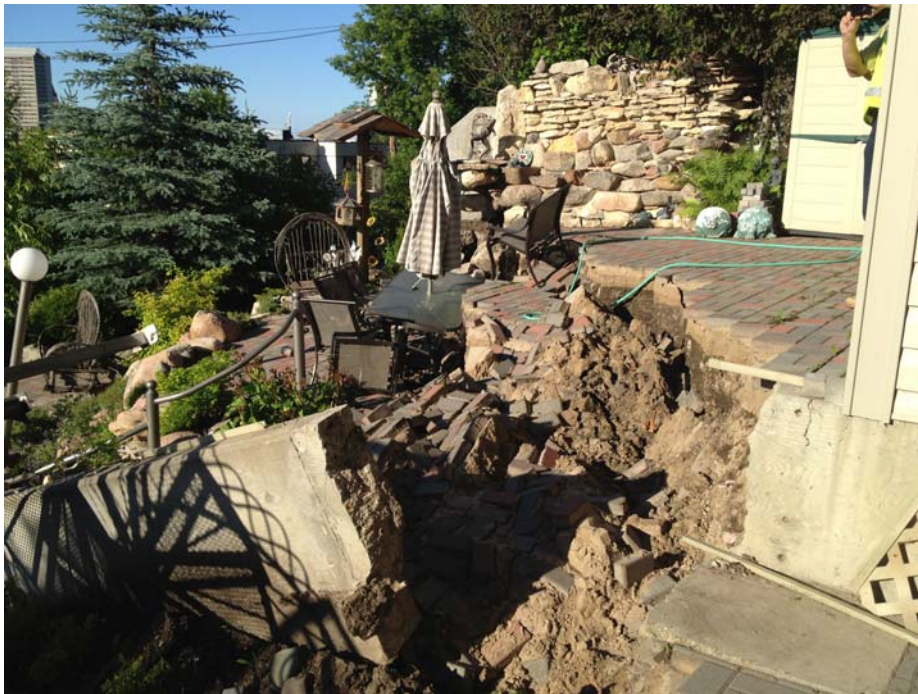
Photo C.5. Headscarp in the Backyard of 233-235 11th St. E. (June 21, 2012)

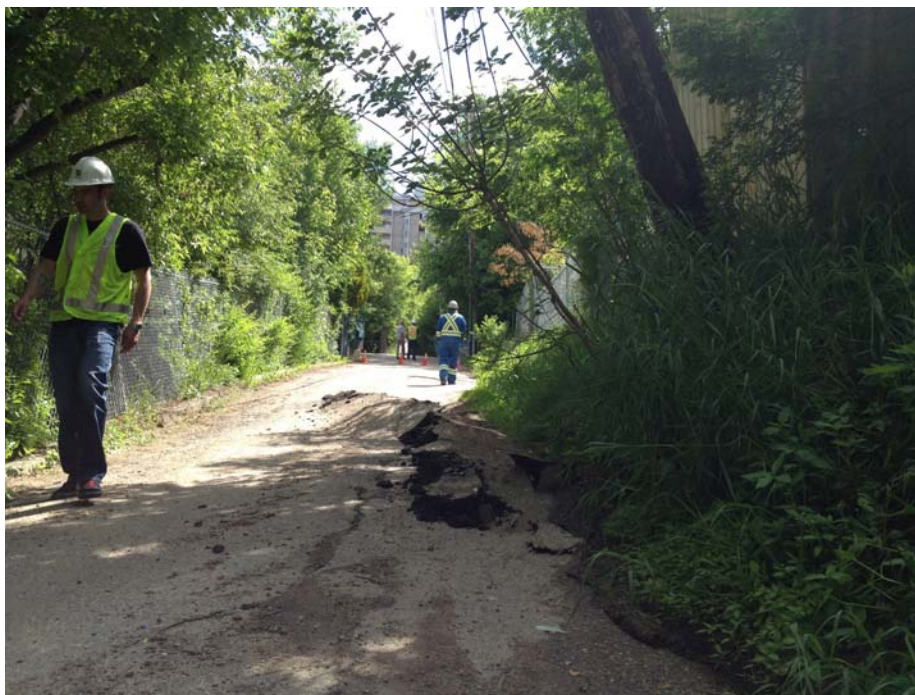
Photo C.6. Bulging Toe of Slide on Cherry Lane (June 21, 2012)

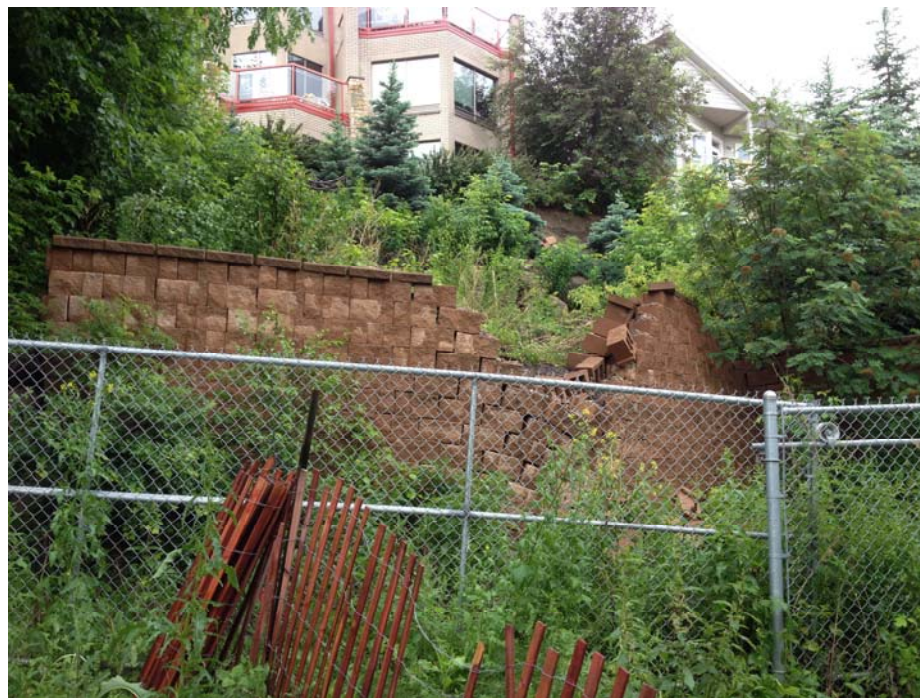
Photo C.18. Retaining Wall in Backyard of 237-239 11th St. E. (June 20, 2013)

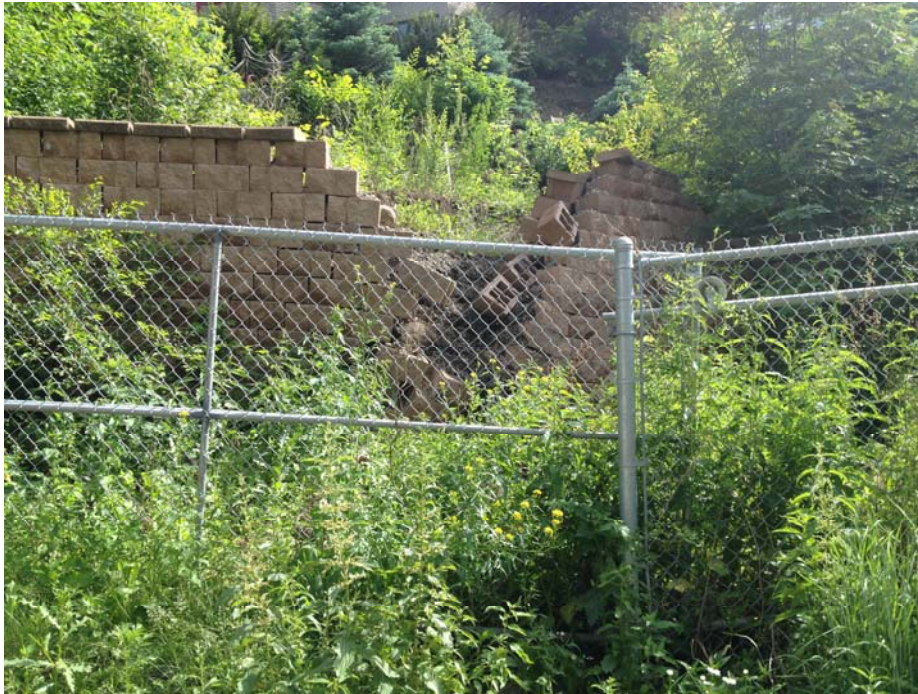
Photo C.19. Retaining Wall in Backyard of 237-239 11th St. E. (June 24, 2013)

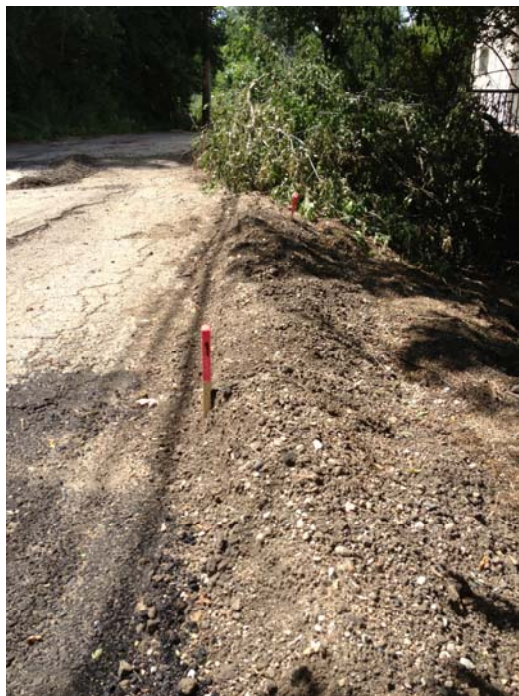
Photo C.23. Looking West at Berm Along North Edge of Cherry Lane, behind 306 Sask. Cres. E. (July 7, 2013)

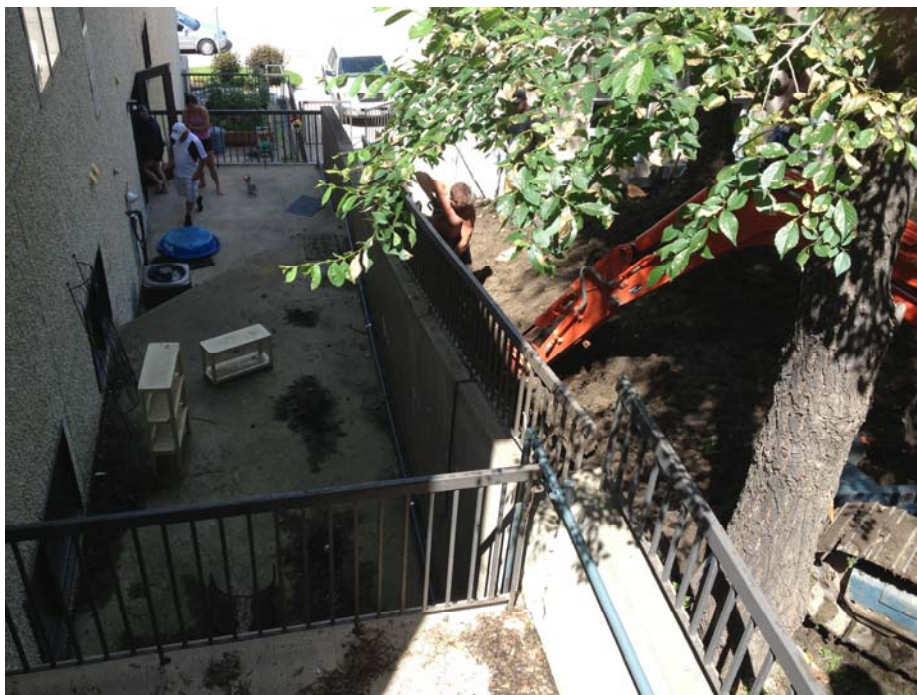
Photo C.24. Looking Northeast at Trench being Excavated Adjacent to Wall between 230 & 306 Sask. Cres. E. (July 7, 2013)
