CHERRY LANE SLOPE MOVEMENT, SASKATOON, SK

Geotechnical Investigation and Evaluation of Conceptual Remedial Options

Report Number: 11-1362-0057/5100

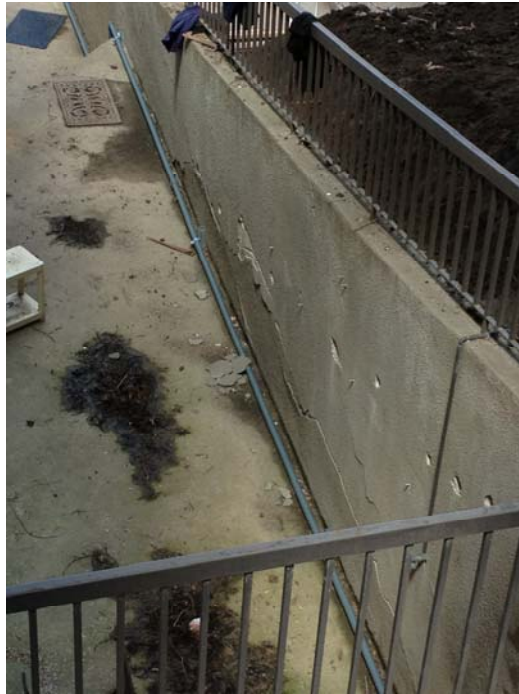
Photo C.25. Looking Northeast at Concrete Retaining Wall between 230 & 306 Sask. Cres. E. (July 7, 2013)

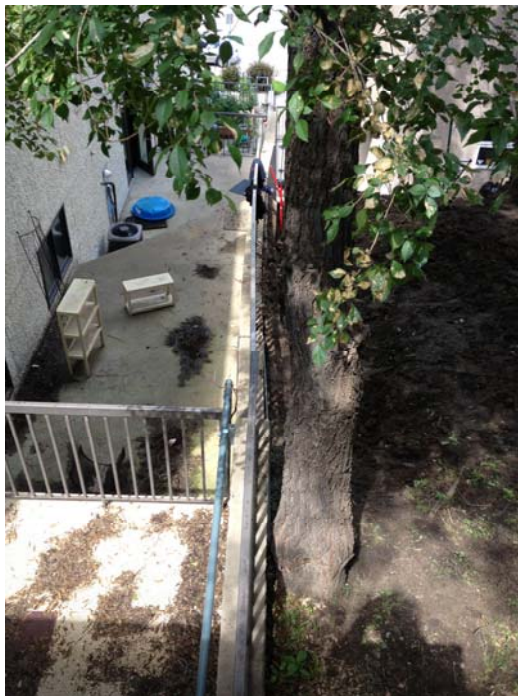
Photo C.26. Looking North at Concrete Retaining Wall between 230 & 306 Sask. Cres. E. (July 7, 2013)

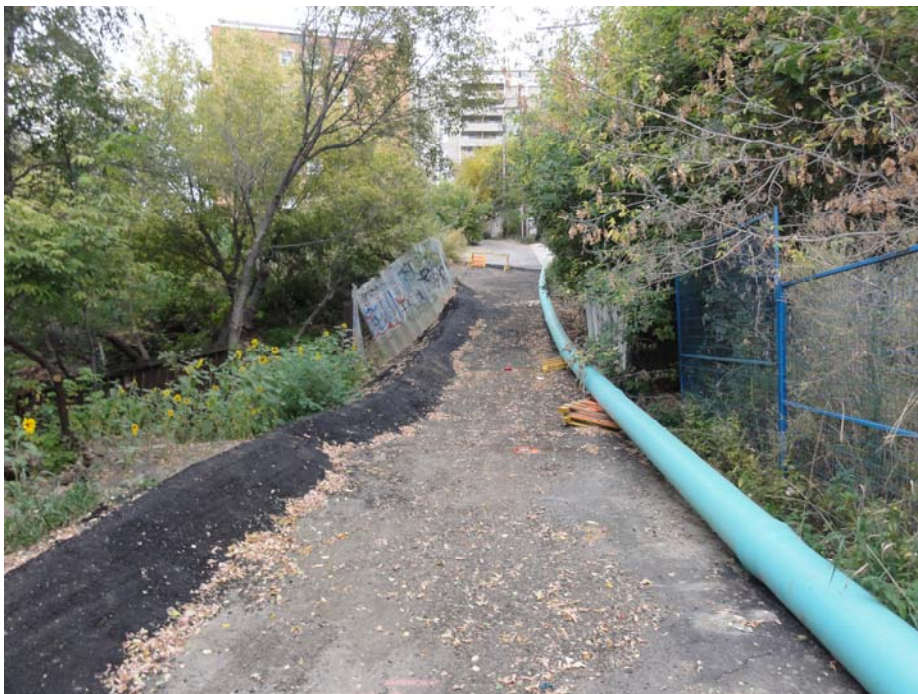
Photo C.29. Looking East at Above Ground Driantage System Installed on Cherry Lane (September 18, 2013)

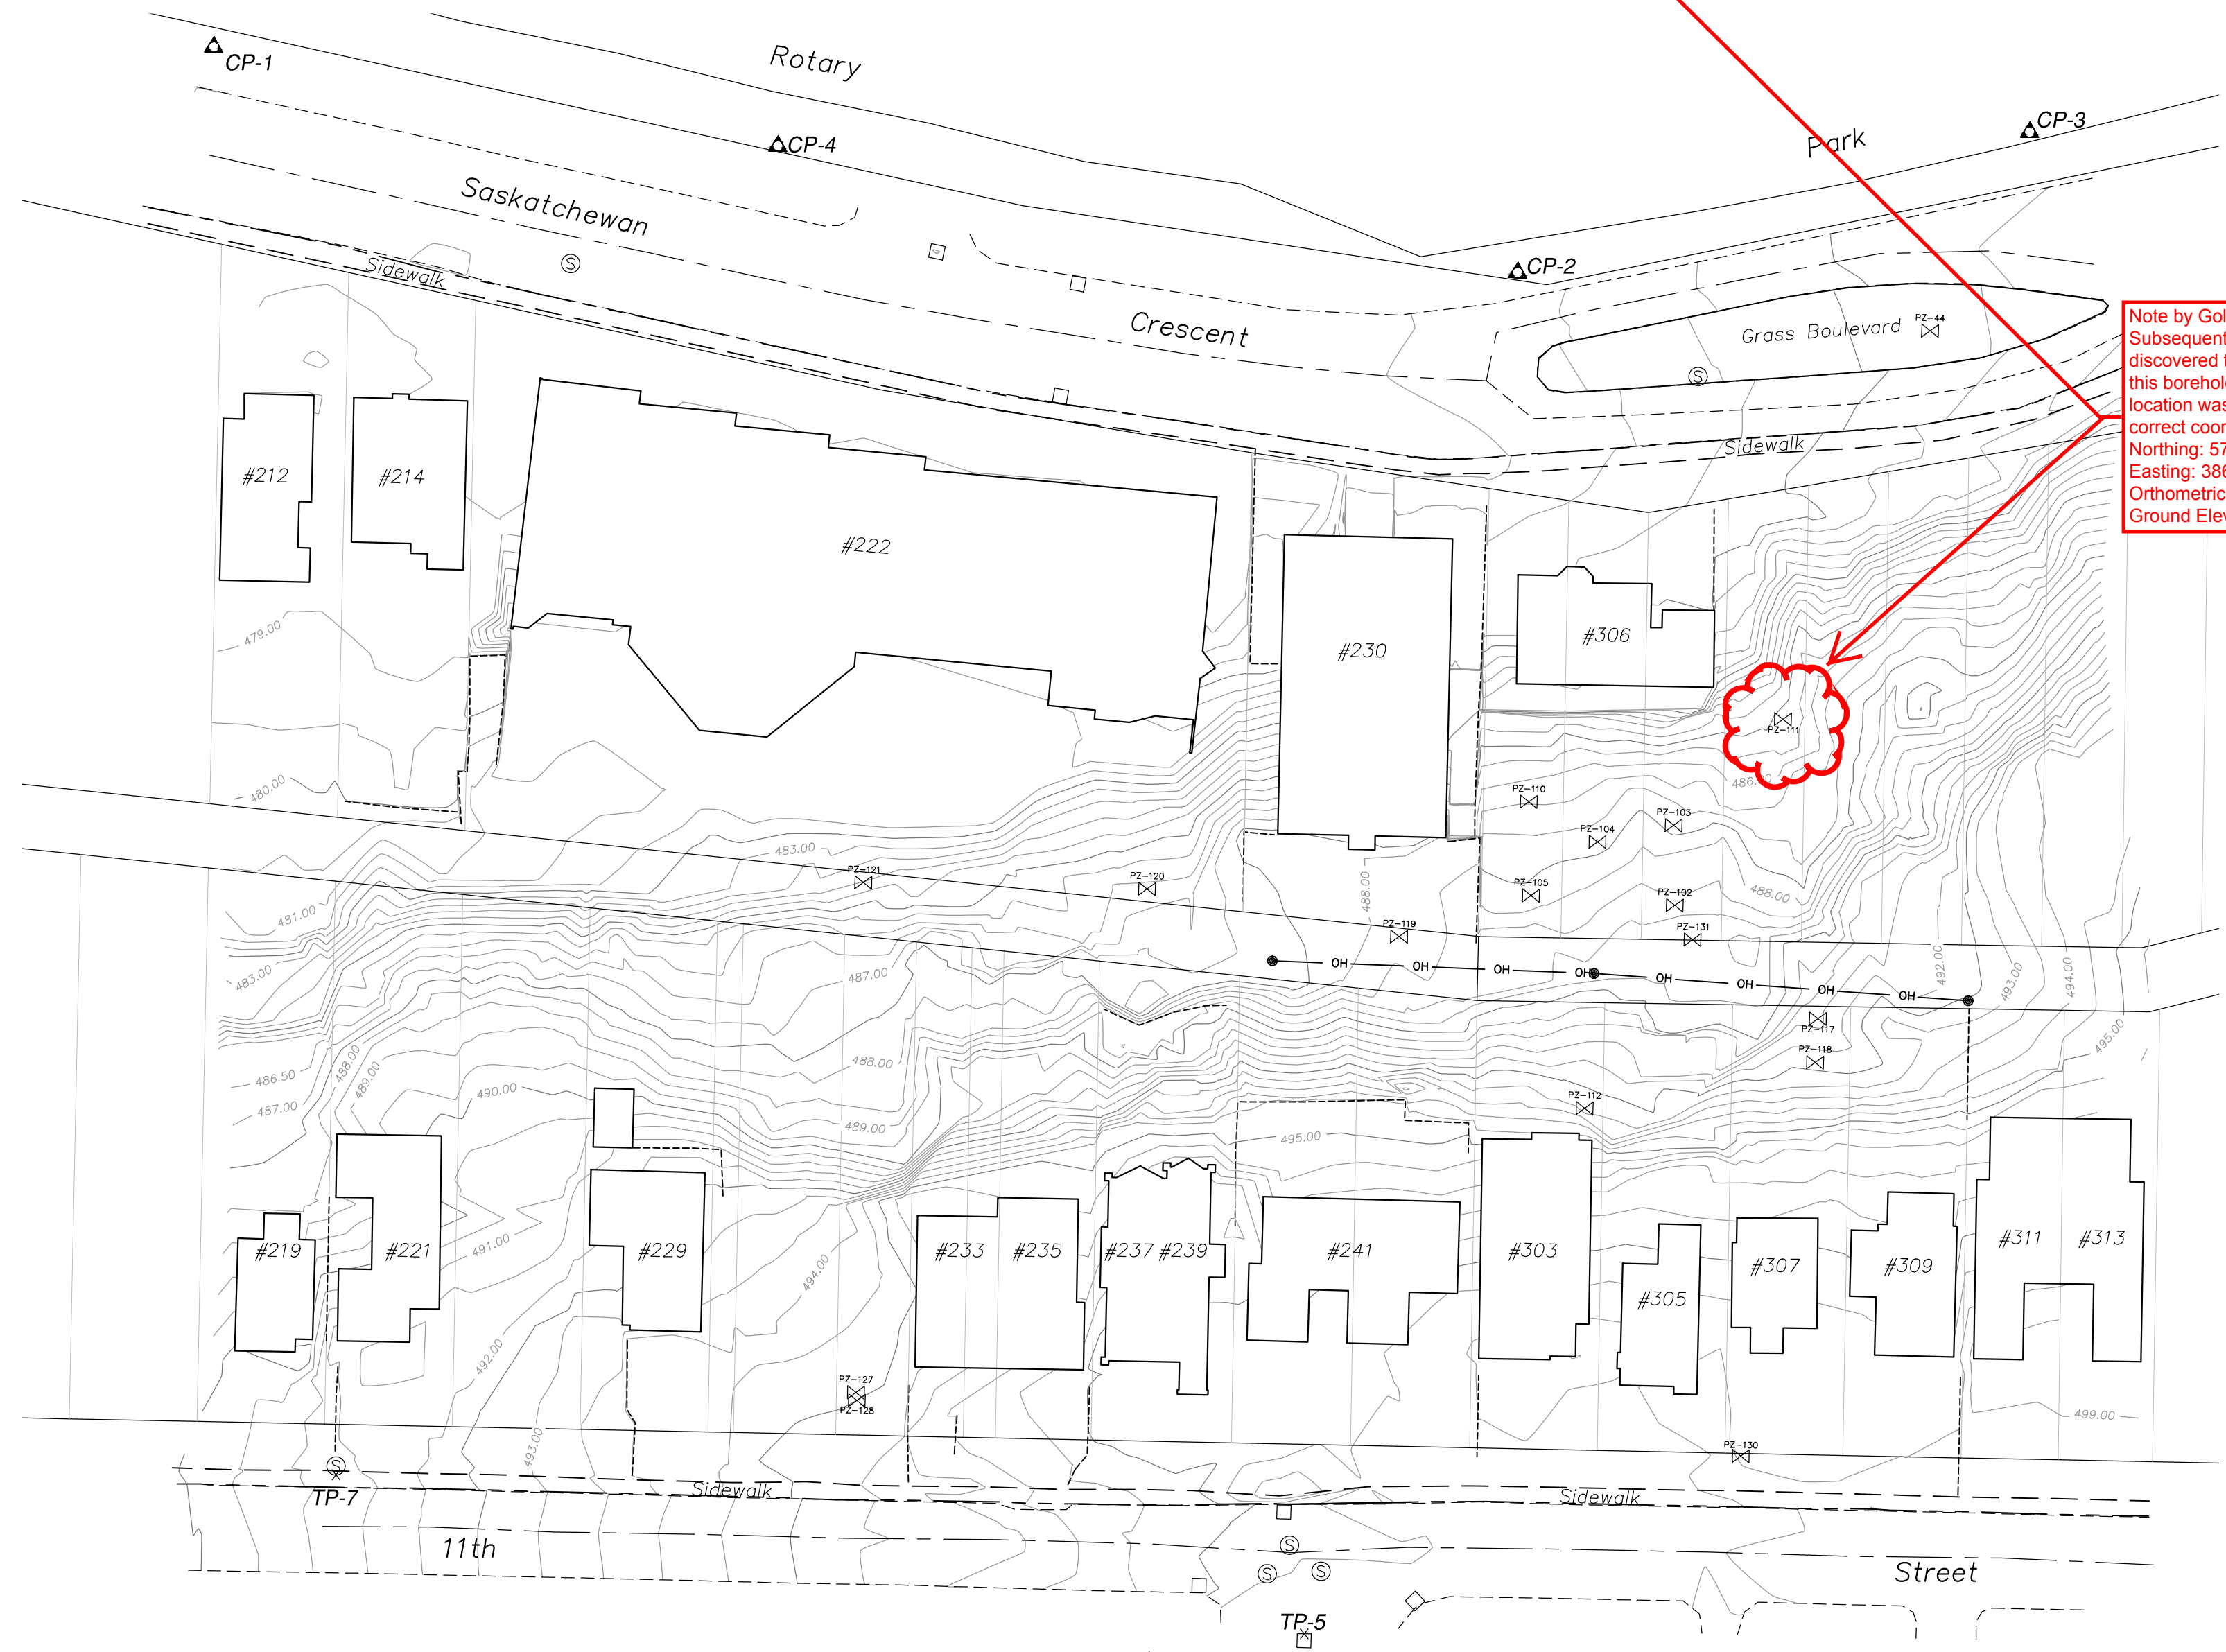
Note by Golder:
Subsequent to this survey, Golder discovered that the surveyed location of this borehole was incorrect. The borehole location was resurveyed by Golder. The correct coordinates are:
Northing: 5775631.30 m
Easting: 386078.85 m
Orthometric Elevation: 494.39 masl
Ground Elevation: 494.48 masl

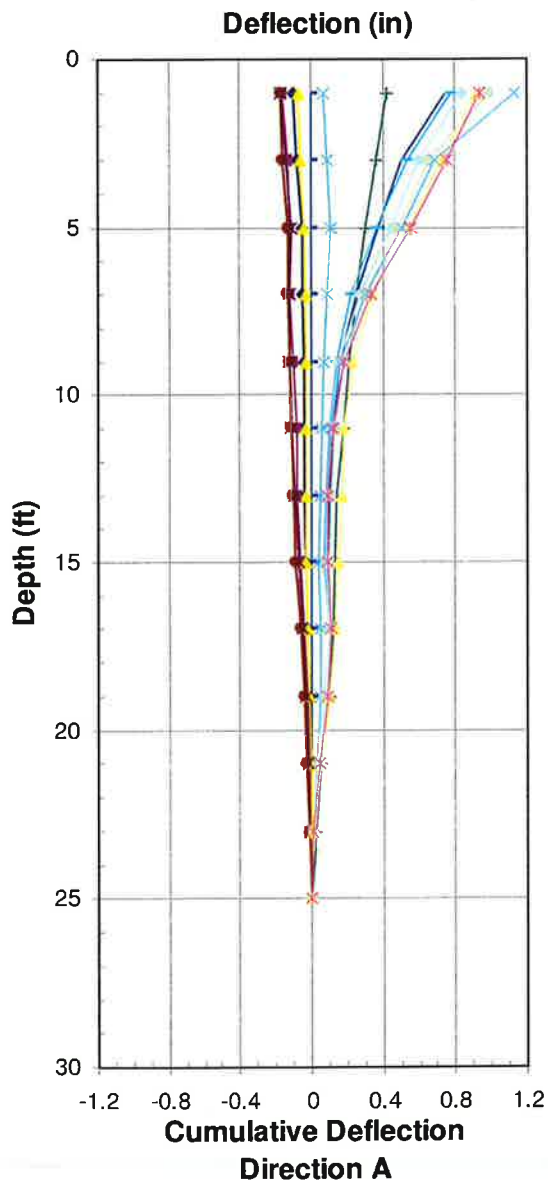
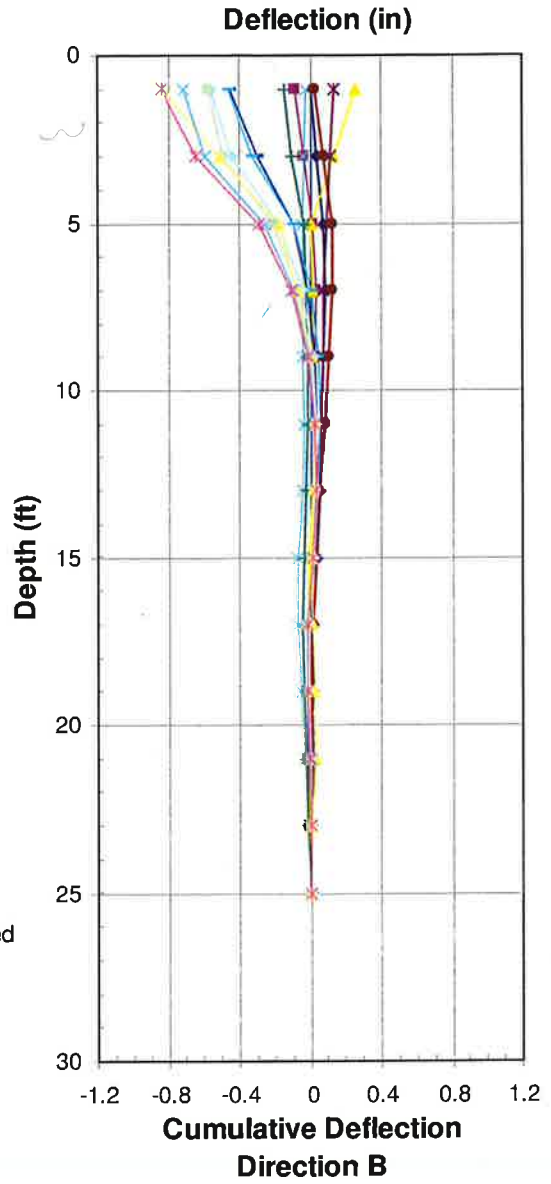
COS#12 - EAST RIVER BANK, Inclinometer SI-84ICL
Cherry Lane (West Casing)

Note: Casing in need of repair since 2005

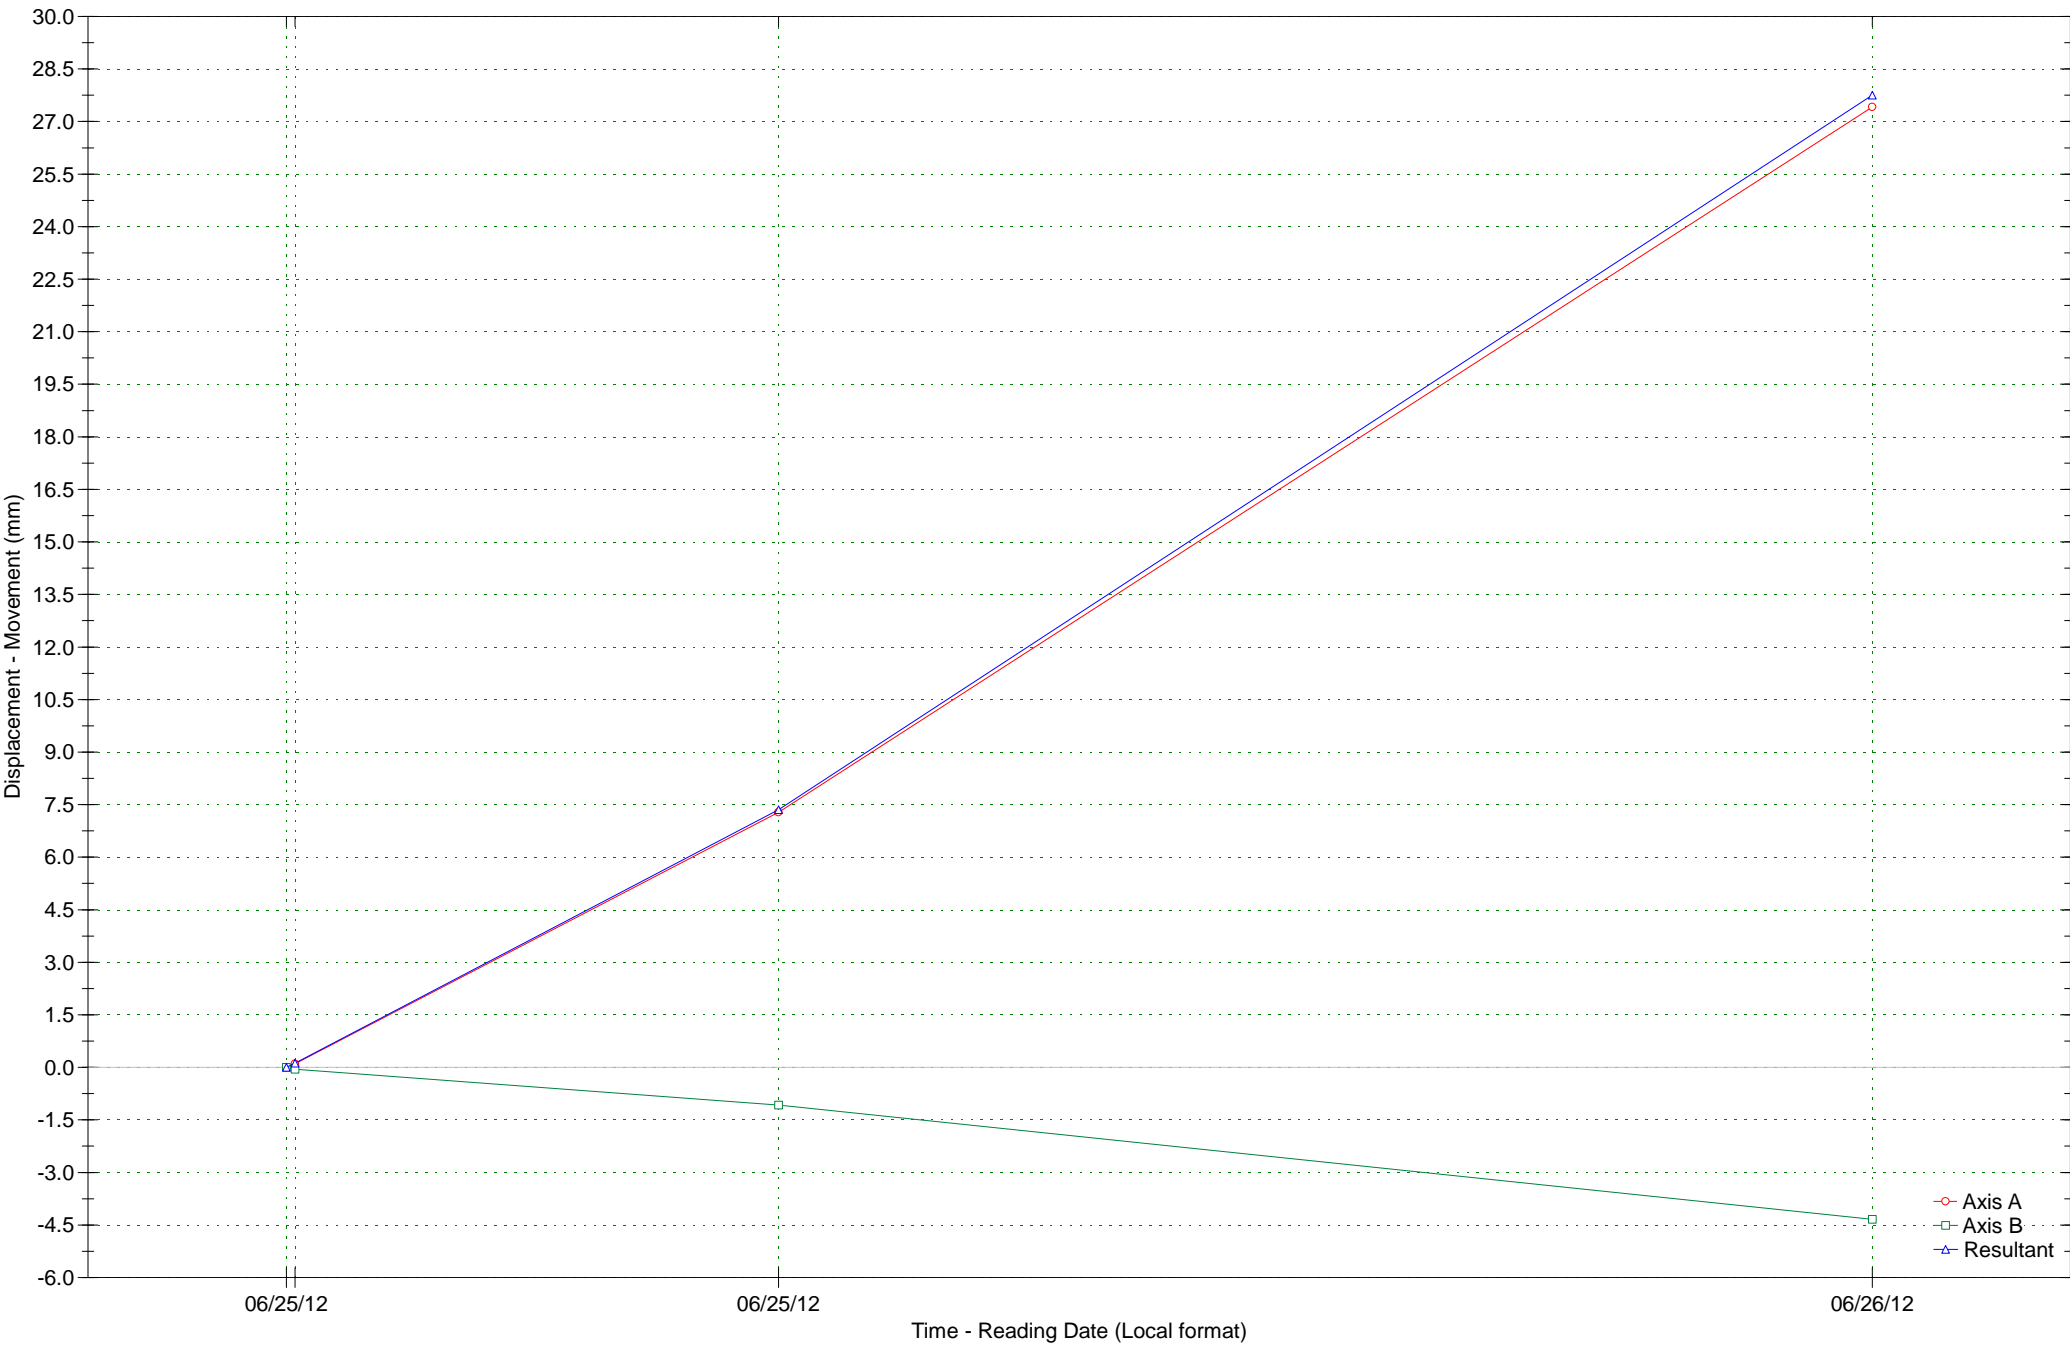
Spiral Correction : N/A
Movement Depth : 2.0 - 3.5 meters
Borehole Total Depth : 4.5 meters
A+ Groove Azimuth :
Latest Reading : 2012 Jun 26 09:02
Initial Reading : 2012 Jun 25 09:39
Applied Azimuth : 0.0 degrees

Time Plot : 2.0 - 3.5 meters

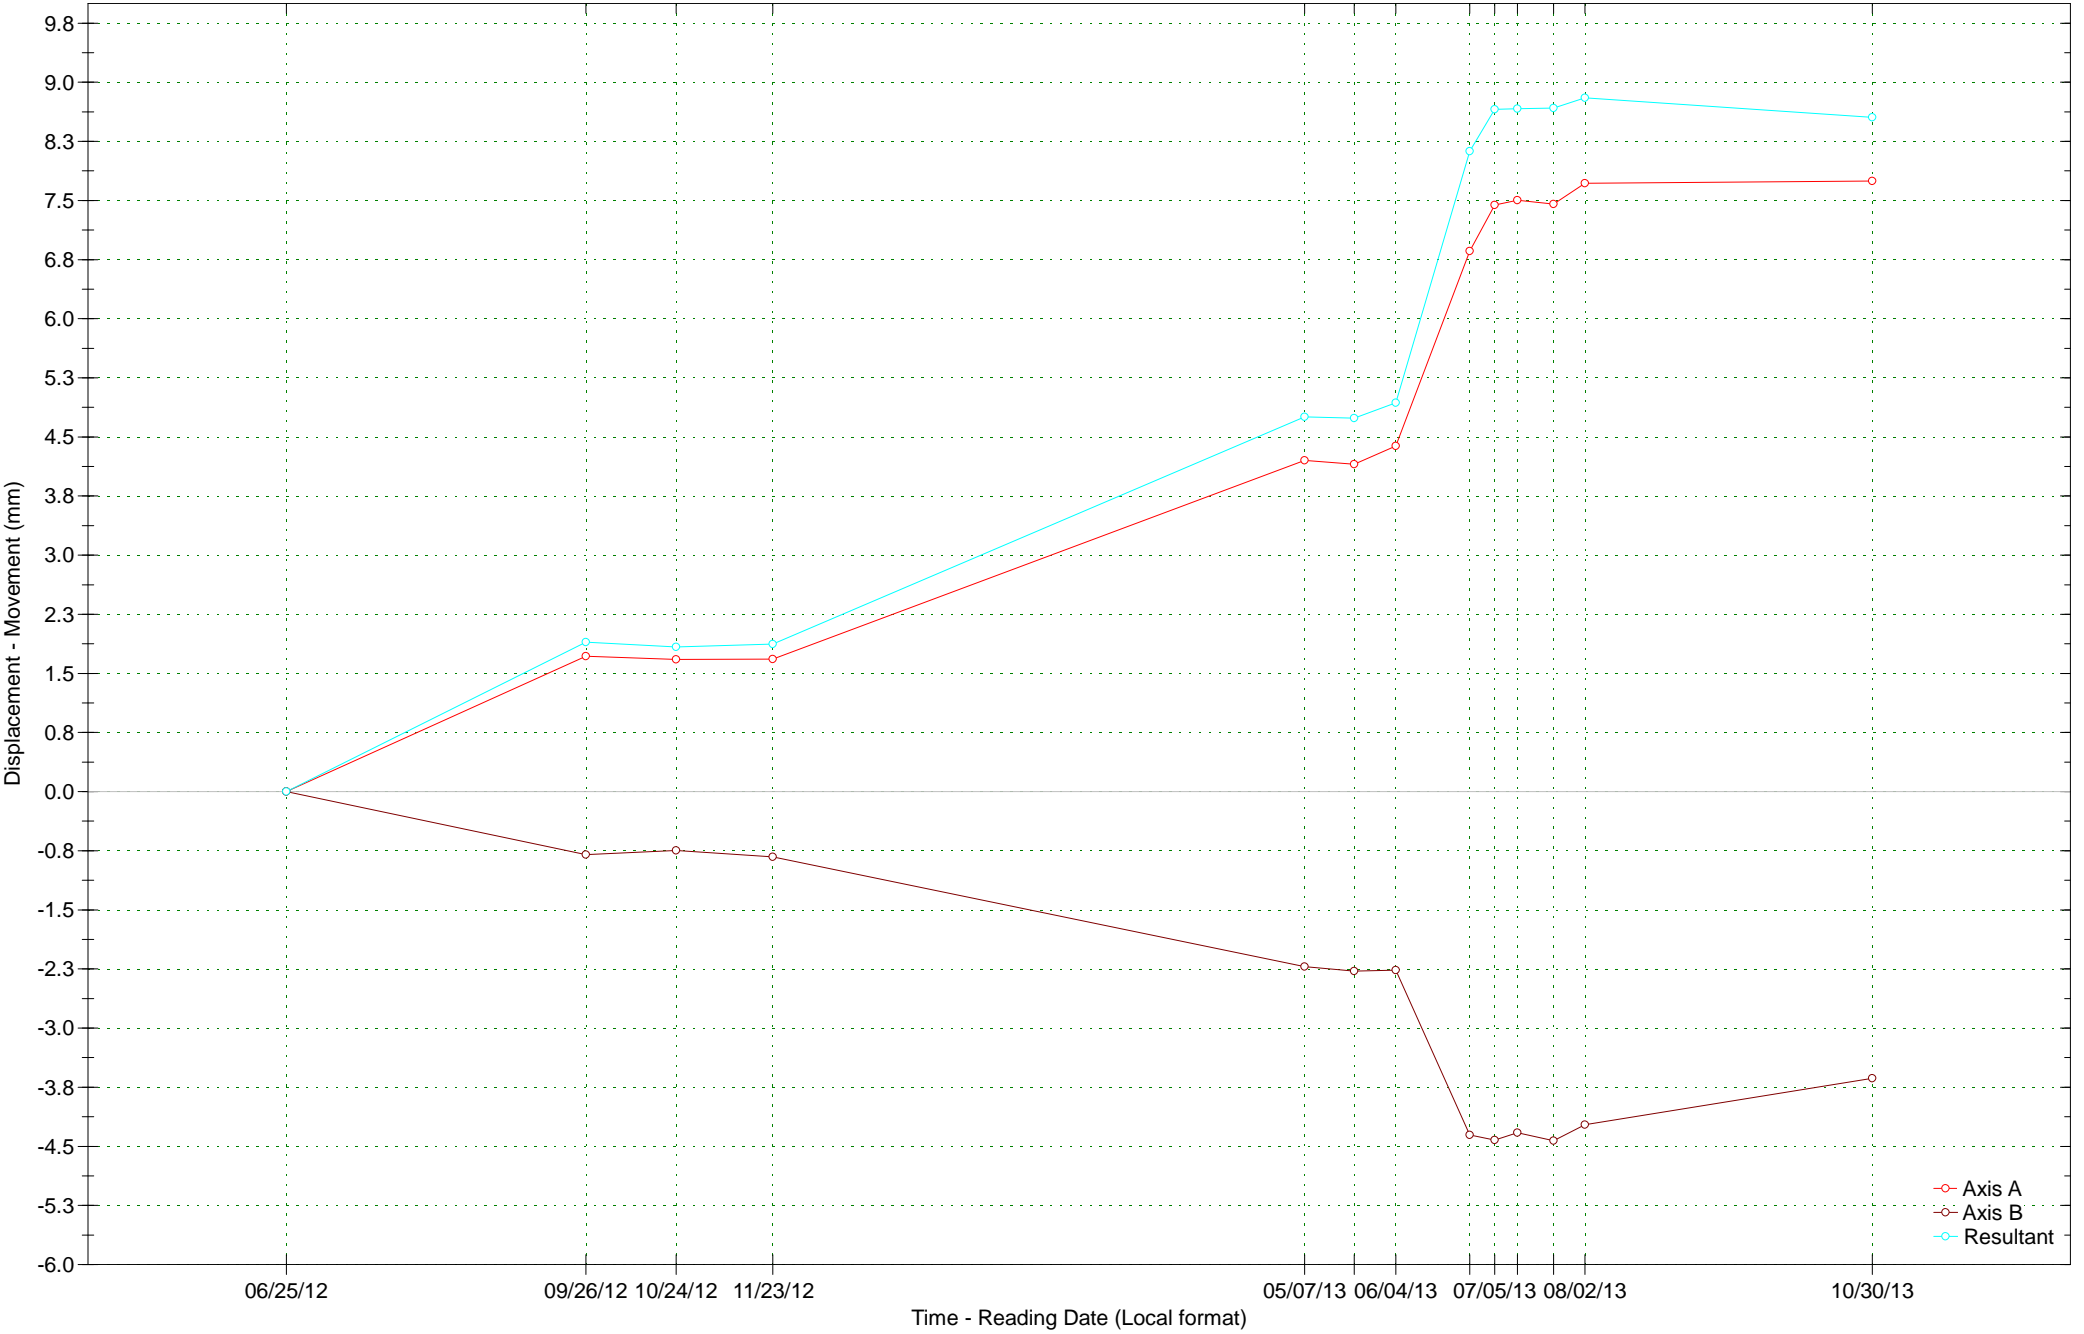
Spiral Correction : N/A
Movement Depth : 0.5 - 1.5 meters
Borehole Total Depth : 3.5 meters
A+ Groove Azimuth :
Latest Reading : 2013 Oct 30 10:49
Initial Reading : 2012 Jun 25 10:17
Applied Azimuth : 0.0 degrees

Time Plot : 0.5 - 1.5 meters

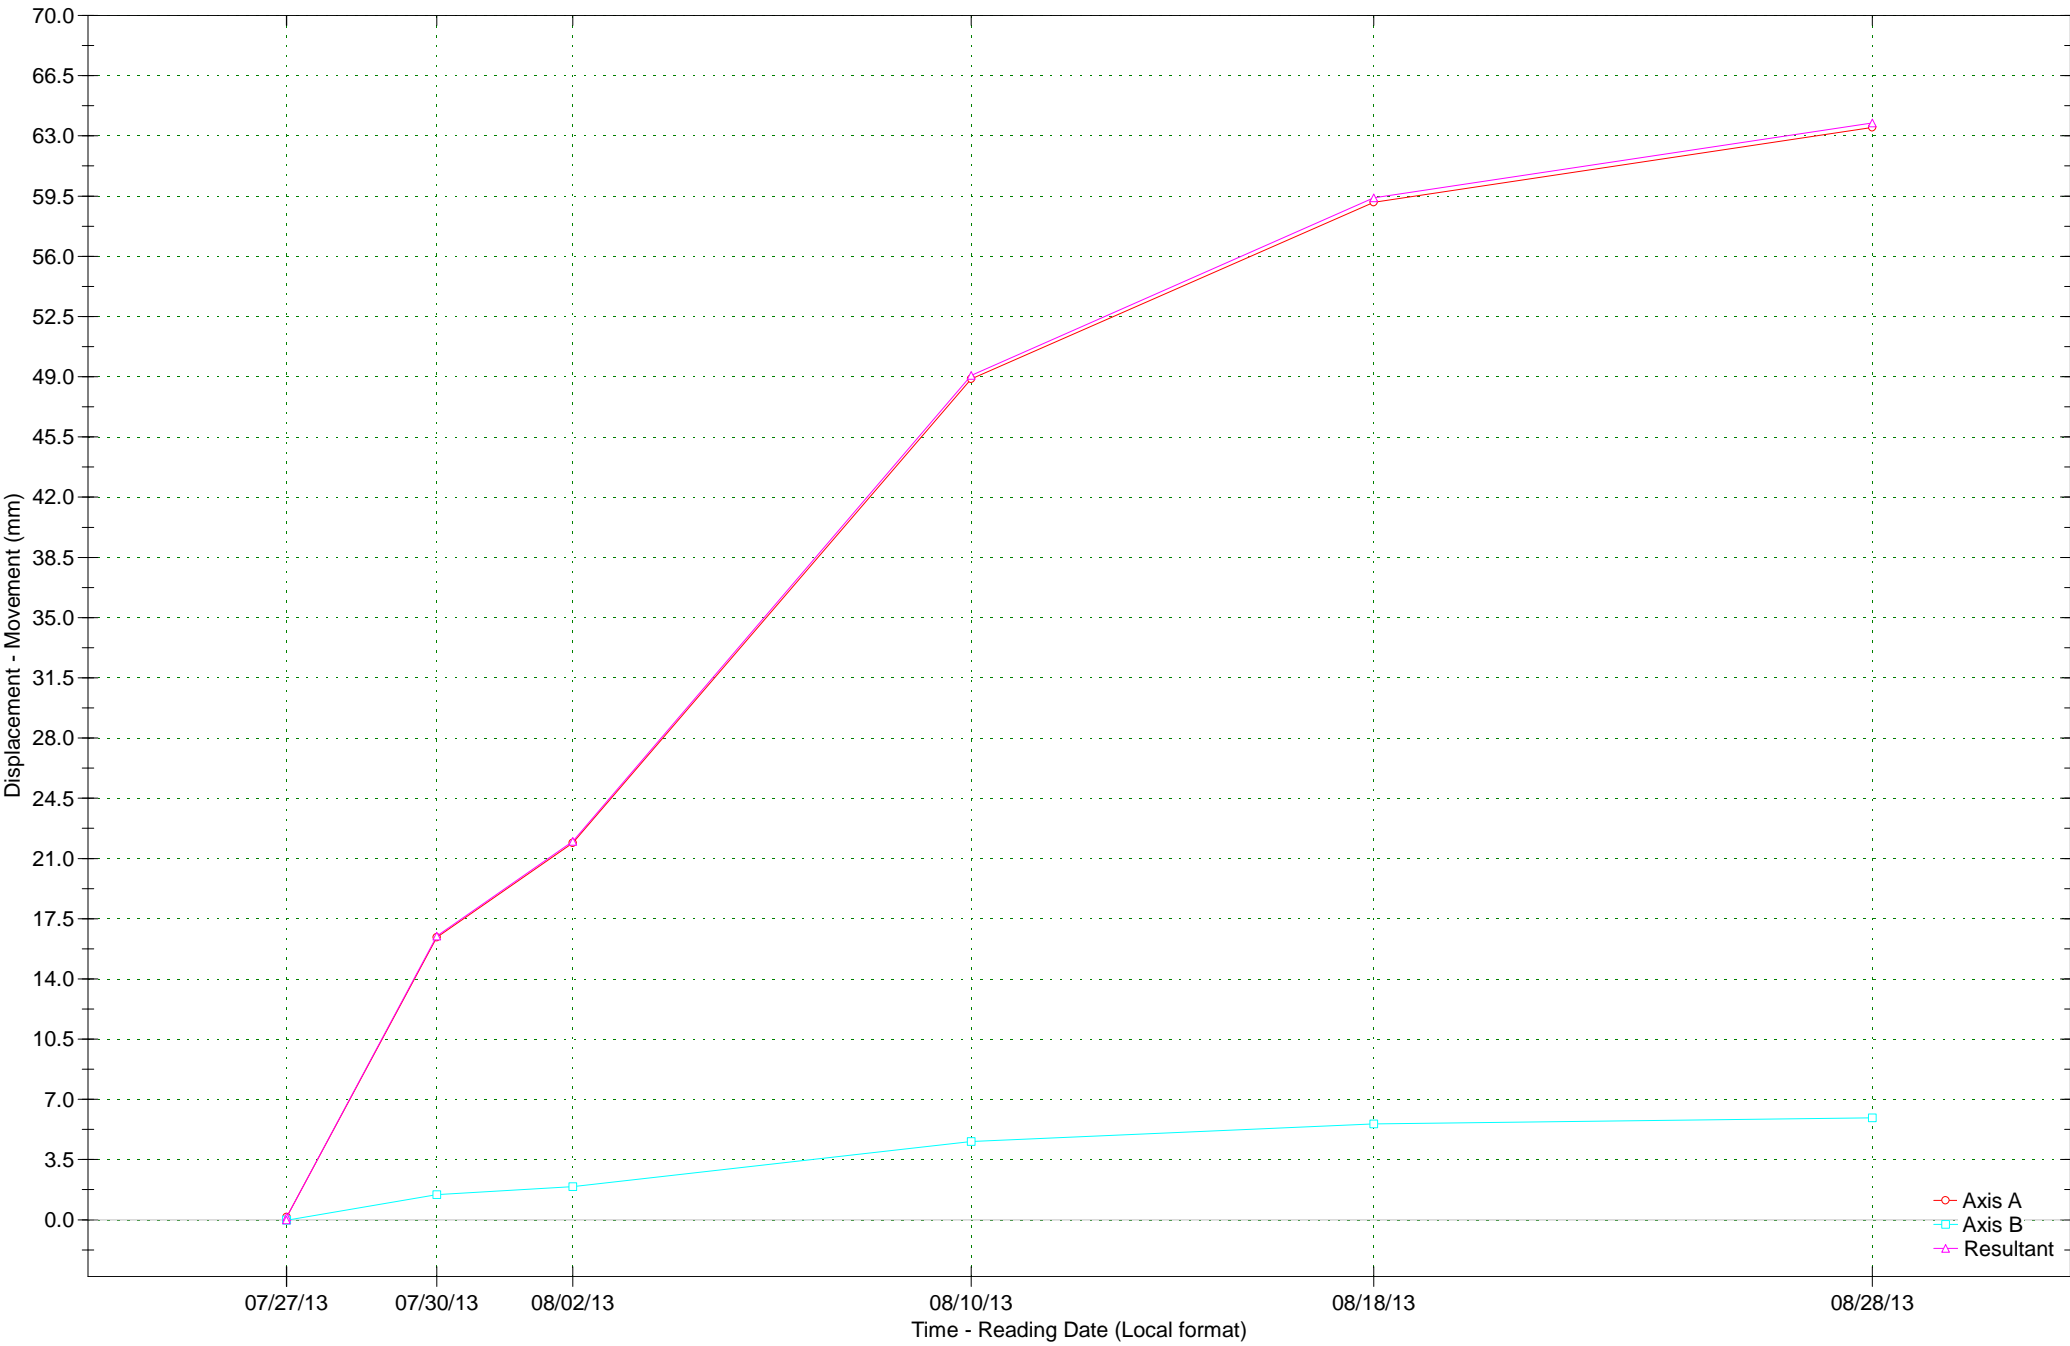
Spiral Correction : N/A
Movement Depth : 4.5 - 6.5 meters
Borehole Total Depth : 7.5 meters
A+ Groove Azimuth :
Latest Reading : 2013 Aug 28 08:05
Initial Reading : 2013 Jul 27 15:17
Applied Azimuth : 0.0 degrees

Time Plot : 4.5 - 6.5 meters

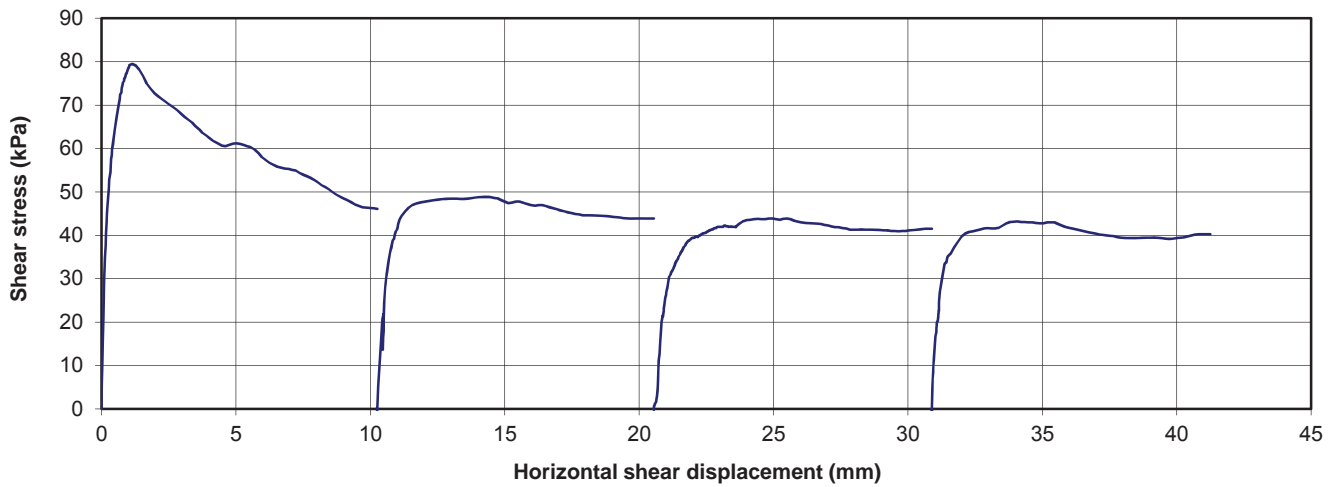
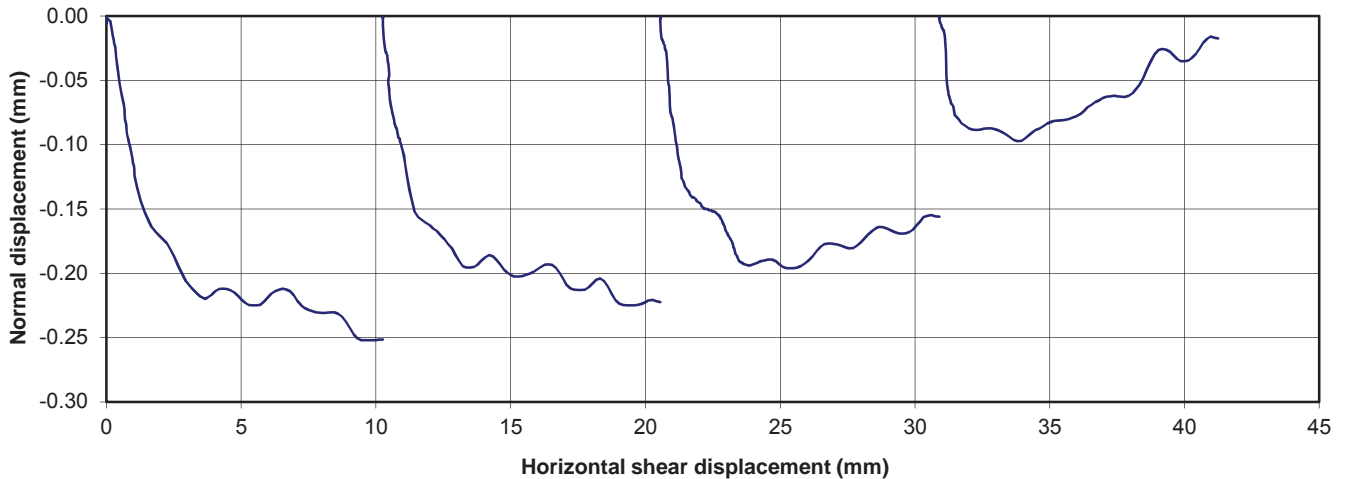
Project #: 11-1362-0057 Phase: 5100 / 4000
 Short Title: COS East Riverbank / Cherry Lane - Geotech Investigation / Saskatoon, SK
 Tested By: B.Y. / D.B. Date: November 10, 2013
 Sample: COS-13-004 004-8 7.01-7.62 m depth

Effective Stress:	200	kPa	Peak Shear Stress:	80	kPa
			Residual Shear Stress	40	kPa
Sample Data:			Comments:		
Sample Length:	60.0	mm			
Initial Height:	20.0	mm			
Initial Water Content:	36.8	%			
Initial Dry Density:	1356	kg/m ³			
Final Water Content:	39.0	%

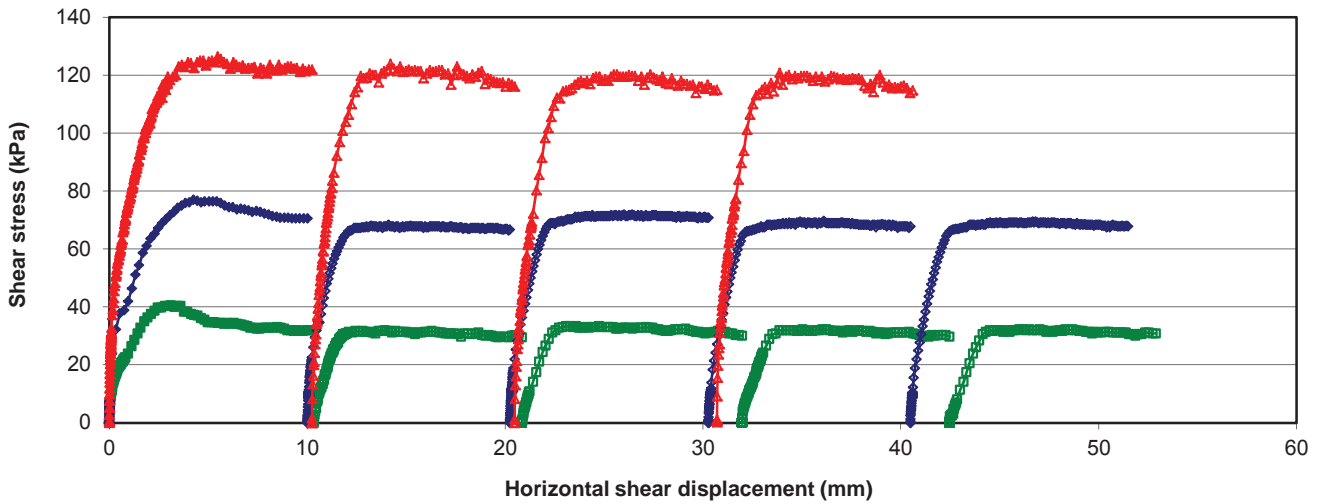
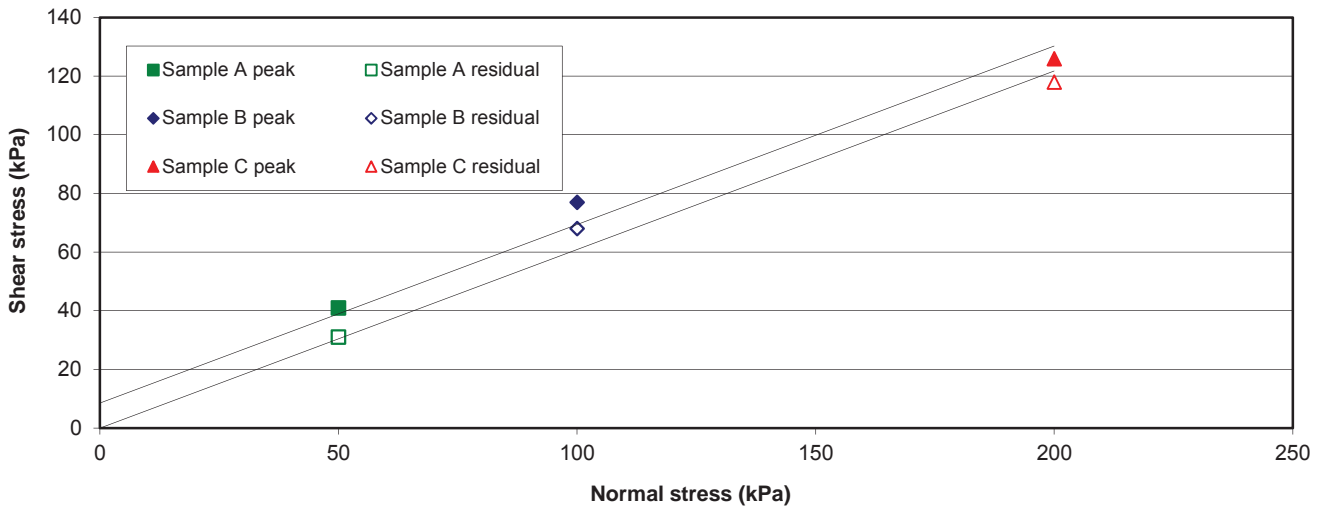
Sample	Normal Stress	Shear Stress	
	(kPa)	Peak (kPa)	Residual (kPa)
COS-13-005 005-13 11.43-12.04 m depth	50	41	31
	100	77	68
	200	126	118

Peak	Residual
Friction angle (degrees):	31.3	31.3
cohesion (kPa):	9	0

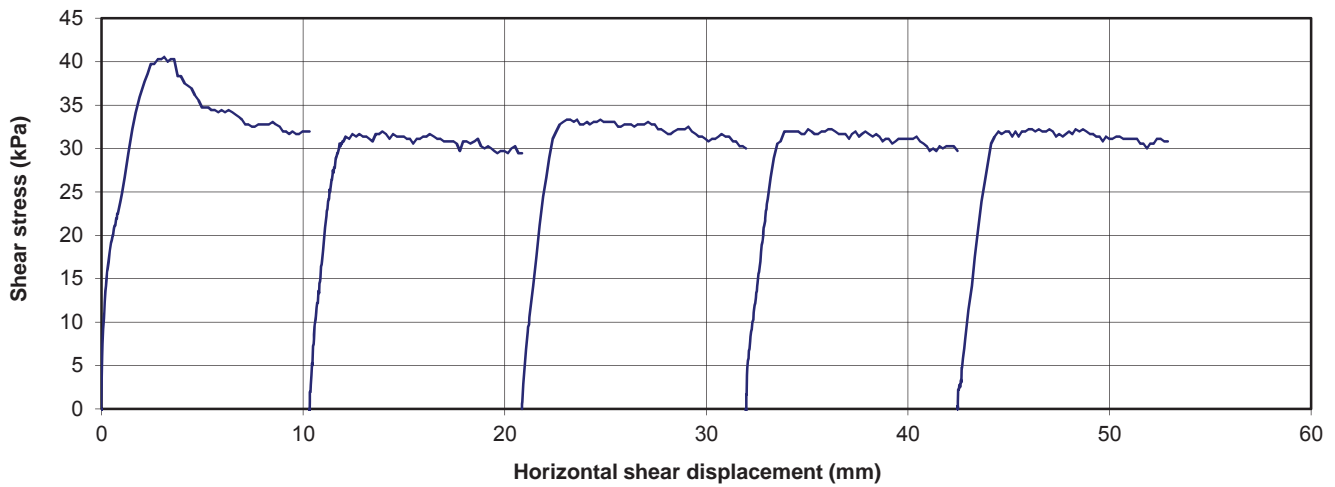
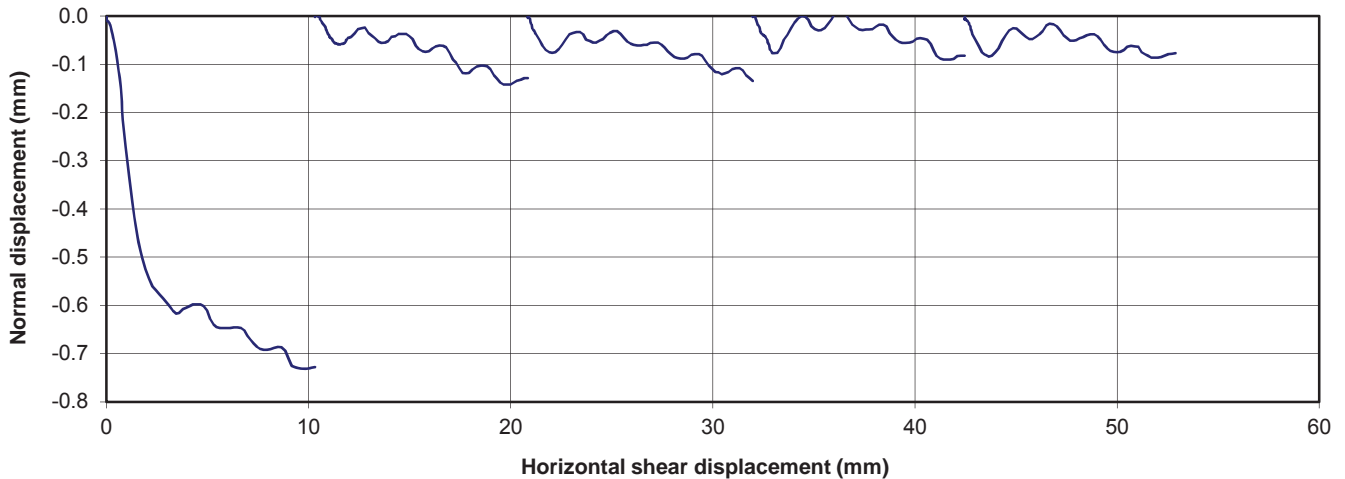
Project #: 11-1362-0057	Phase: 5100 / 4000
Short Title: COS East Riverbank / Cherry Lane - Geotech Investigation / Saskatoon, SK	
Tested By: B.Y. / D.B.	Date: October 22, 2013
Sample: COS-13-005 005-13 11.43-12.04 m depth

Effective Stress: 50 kPa	Peak Shear Stress: 41 kPa	Residual Shear Stress: 31 kPa
Sample Data:	Comments:	
Sample Length: 60.0 mm		
Initial Height: 20.0 mm		
Initial Water Content: 26.2 %		
Initial Dry Density: 1512 kg/m ³		
Final Water Content: 30.9 %

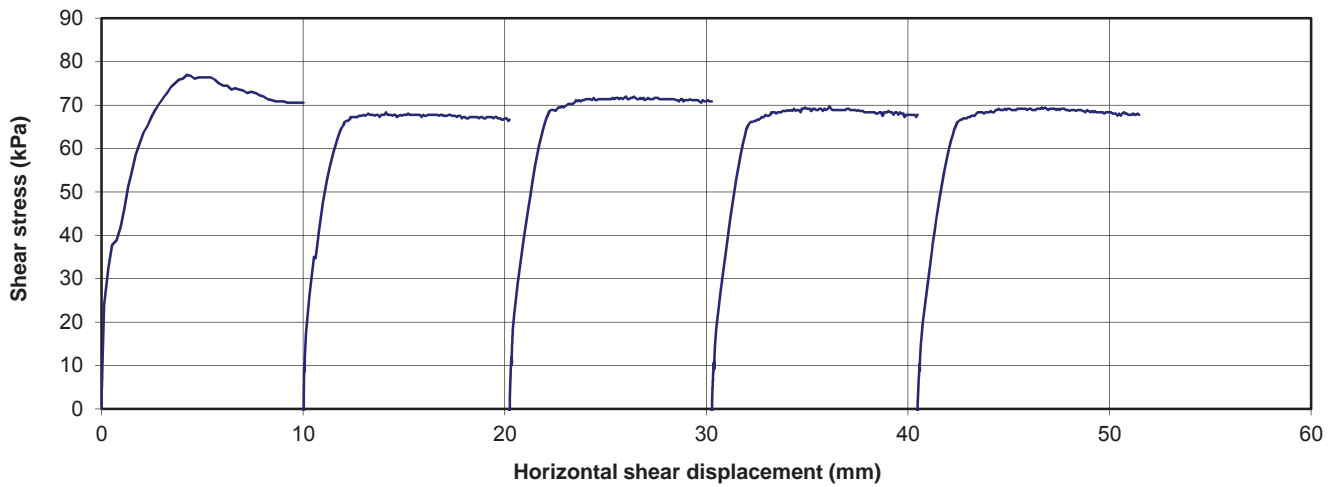
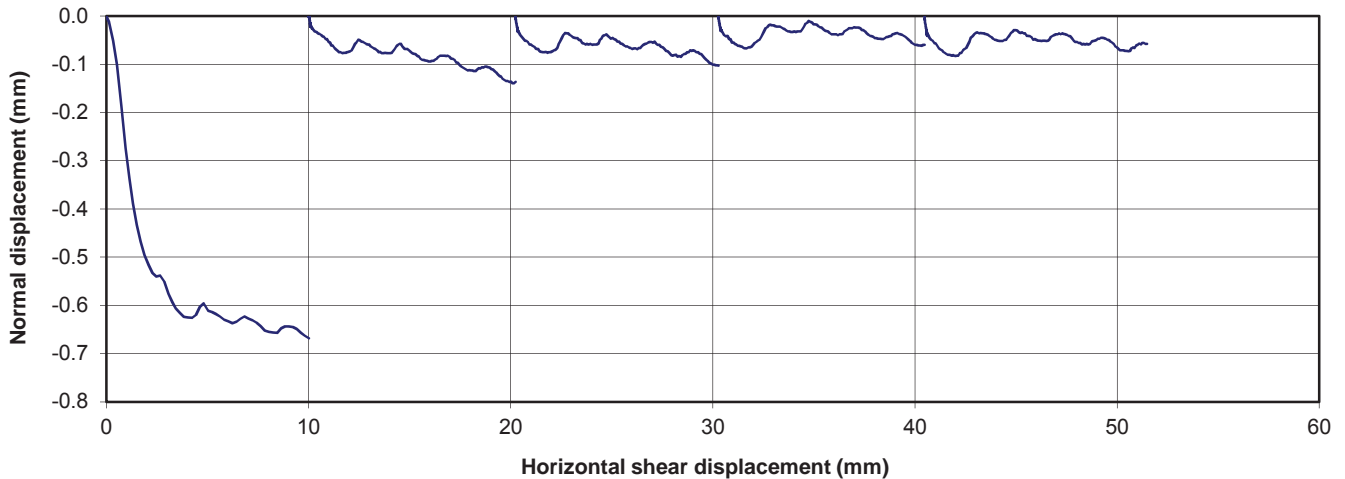
Project #: 11-1362-0057 Phase: 5100 / 4000
 Short Title: COS East Riverbank / Cherry Lane - Geotech Investigation / Saskatoon, SK
 Tested By: B.Y. / D.B. Date: October 22, 2013
 Sample: COS-13-005 005-13 11.43-12.04 m depth

Effective Stress:	100	kPa	Peak Shear Stress:	77	kPa
			Residual Shear Stress	68	kPa
Sample Data:			Comments:		
Sample Length:	60.0	mm			
Initial Height:	20.0	mm			
Initial Water Content:	27.2	%			
Initial Dry Density:	1507	kg/m ³			
Final Water Content:	30.2	%

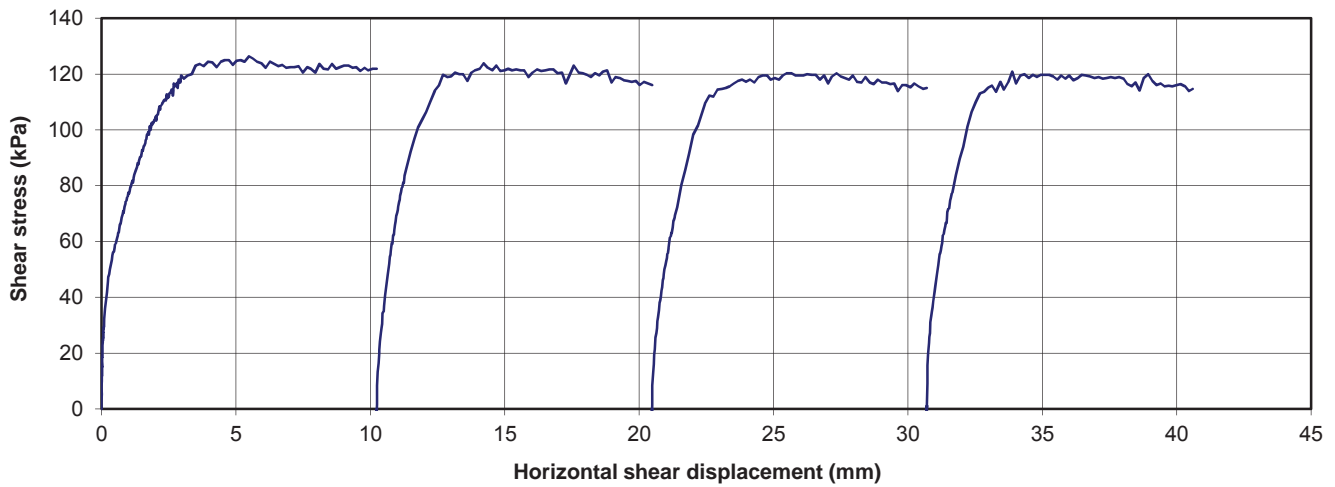
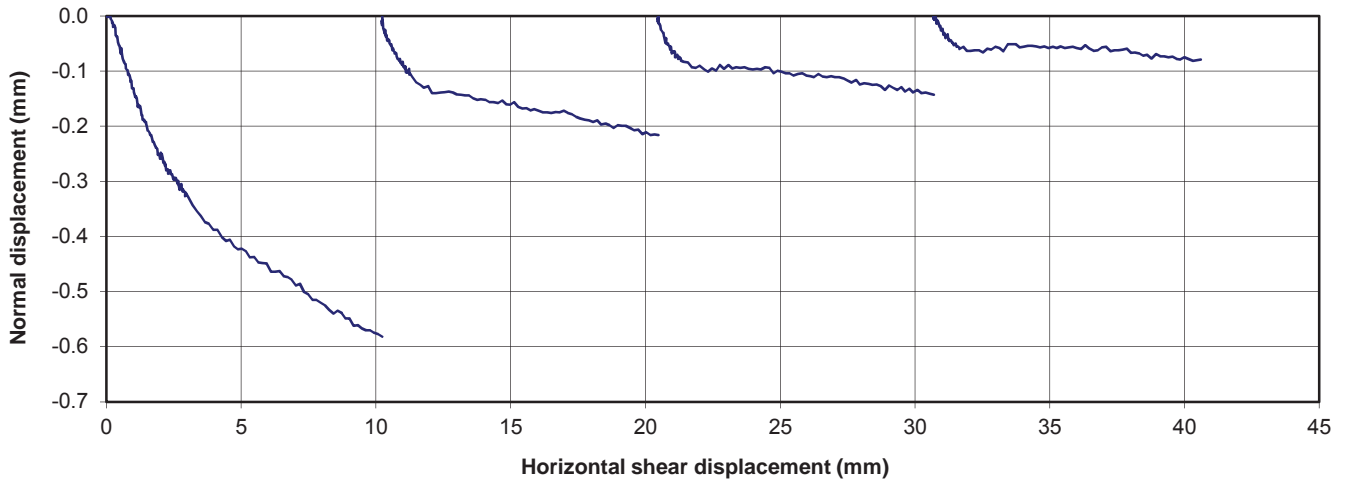
Project #: 11-1362-0057	Phase: 5100 / 4000
Short Title: COS East Riverbank / Cherry Lane - Geotech Investigation / Saskatoon, SK	
Tested By: B.Y. / D.B.	Date: October 22, 2013
Sample: COS-13-005 005-13 11.43-12.04 m depth

Effective Stress: 200 kPa	Peak Shear Stress: 126 kPa
	Residual Shear Stress: 118 kPa
Sample Data:	Comments:
Sample Length: 60.0 mm	
Initial Height: 20.0 mm	
Initial Water Content: 26.4 %	
Initial Dry Density: 1507 kg/m ³	
Final Water Content: 28.5 %
